Authorized Field Change

AFC G-05907

Subject File: REAR AXLE

Subject: Certain 9000i Models Built Between March 29, 2005 and April 26, 2005 with ArvinMeritor RT40 Series Tandem Axles and Suspension Codes 14UNL, 14UNM, and 14UNN, May Require the Inter Axle Prop Shaft Replaced

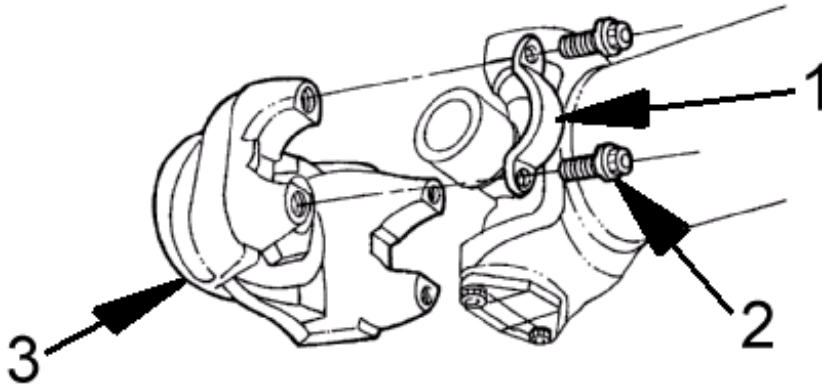
Figure 1 Remove / Install Bearing Caps

1. Bearing Strap
 2. Mounting Bolts
 3. Yoke
4. Compress the slip joint of the inter axle prop shaft for removal clearance and disconnect the inter axle shaft from the yoke.
 5. Repeat Steps 1 and 2 for the other end of the inter axle prop shaft.
 6. Remove the inter axle prop shaft from the vehicle.
 7. Install the new inter axle prop shaft, using new bearing straps, following Steps 1 to 4 in reverse order. Make sure the bearing caps are seated correctly (Figure 2). Tighten the bearing strap mounting bolts:
 - A. 1710 U-Joint Series: 115 to 135 Lbf-ft (156 to 183 Nm)
 - B. SPL170 U-Joint Series: 100 to 120 Lbf-ft (136 to 163 Nm)

2. Raise the forward rear axle and support with jack stands. This will spread the distance between the tandem axles and aid the removal of the inter axle prop shaft.
3. Remove the four bearing strap mounting bolts (Figure 1) from the forward rear tandem axle output yoke.
