41st EU PVSEC 2024, 4AO.8.2, 23.09.2024

# Analysis of Fault Detection and Defect Categorization in Photovoltaic Inverters for Enhanced Reliability and Efficiency in Large-scale Solar Energy Systems

Stephanie Malik<sup>1</sup>, David Daßler<sup>1</sup>, Dharm Patel<sup>1</sup>, Carola Klute<sup>1</sup>, Robert Klengel<sup>1</sup>, Andreas Dietrich<sup>2</sup>, Kai Kaufmann<sup>3</sup>, Carsten Hennig<sup>4</sup>, Danny Wehnert<sup>5</sup>, Matthias Ebert<sup>1</sup>

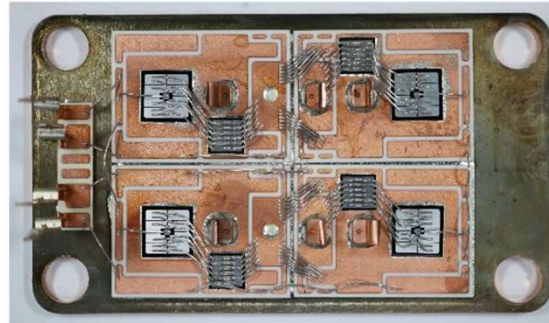
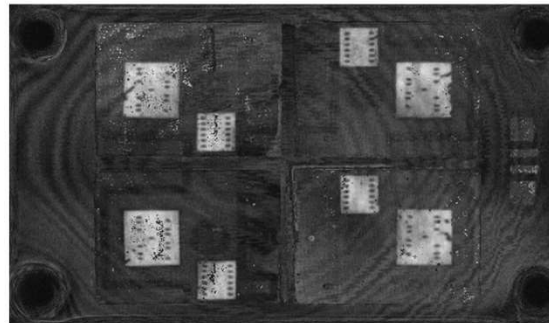
Power module after field ageing

Characterization of the failure mechanisms in inverter components,  
above: Power modules without housing and potting  
bottom: non-destructive scanning acoustic microscopy (SAM) analysis (wire bond level) before removal of housing and potting

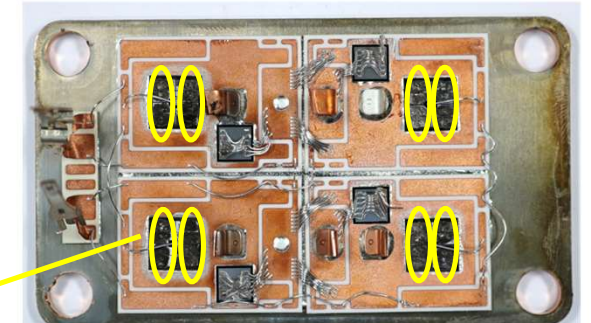
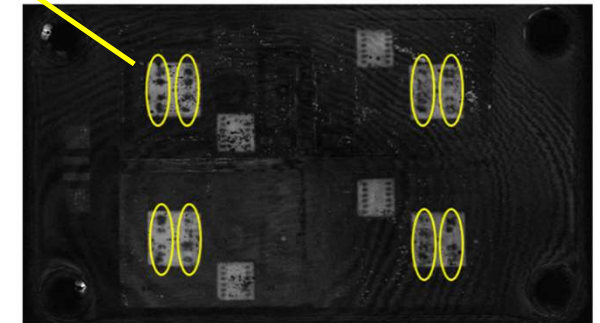
Power module after failure

- **a** Impairments in plane of the wire bond connections
- **b** The emitter metallization of the IGBT components is completely degraded and the associated wire bond connections to the DCB substrate are also destroyed.
- **c** Re-melting of the solder connections of the chips and the pins of the connection terminals is visible.

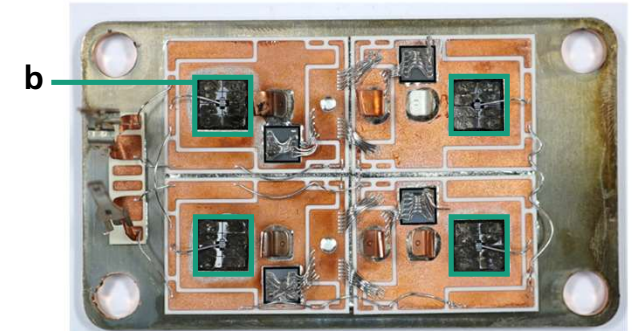
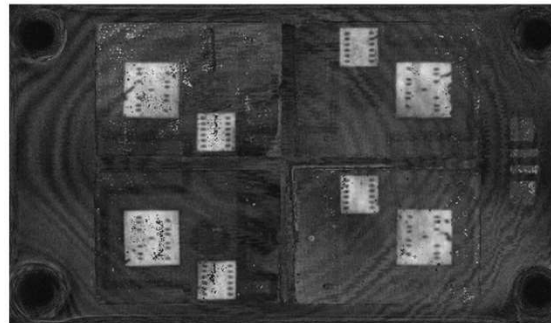
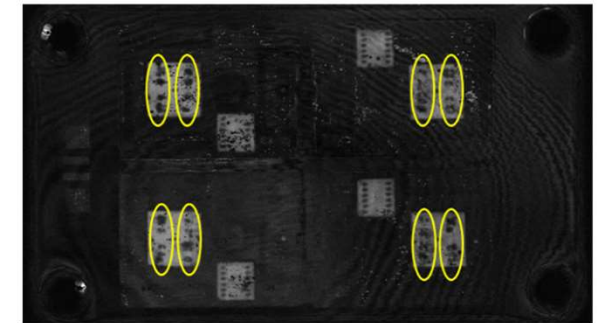
Power module after failure

- **a** Impairments in plane of the wire bond connections
- **b** The emitter metallization of the IGBT components is completely degraded and the associated wire bond connections to the DCB substrate are also destroyed.
- **c** Re-melting of the solder connections of the chips and the pins of the connection terminals is visible.

Characterization of the failure mechanisms in inverter components,  
above: Power modules without housing and potting  
bottom: non-destructive scanning acoustic microscopy (SAM) analysis (wire bond level) before removal of housing and potting

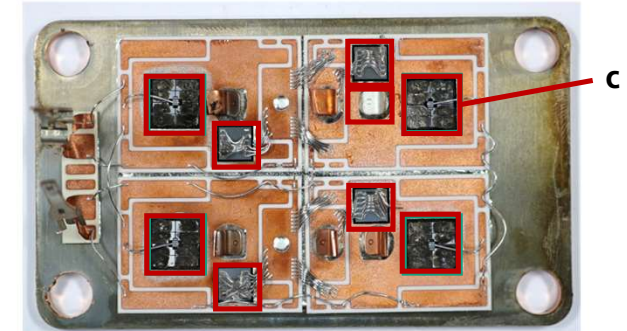
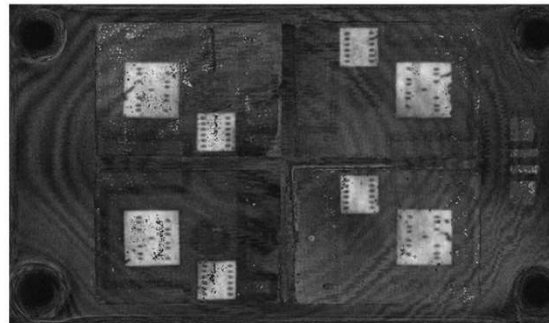
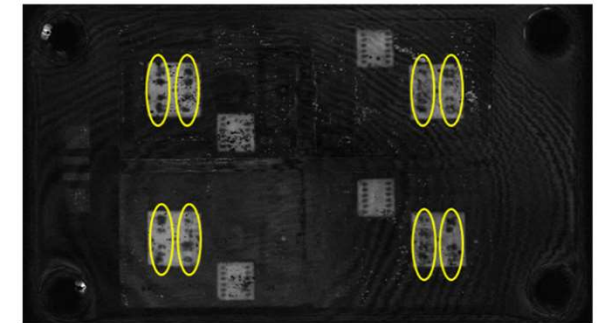
Power module after failure

- **a** Impairments in plane of the wire bond connections
- **b** The emitter metallization of the IGBT components is completely degraded and the associated wire bond connections to the DCB substrate are also destroyed.
- **c** Re-melting of the solder connections of the chips and the pins of the connection terminals is visible.

Characterization of the failure mechanisms in inverter components,  
above: Power modules without housing and potting  
bottom: non-destructive scanning acoustic microscopy (SAM) analysis (wire bond level) before removal of housing and potting

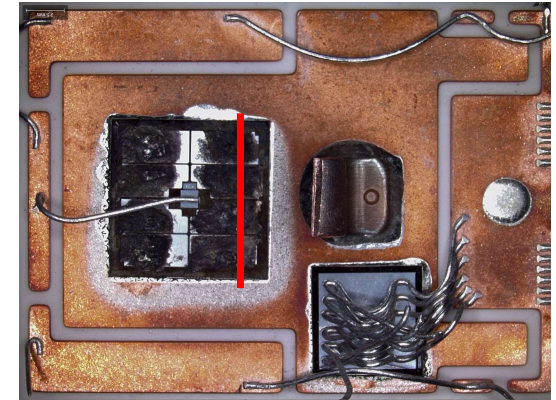
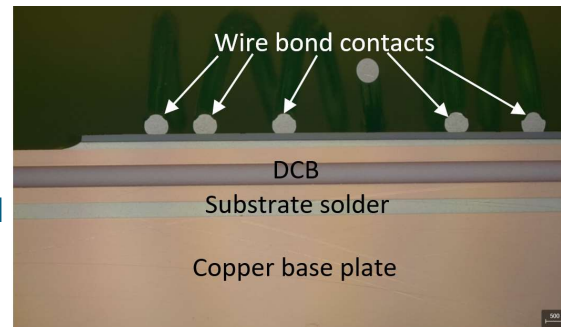
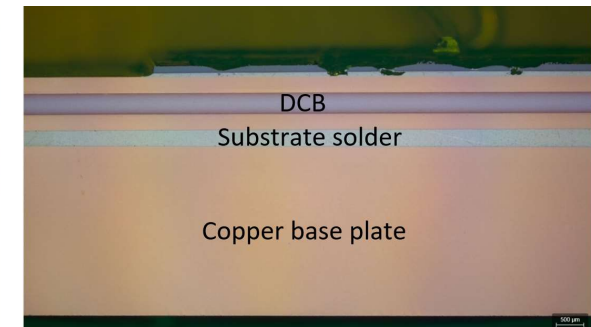
Power module after failure

- wire bond contacts are destroyed and not visible
- partially missing chip and solder area up to the DCB substrate
- The module was exposed to enormous heat, causing melting the chip and solder materials locally.

1. all four IGBT components are equally affected
  2. the associated diodes show no damage
  3. the peripheral extent of damage is less drastic overall
- ➔
- a longer lasting overtemperature load has led to degradation of the semiconductors
  - In the end, a breakthrough occurred and the final damage was caused by the short-term release of massive heat.

Cross sectional view of the bonding wires and solder contact using light microscope imaging of the IGBTs

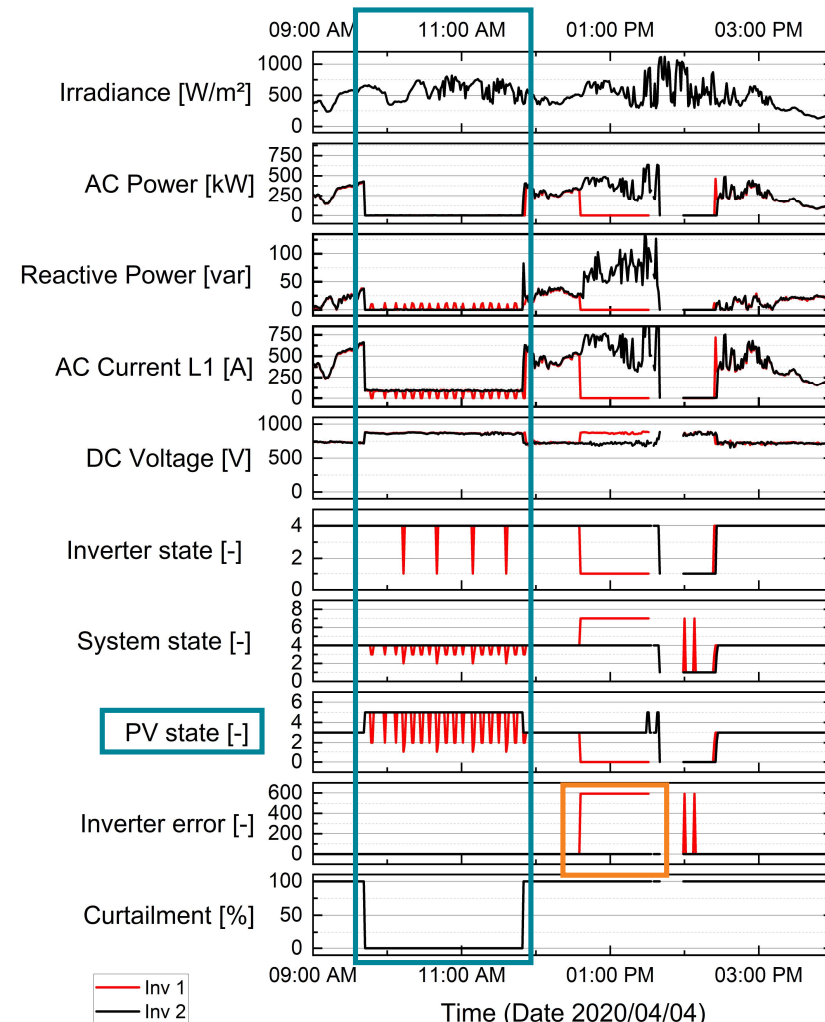
- Deviating inverter behavior recognizable during a grid-related curtailment of inverter 1
- Different states are approached alternately (“underload” - “wake-up” - “underload”, “night”) in contrast to inverter 2
- Occurrence of the error message “IGBT switching error” ½ h after curtailment ended → IGBT module defective

Comparison of measured electrical variables and status information of Inv 1 and a comparable Inv 2 in the same system

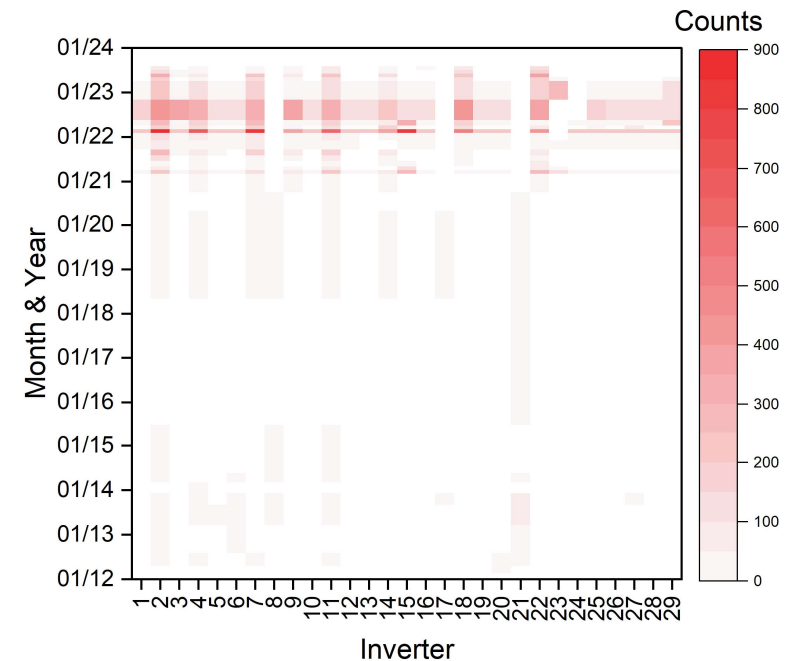
Amount of faulty inverter behavior during curtailment; determined by the state information and its change from one minute to the next
