School District of Philadelphia  
Office of Environmental Management Services  
440 North Broad St.  
Philadelphia, PA 19030

## Asbestos Design Data Collection (DDC)

Name of Building: Webster Elementary School

Address: 3400 Frankford Avenue ULCS # 5490

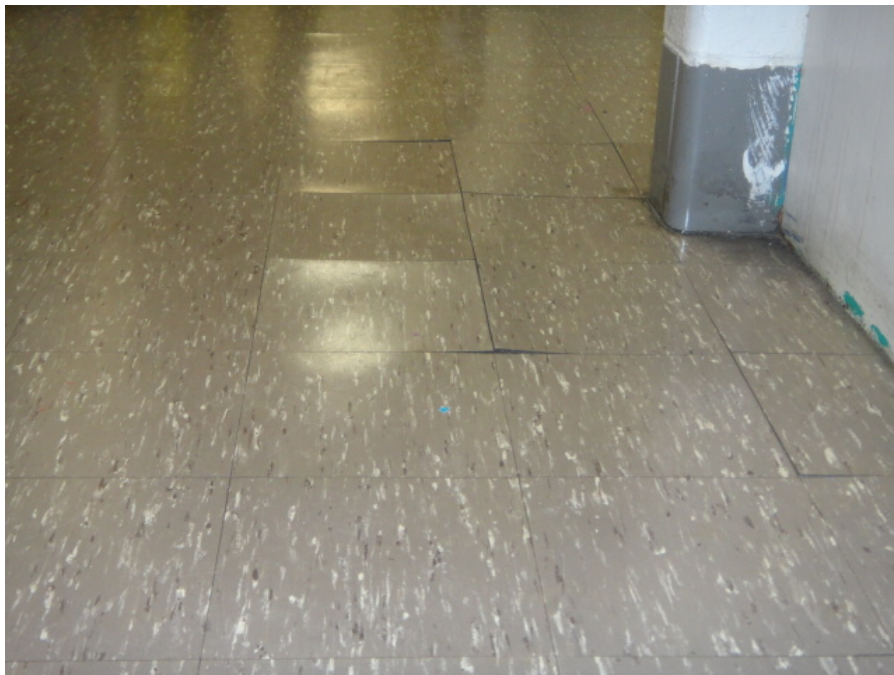
Photo 1 – Room 102  
Delaminated sections of 9”x9” floor tile were noted.

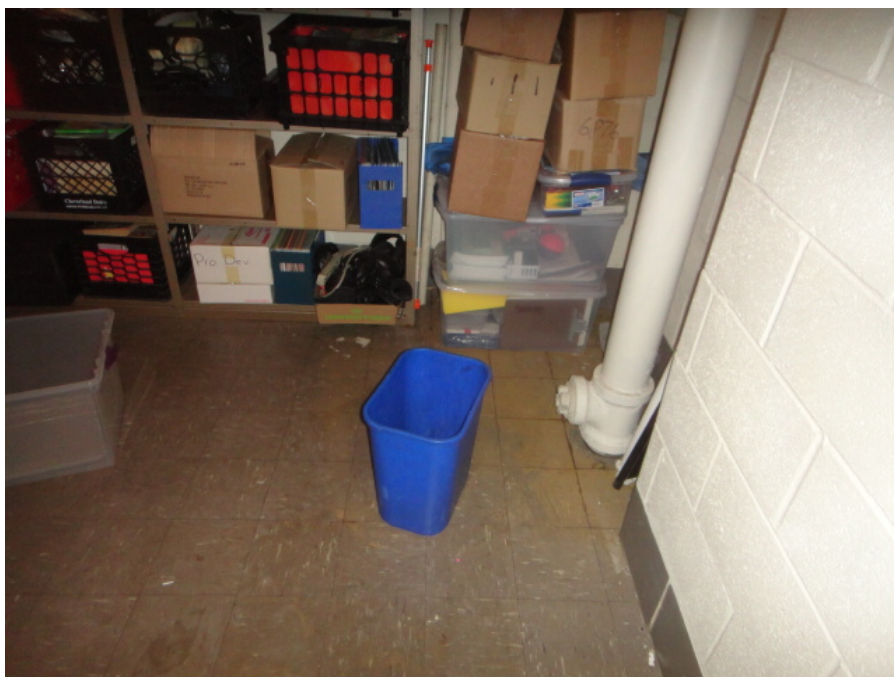
Photo 2 – Reading Intervention Room  
A delaminated section of 9”x9” floor tile was noted.
