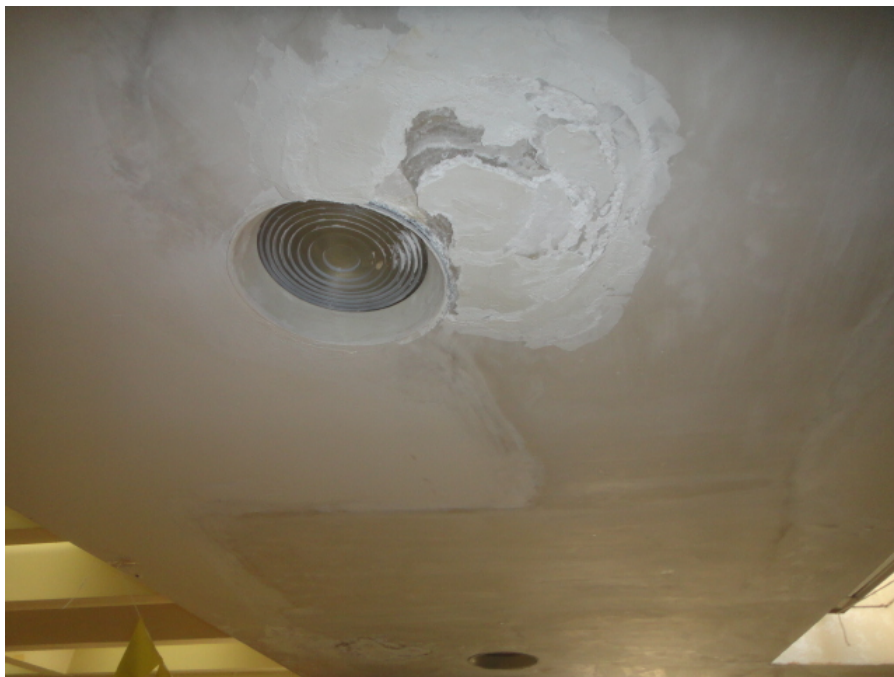
Photo 2 – Room 127

Sections of moisture damaged plaster ceilings were observed.

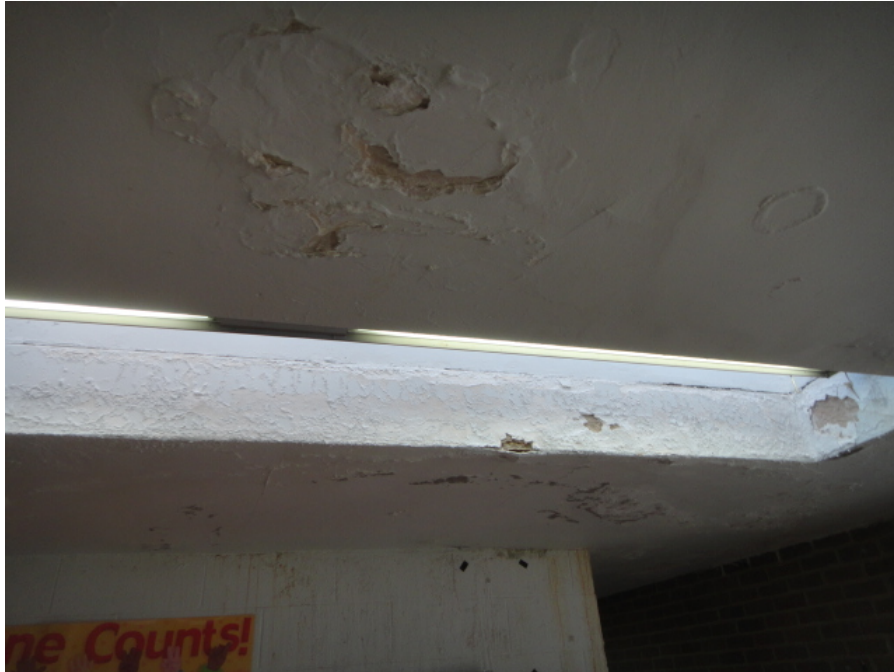
Photo 3 – Room 128
Sections of moisture damaged plaster ceilings were observed.

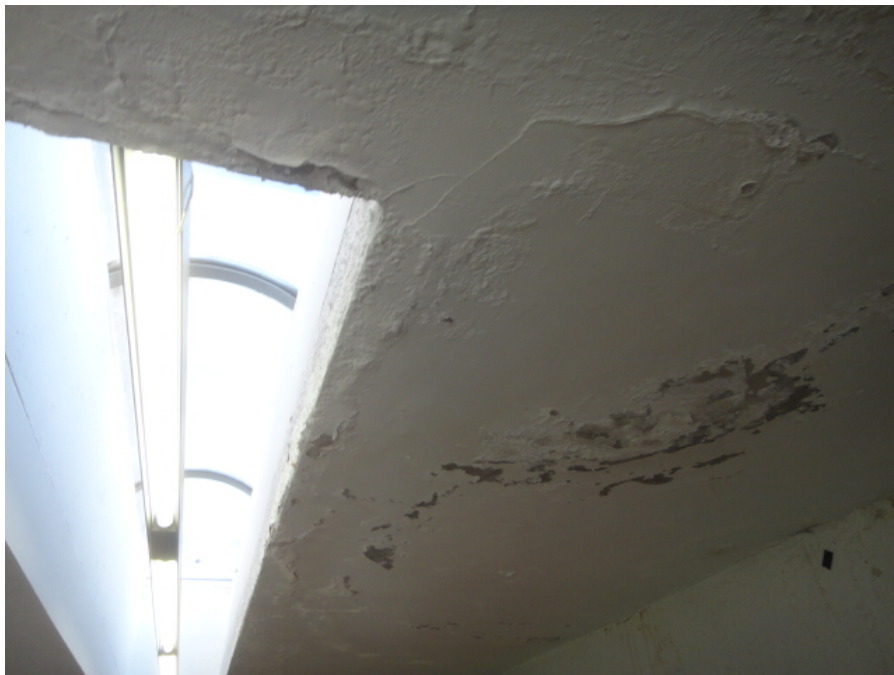
Photo 4 – Room 128
Sections of moisture damaged plaster ceilings were observed.

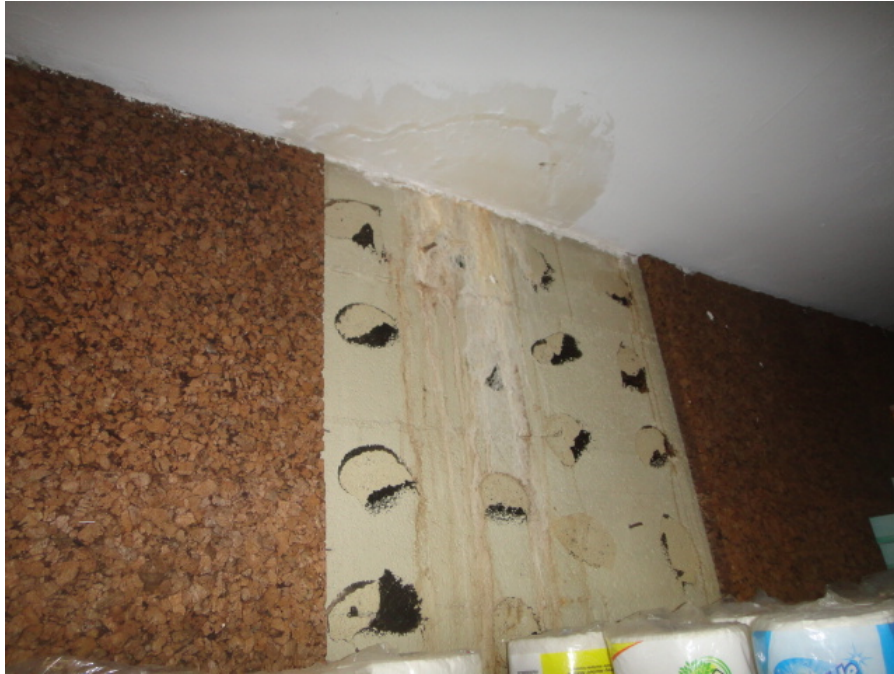
Photo 5 – Room 128 Closet
Water staining was observed on sections of the walls.

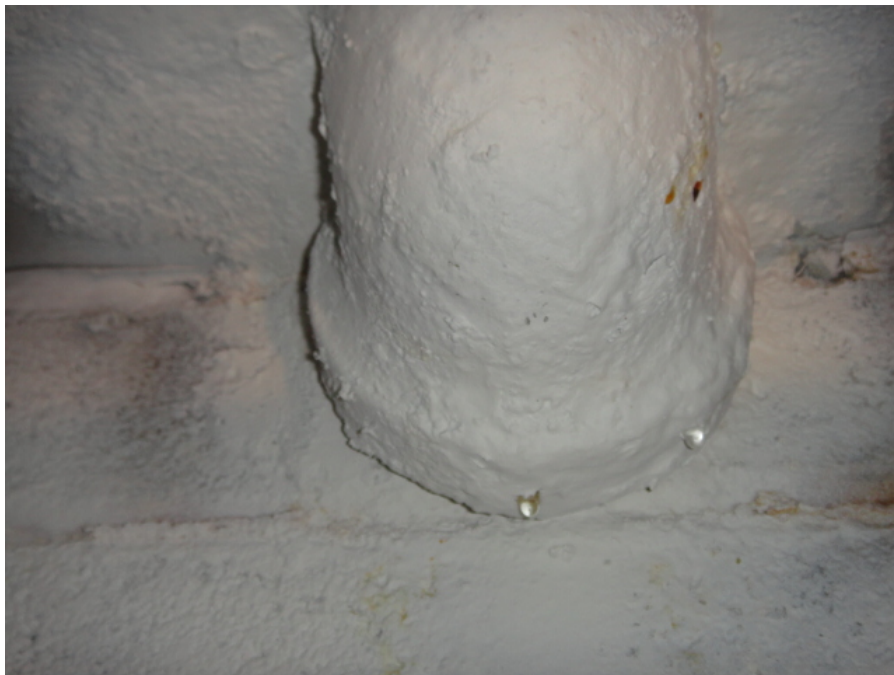
Photo 6 – Room 128 Storage Closet
An active leak was observed on the roof drain.

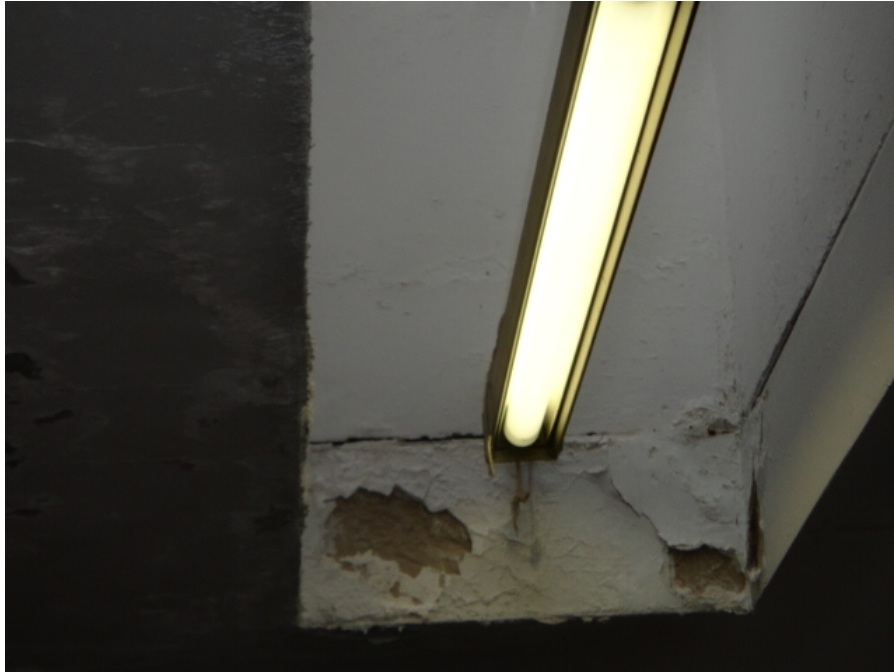
Photo 7 – Room 128
Moisture damaged plaster was observed around the skylights.

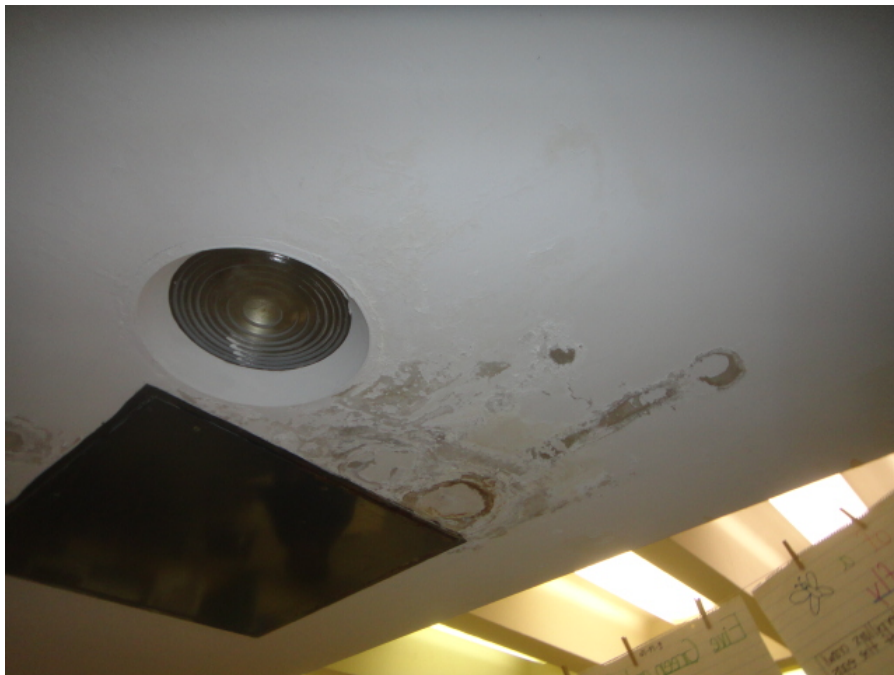
Photo 8 – Room 130
Sections of moisture damaged plaster ceilings were observed.

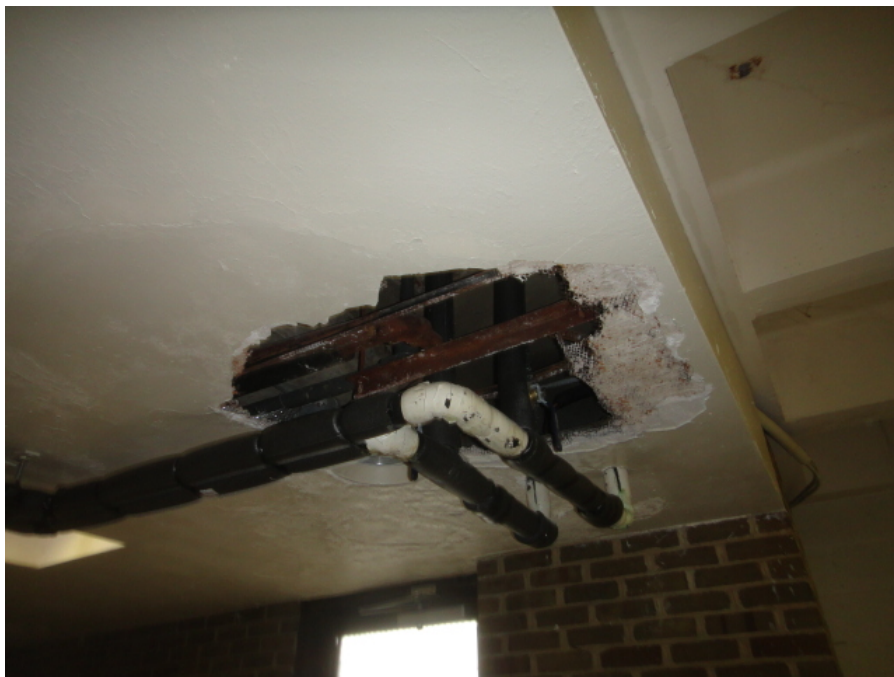
Photo 10 – Room 131

Sections of missing and moisture damaged plaster ceilings were observed.

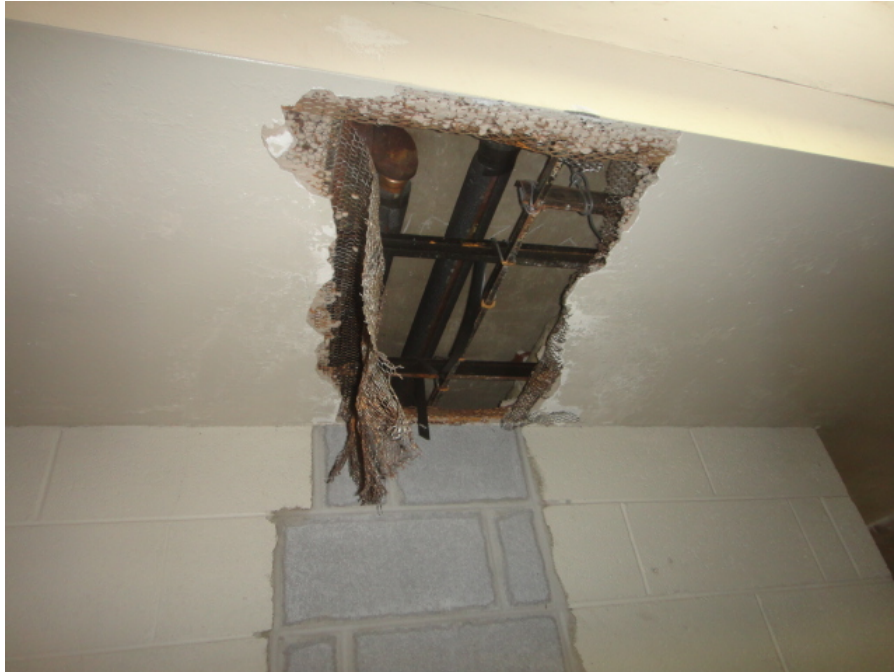
Photo 11– Room 131

Sections of missing and moisture damaged plaster ceilings were observed.

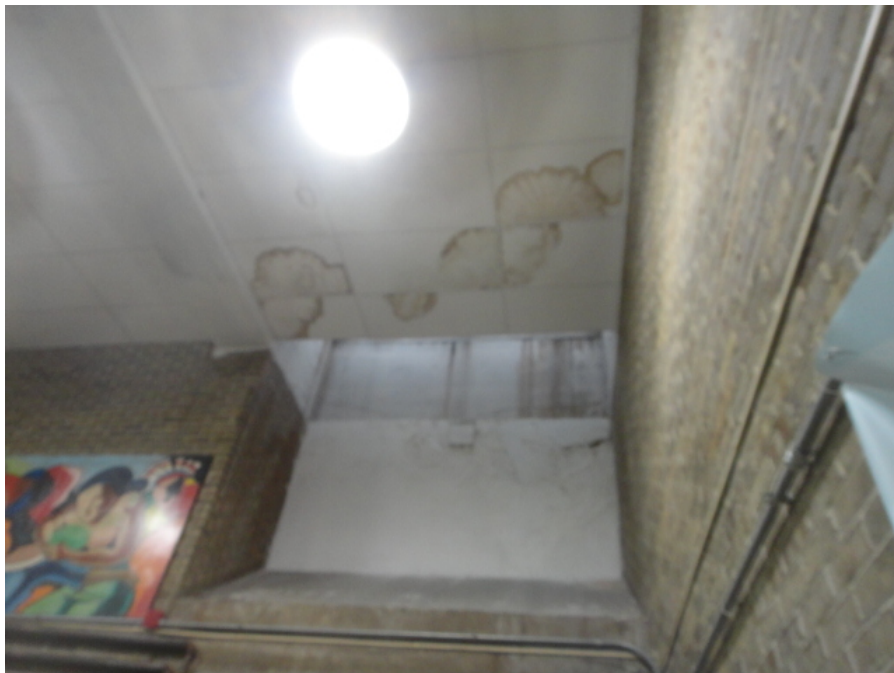
Photo 12 – Cafeteria

Water damaged walls and stained ceiling tiles were observed.

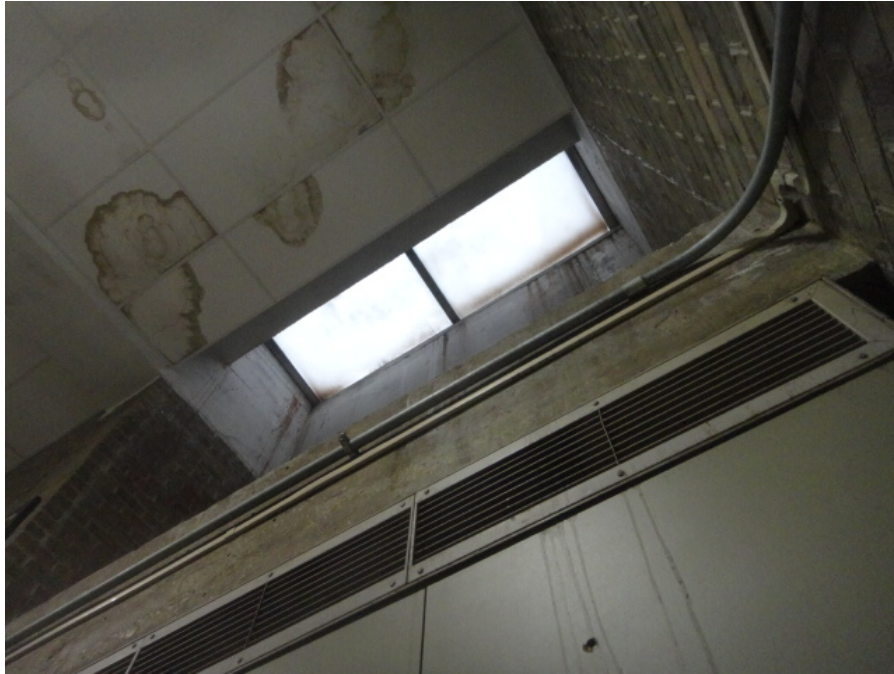
Photo 13 –Cafeteria
Water damaged walls and stained ceiling tiles were observed

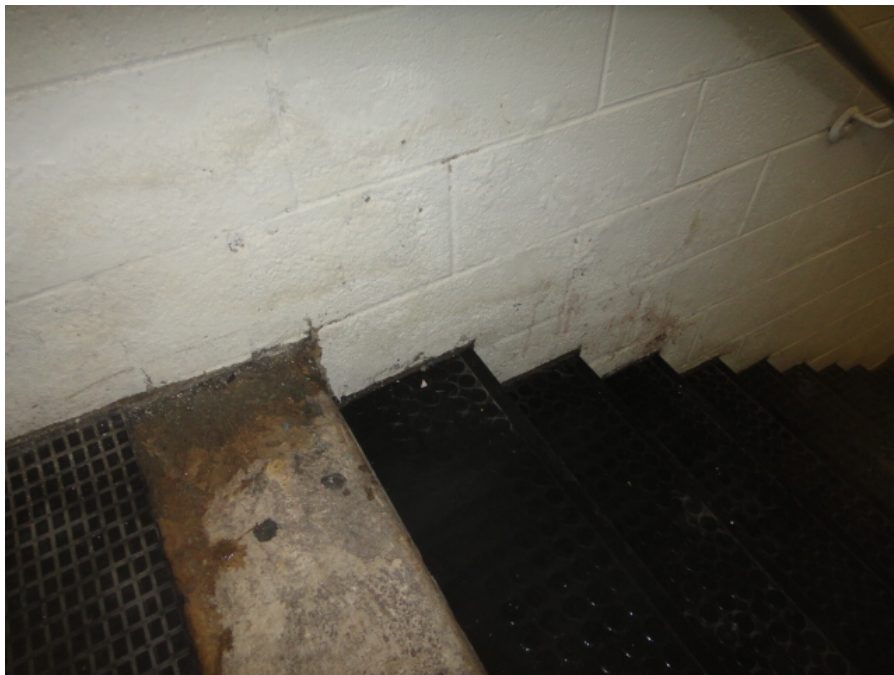
Photo 14 – Stairwell along Spruce Street
Water appeared to be seeping into the stairwell from the exterior sidewalk and steps.

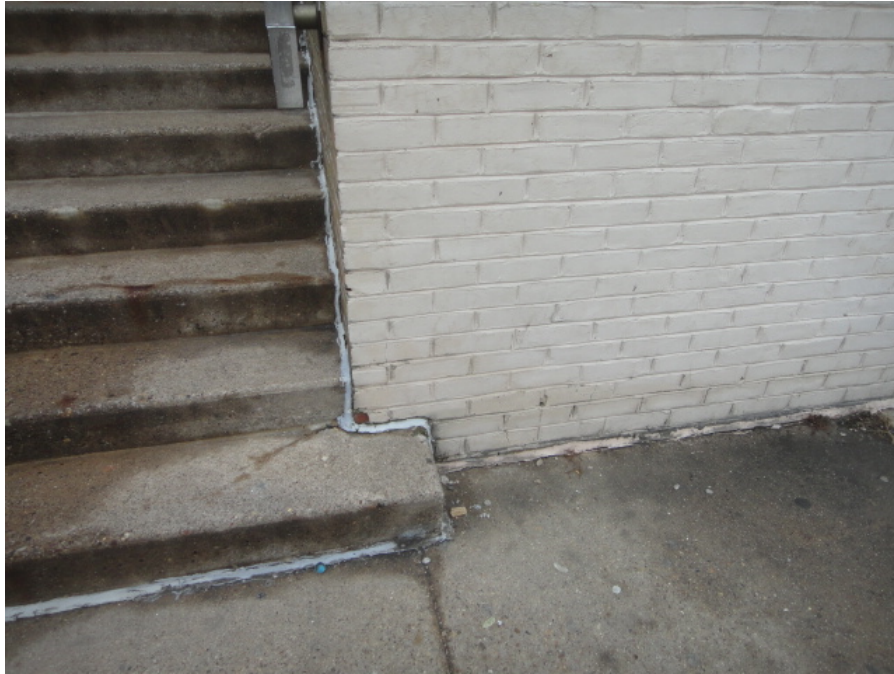
Photo 15 – Stairwell along Spruce Street
Water appeared to be seeping into the stairwell from the exterior sidewalk and steps.

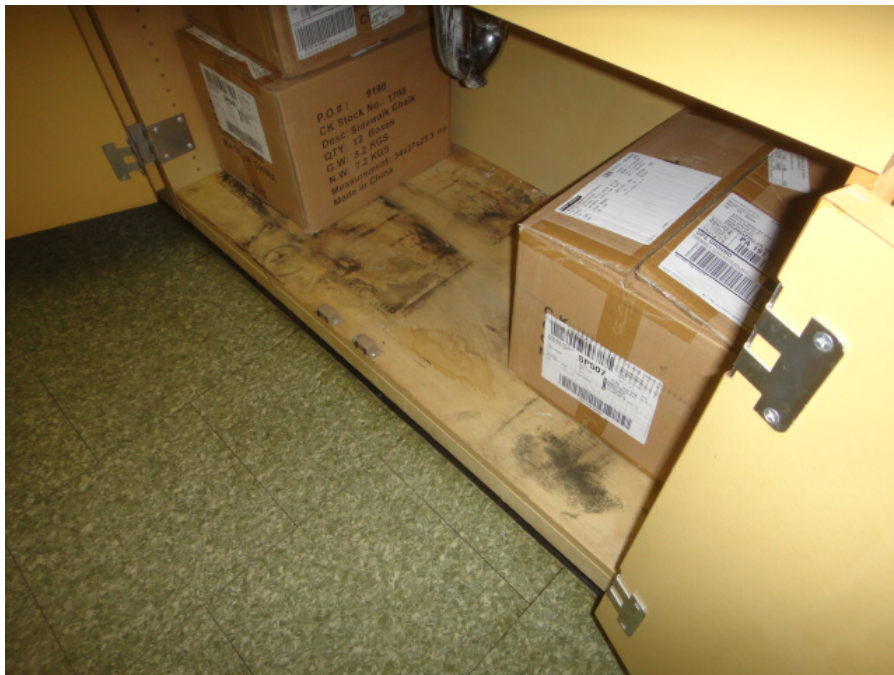
Photo 16 – Nurse's Exam Room A
Mold growth was observed on the bottom of the wooden sink cabinet.

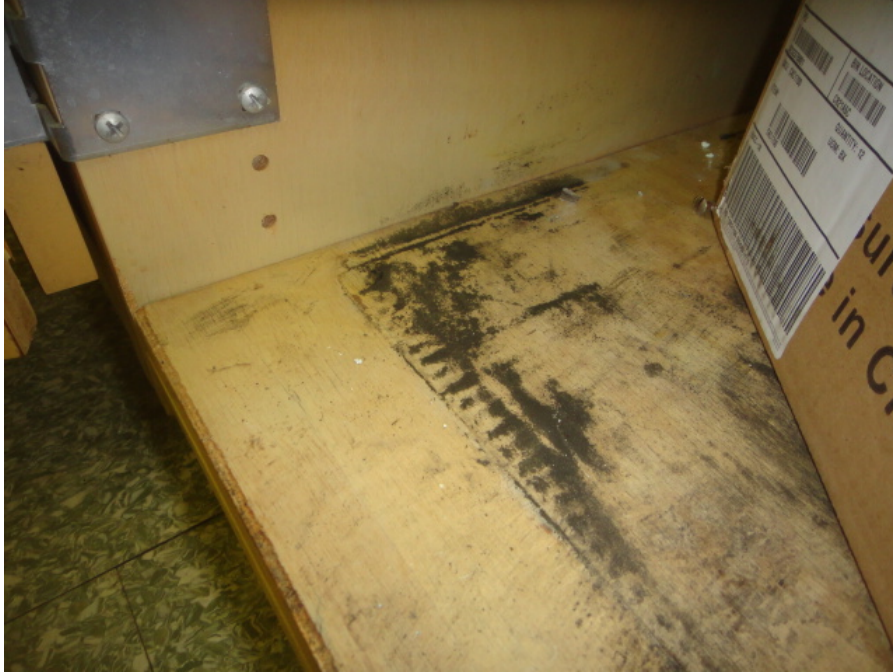
Photo 17 – Nurse’s Exam Room A
Mold growth was observed on the bottom of the wooden sink cabinet.

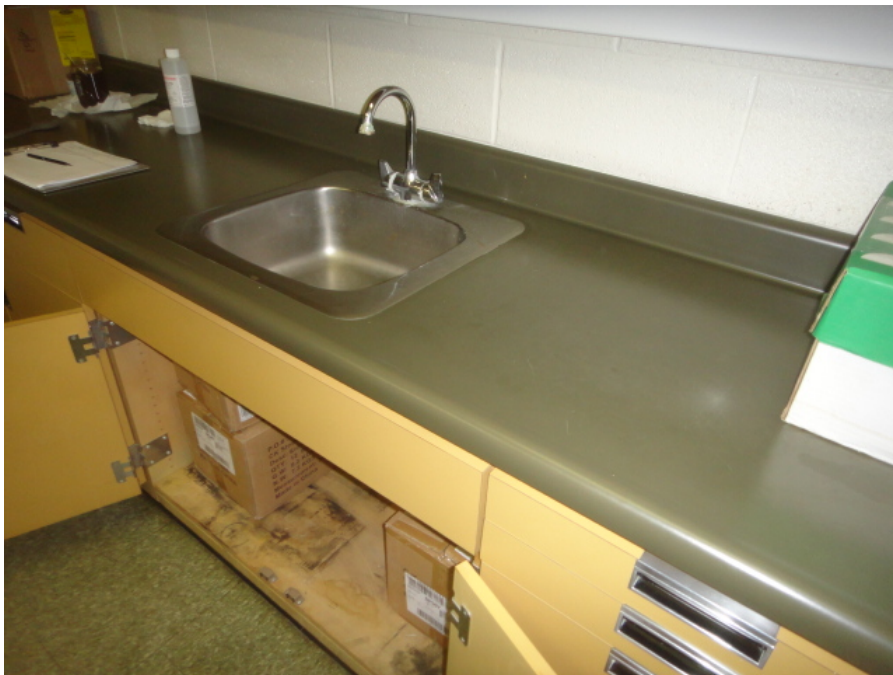
Photo 18 – Nurse’s Exam Room A
Mold growth was observed on the bottom of the wooden sink cabinet.

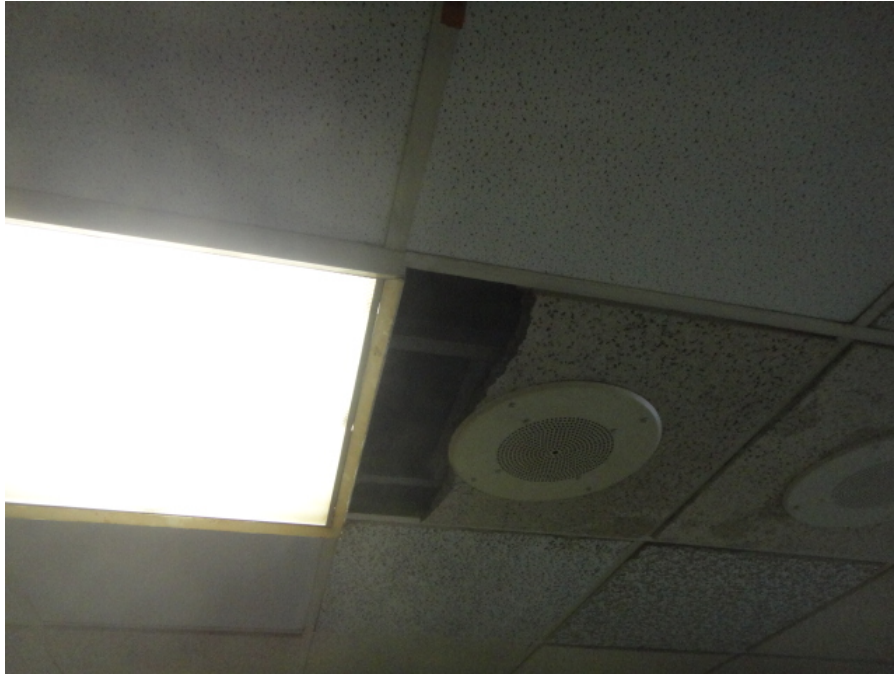
Photo 19 – Hallway outside Room 334
Water stained ceiling tiles were observed.

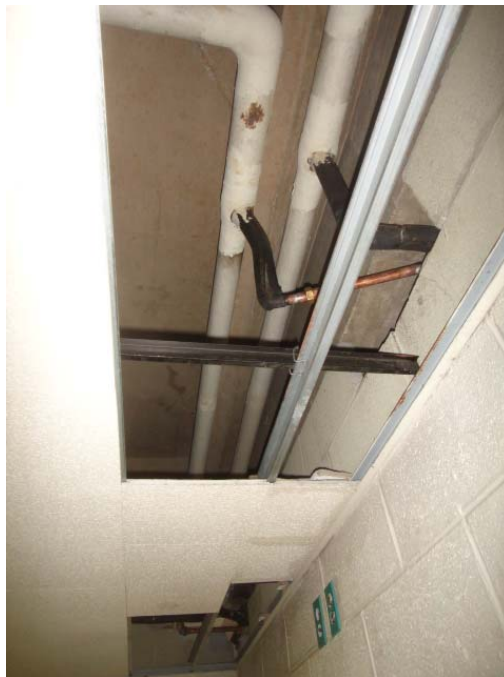
Photo 20 – Room 321
Mold growth was observed on sections of the fiberglass pipe insulation.

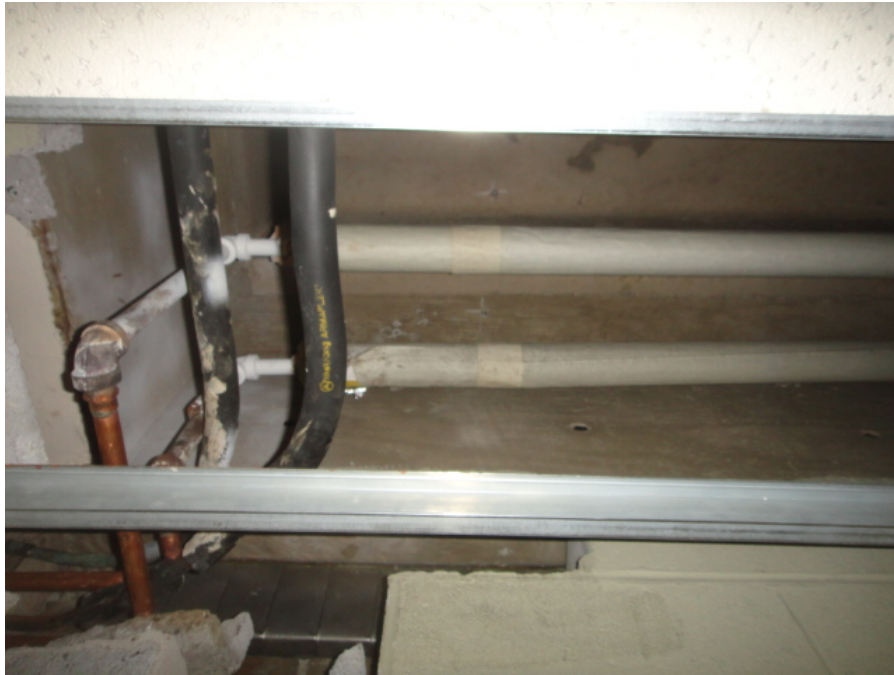
Photo 21 – Room 321
Mold growth was observed on sections of the fiberglass pipe insulation.

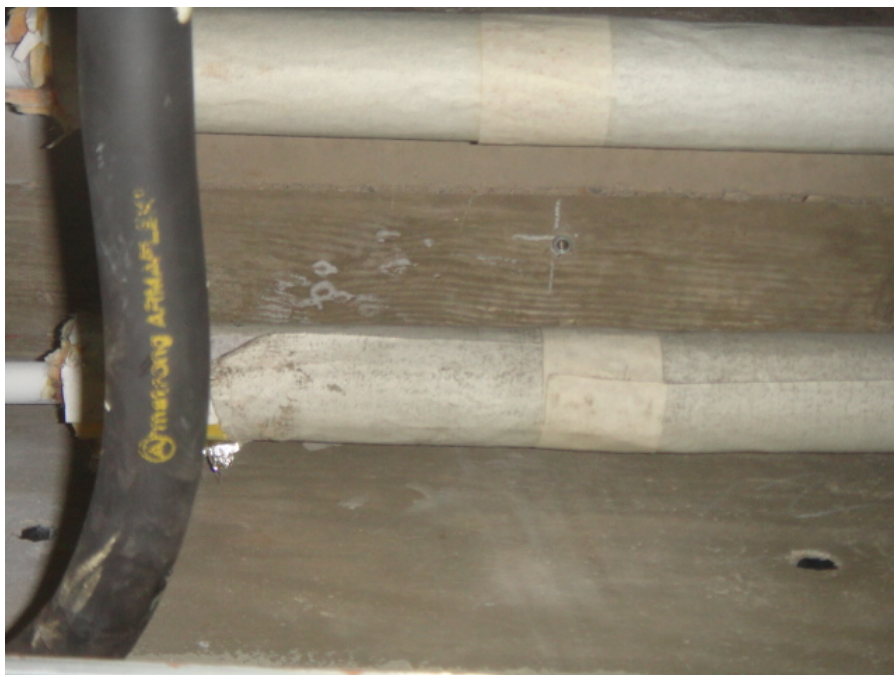
Photo 22 – Room 321
Mold growth was observed on sections of the fiberglass pipe insulation.

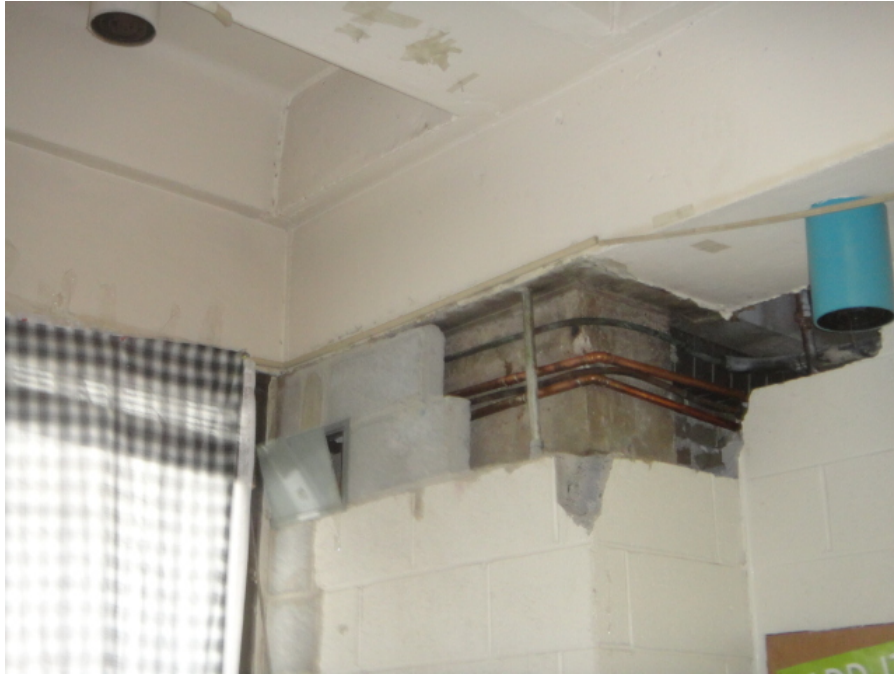
Photo 23 – Room 322

A hole in the block wall was observed from repairs to the piping.

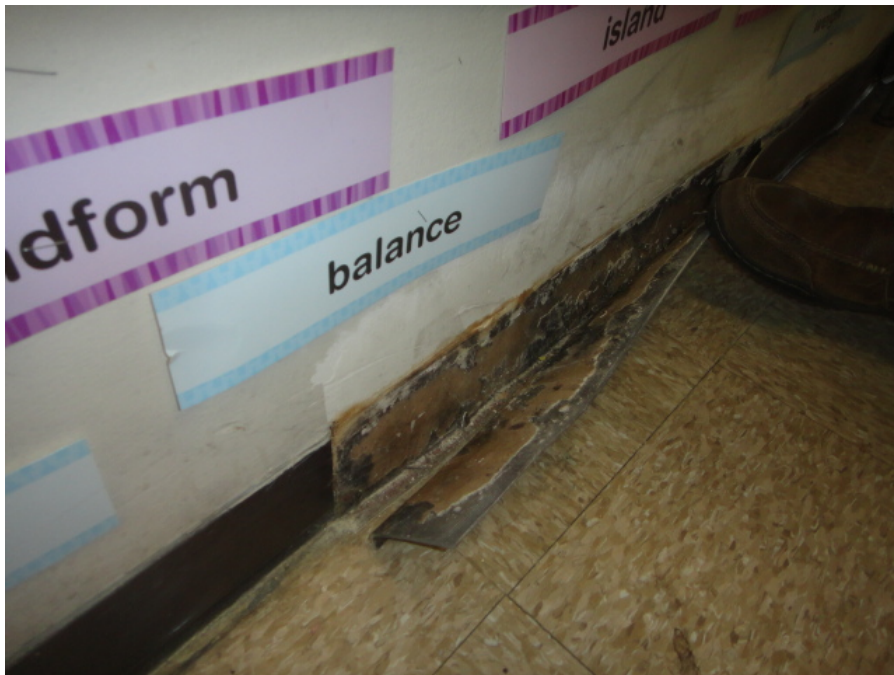
Photo 24 – Room 322

Mold growth was observed along the bottom of the gypsum wallboard.

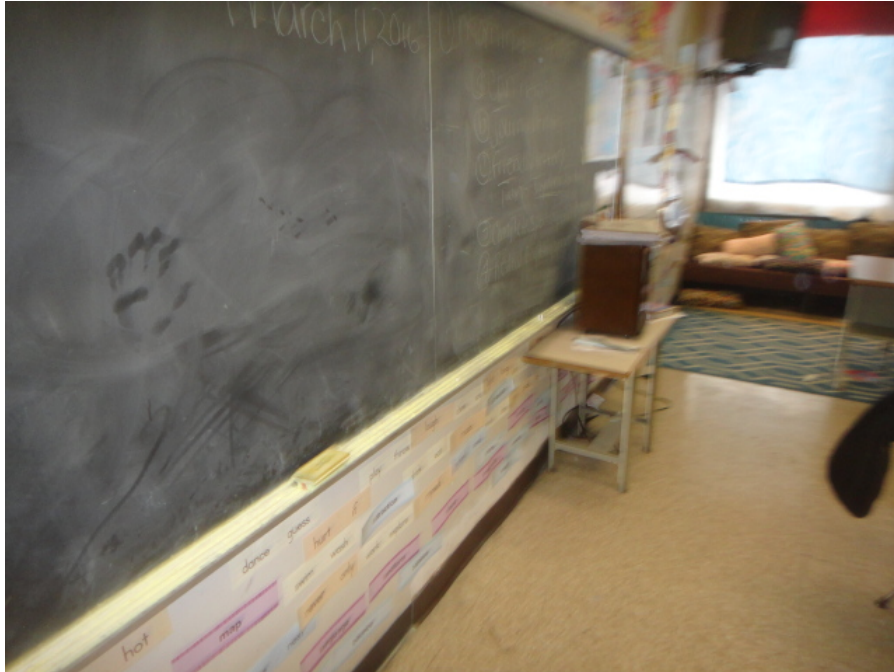
Photo 25 – Room 322

Mold growth was observed along the bottom of the gypsum wallboard.

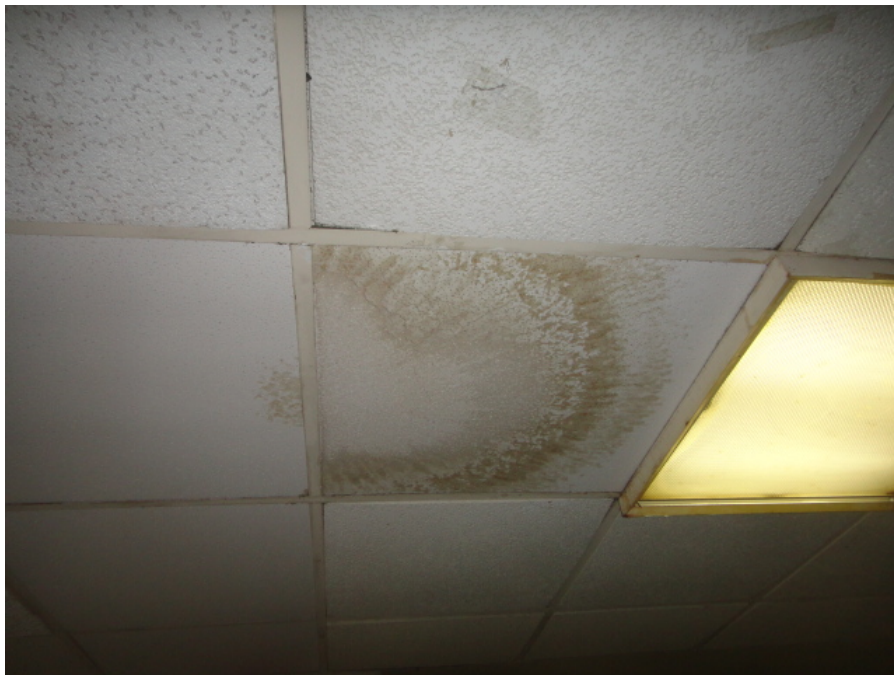
Photo 26 – Hallway outside Room 337
Water stained ceiling tiles were observed.

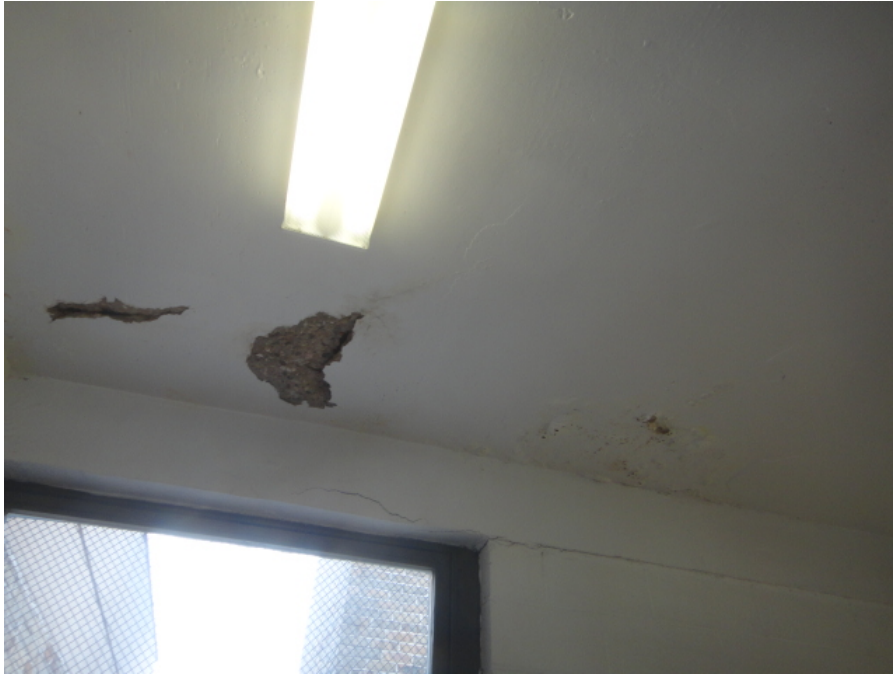
Photo 27 – Stairwell near Room 337
Sections of flaking paint and damaged concrete ceiling were observed.

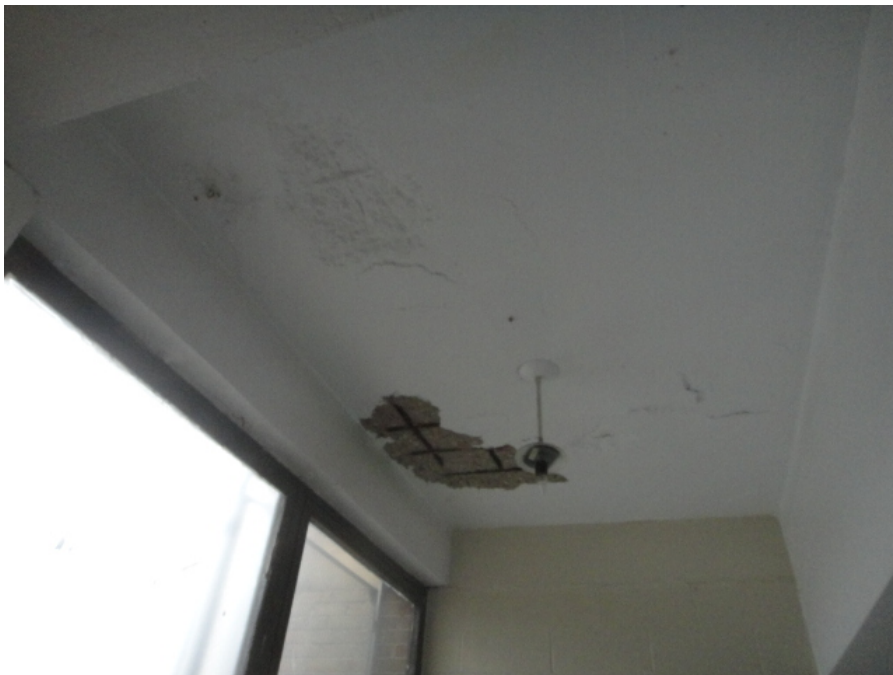
Photo 28 – Stairwell near Room 337
Sections of flaking paint and damaged concrete ceiling were observed.

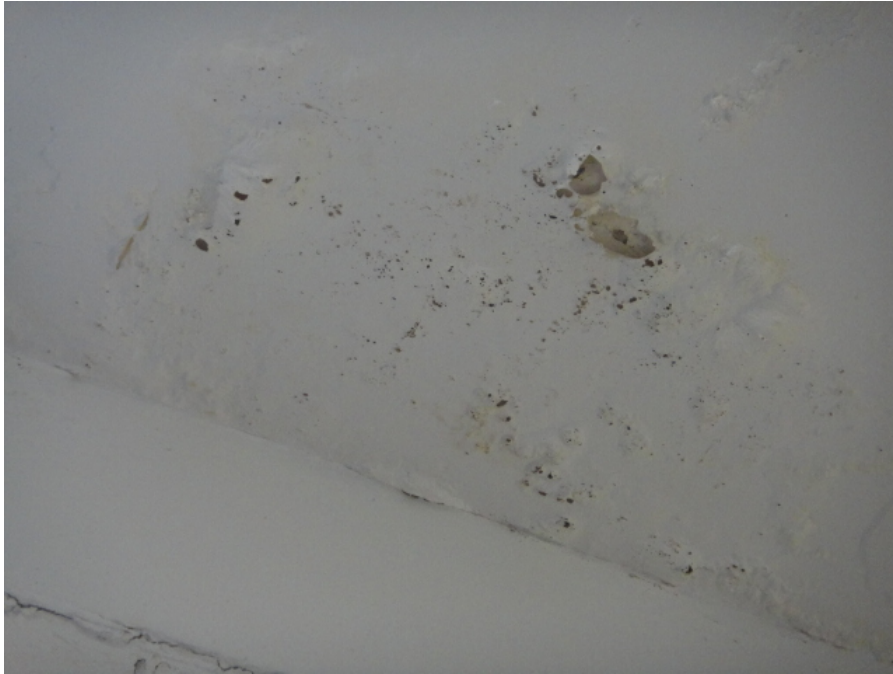
Photo 29 – Stairwell near Room 337
Sections of flaking paint and damaged concrete ceiling were observed.
