School District of Philadelphia
Office of Environmental Management Services
440 North Broad St.
Philadelphia, PA 19030

Asbestos Design Data Collection (DDC)

Name of Building: West Philadelphia Field House

Work Area Location(s): Basement Northwest Storage Room/Coach's Storage Room

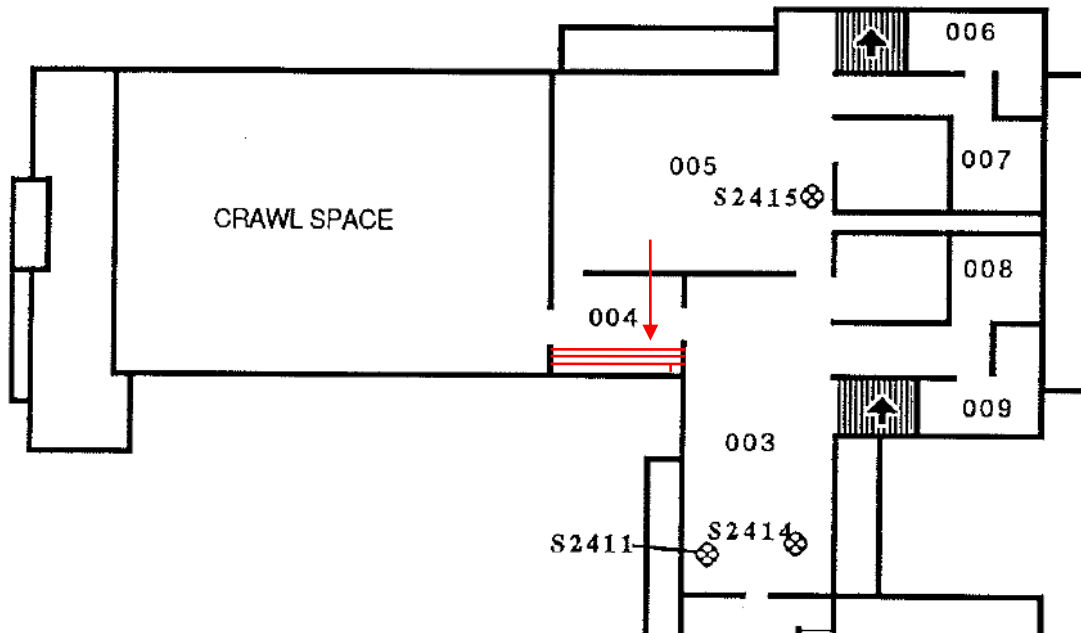
004 – Basement Northwest Storage Room/Coach's Storage Room - Remove 55 LF ACPI & 15 ACPFs
ACPI/ACPF is deteriorating due to high humidity in the adjacent crawlspace - Light fixture is inoperable due to exposure to humidity
Reinstall Critical Barrier at Crawlspace Entrance – Existing Poly Sheeting is Collapsed

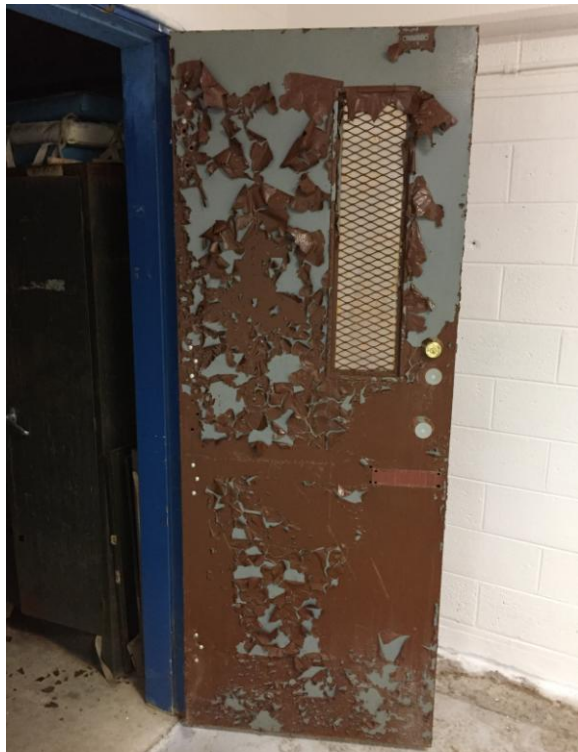
Entrance Door to the Storage Room from the Basement North Locker Room – Paint peeling due to excessive humidity

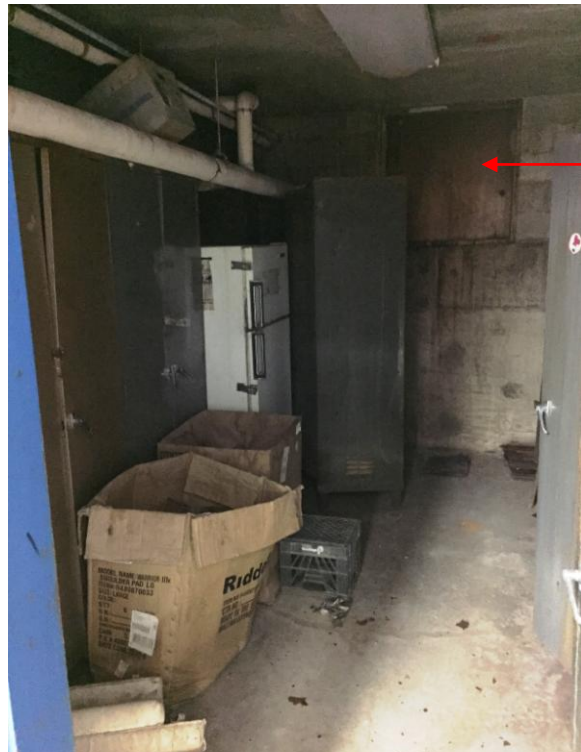
Overview of Storage Room –
Arrow points to the crawlspace entrance on the rear wall

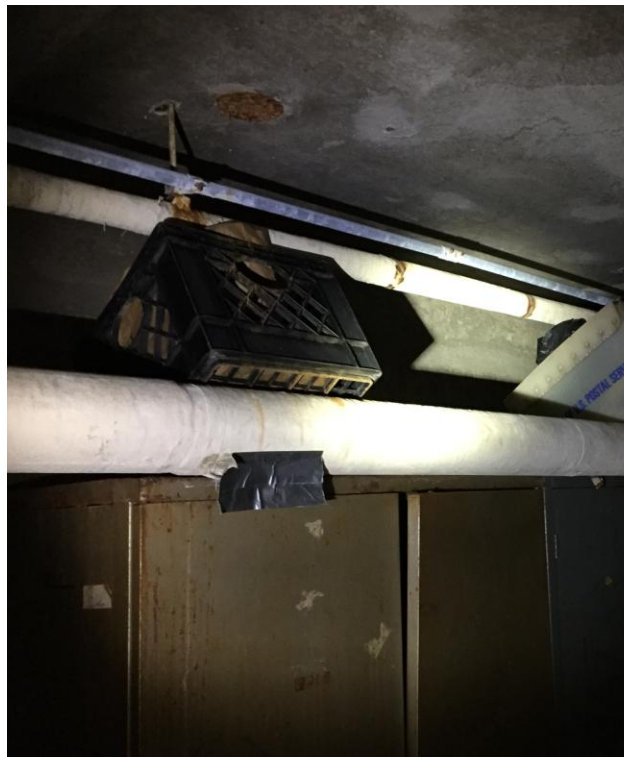
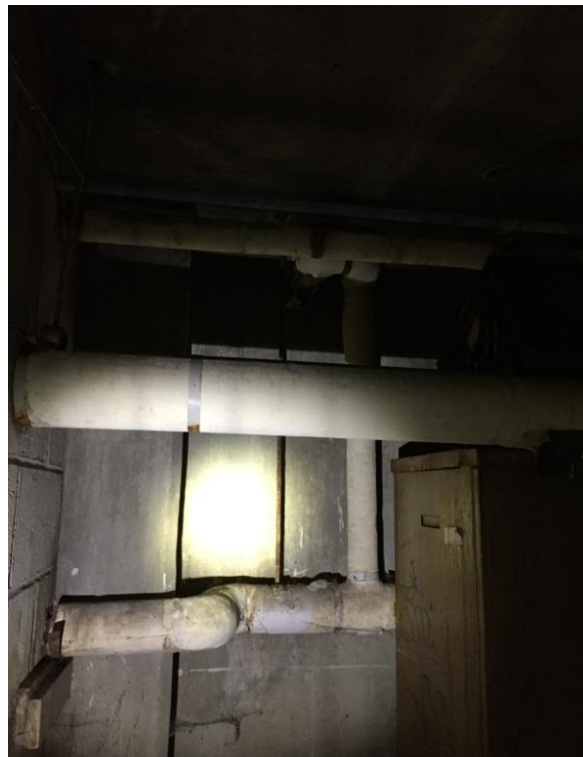
Photos of damaged ACPI/ACPF in the Basement Northwest Storage Room due to excessive humidity and impact

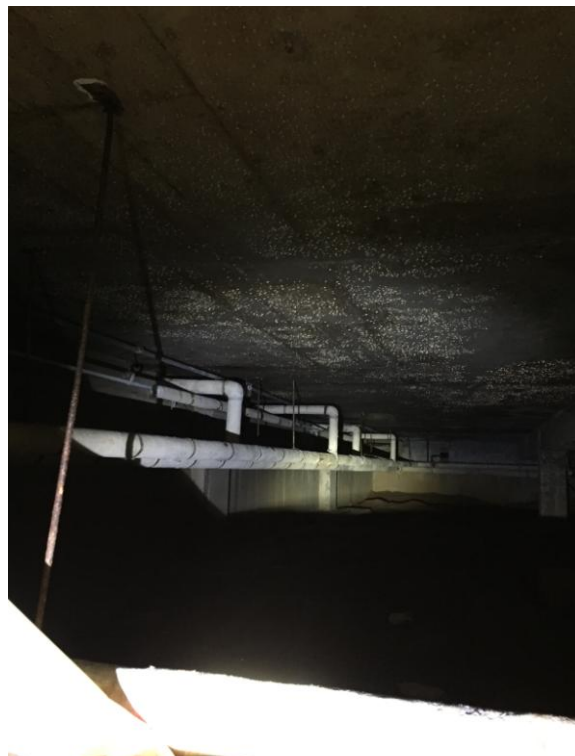
Overview of crawlspace – Water droplets are collecting on the concrete ceiling throughout –
The crawlspace is not properly ventilated - ACPI/ACPF is slowly deteriorating - plan for removal in the future
