Date
Inspected:
10/30/13

Mold Design Data Collection (DDC)

Name of Building: Meehan Middle School Phone # 215-335-5992

Work Area Location(s): (1) Room S-01 and (2) Room S-02

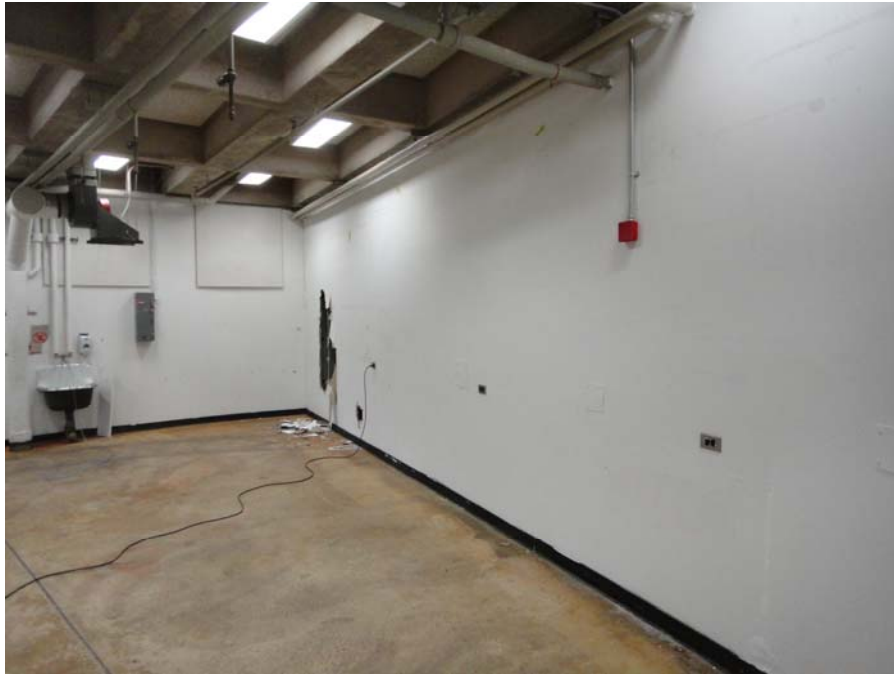
Photo 1 – Room S-01 (Dance Studio)

The impacted drywall walls are located next to room S-02 and along the rear wall to the right of the exterior doors.

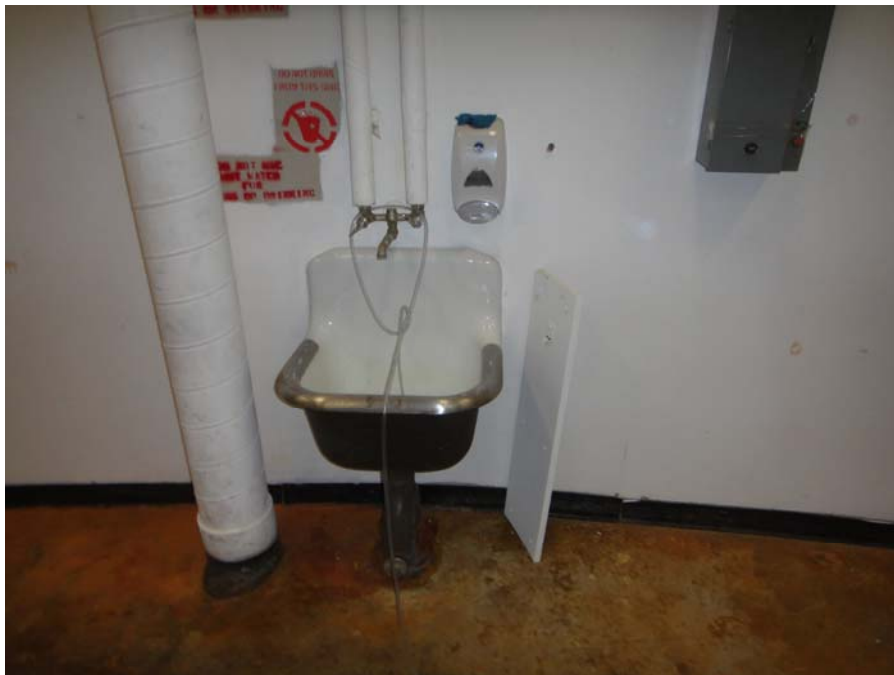
Photo 2 – Room S-01 (Dance Studio)

Sink where the sewage backup occurred and overflowed on the floor.

4	Room S-01	1 EA	CLN		Disinfect the sink where the backup occurred.
5	Room S-01	N/A	DRY		Dehumidifiers should be used to expedite drying of the disinfectant and encapsulant.

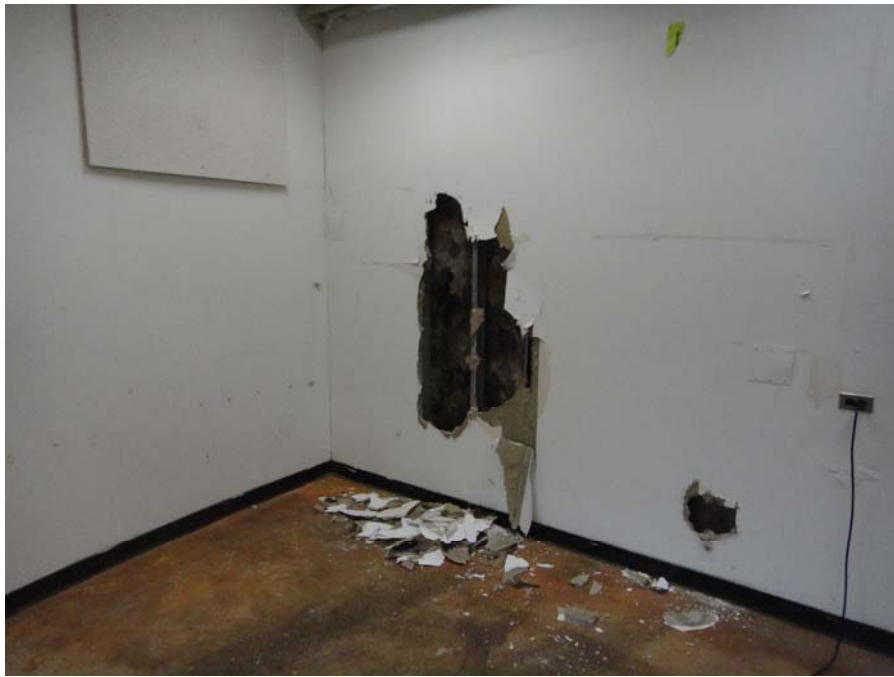
Photo 3 – Room S-01 (Dance Studio)
Exploratory holes were made in the drywall by the B.E.

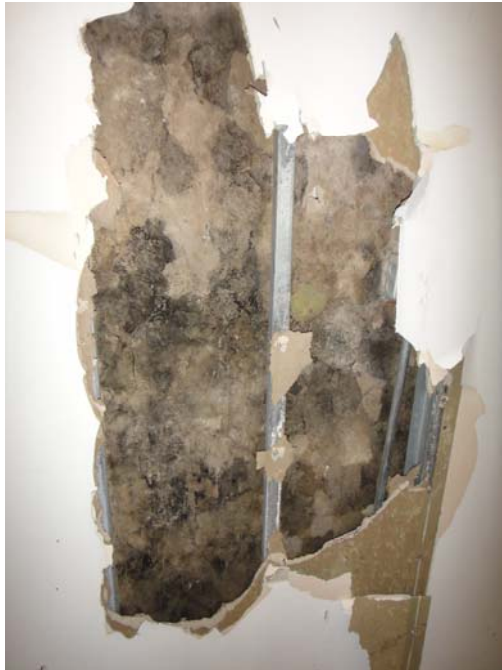
Photo 4 – Room S-01 (Dance Studio)
Exploratory holes were made in the drywall by the B.E.

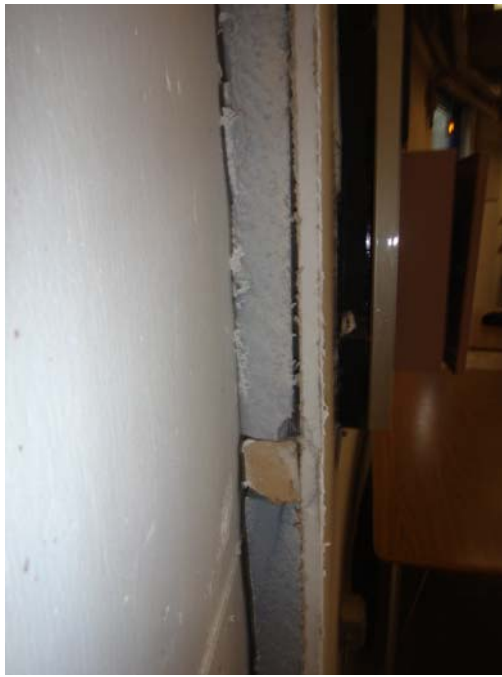
Photo 5 – Room S-01 (Dance Studio)

Wall assembly along the exterior wall is constructed of wooden furring strips and foam insulation boards.

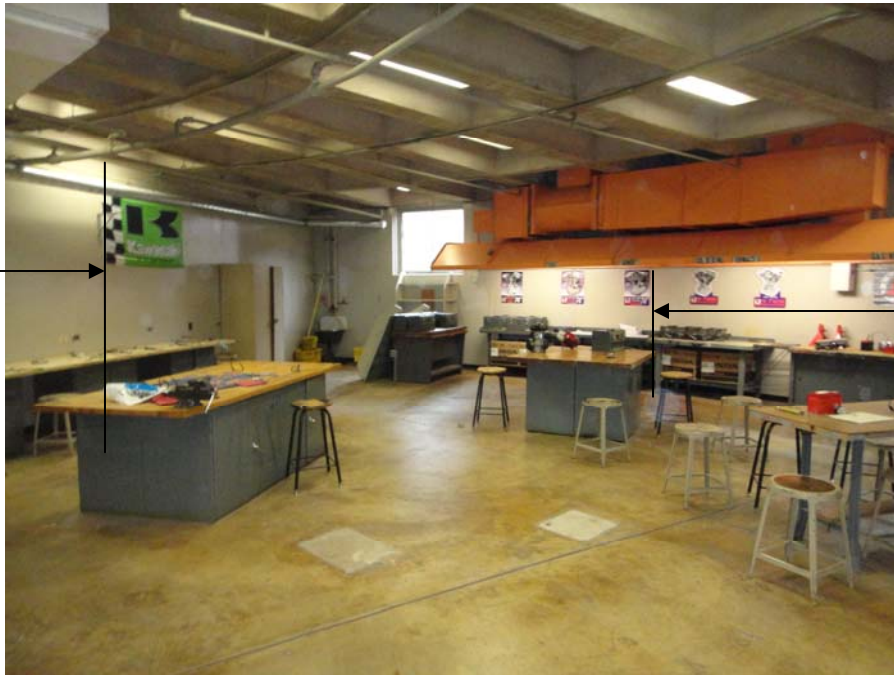
Photo 6 – Room S-02 (Woodshop)

Action Item	Affected Material(s)	Total Quantity	Remediation*	Source of Moisture	Comments/Condition (i.e. dry/wet)
6	Elevated moisture content readings were detected on the drywall next to room S-01 from floor to decking and along the exterior wall.	300 SF	RMV, DIS,	The sink in S-01 overflowed and the sink in S-02 backed up with sewage from a blocked line in room 212. Line blockage was cleared.	Measuring from the corner of the room as indicated on page 7; remove drywall partition next to room S-01 from floor to decking 15' from the corner. Also, remove the drywall along the rear exterior wall 15' from the corner to the height of the exhaust hood.
7	Room S-02	N/A	CLN, ENP		Following removal of the drywall, HEPA vacuum, disinfect and encapsulate the metal studs and concrete exterior wall.
8	Room S-02	600 SF	CLN		HEPA vacuum and disinfect the flooring.
9	Room S-02	1 EA	CLN		Disinfect the sink where the backup occurred.

Elevated moisture content was detected on the drywall located between the arrows and vertical lines.

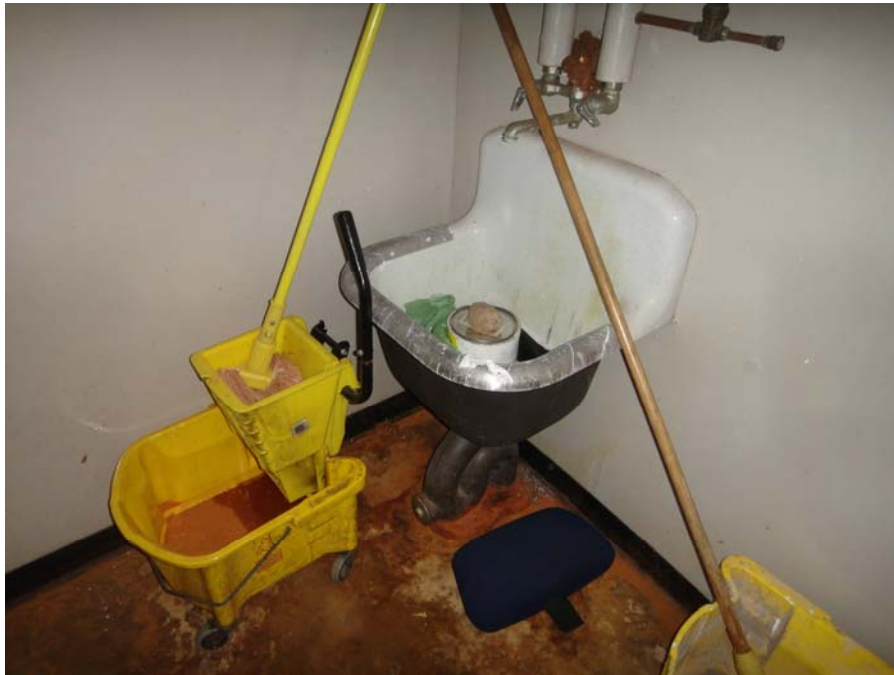
Photo 7 – Room S-02 (Woodshop)
This sink reported backed up with sewage, however, it did not overflow.

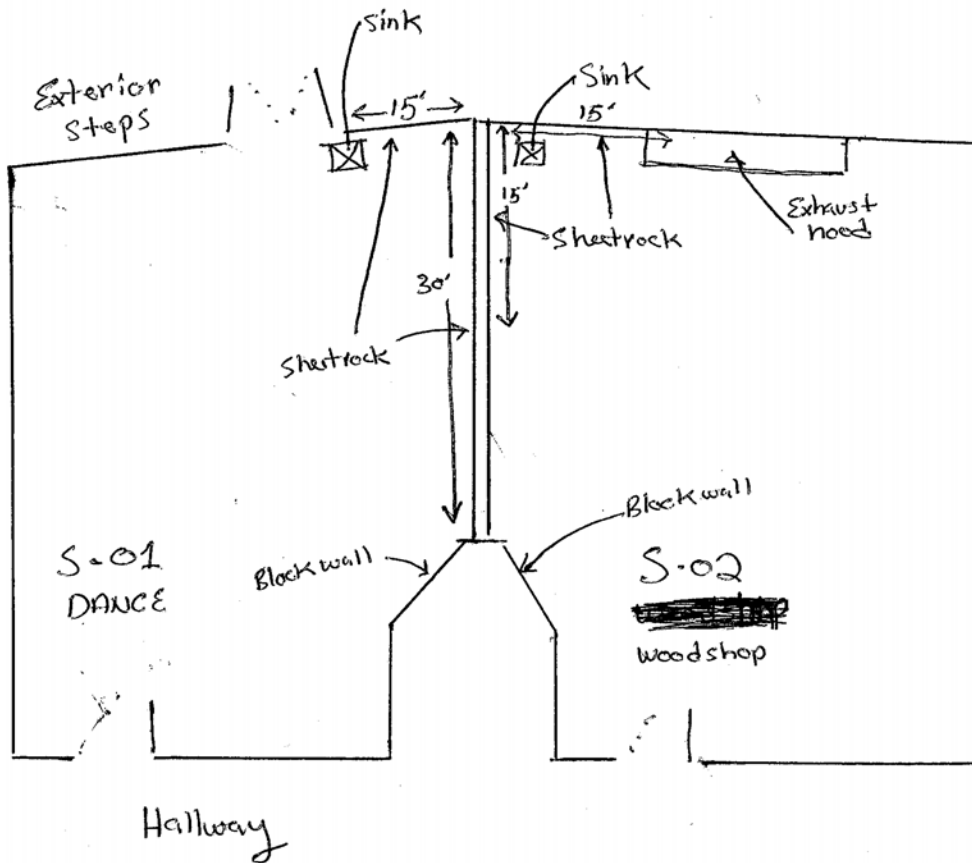
Impacted sheetrock in rooms S-01 & S-02.
