DISSTON E.S. - IEQ-BUILDING CONDITION EVALUATION SUMMARY

SUMMARY

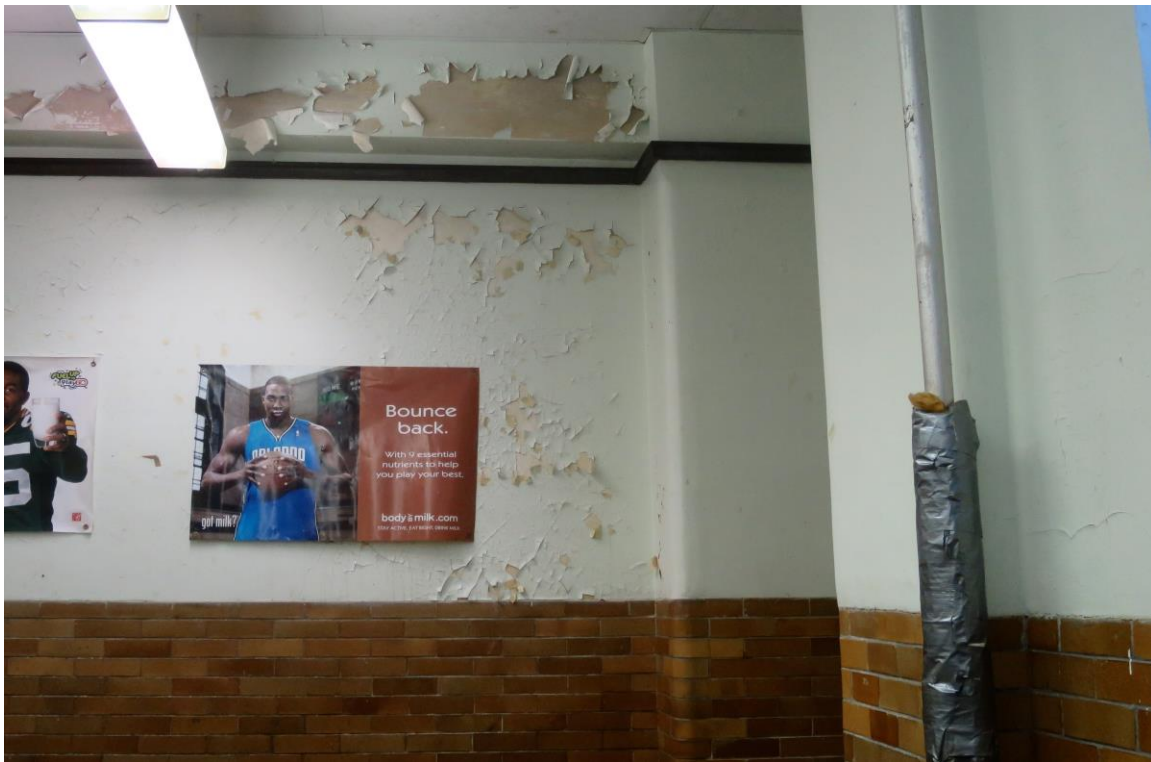
Photo 3: Disston E.S. – 01.06.2016 – Cafeteria – Damaged lead paint on wall

- 2) Assess cafeteria flooring for mold presence and conduct remediation and flooring replacement as necessary;*
- 3) Scrape and remove damaged lead paint from all surfaces in which it is chipping, peeling and deteriorated including, but not limited to, stairwells, duct work, cafeteria walls and ceilings. Lead safe work practices and procedures must be followed;*

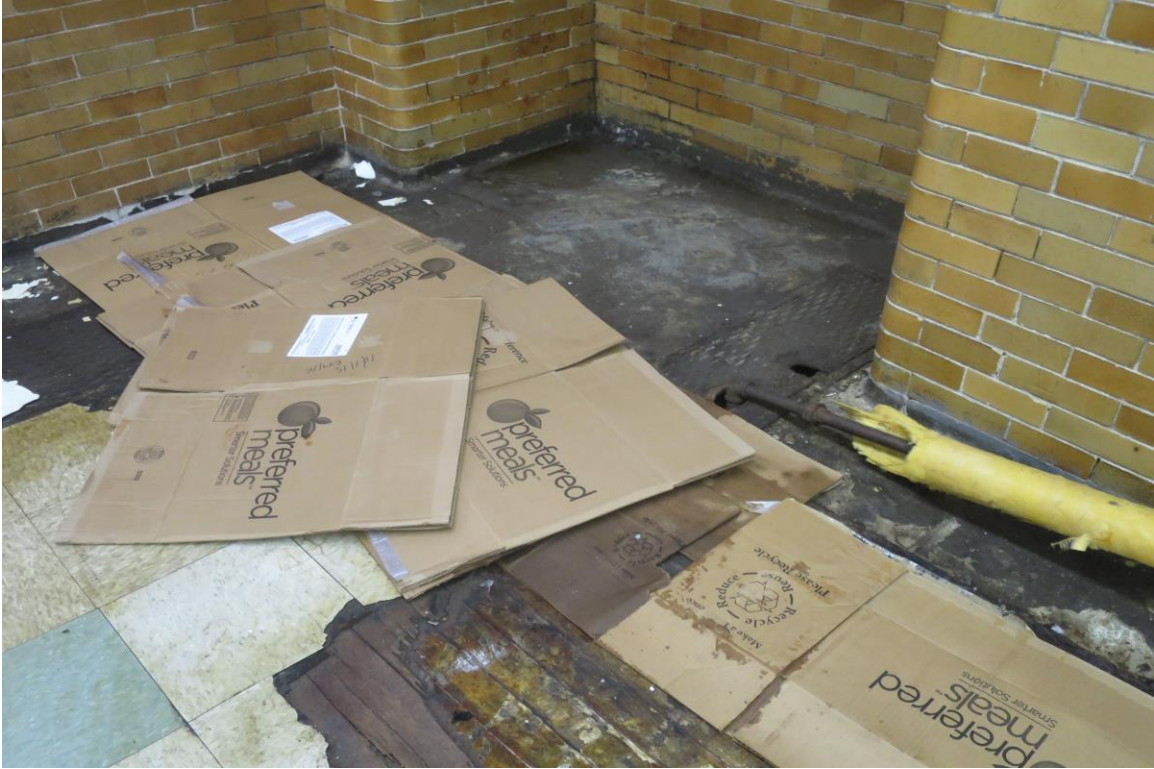
Photo 4: Disston E.S. – 01.06.2016 – Cafeteria – Close up of Wall Damage
