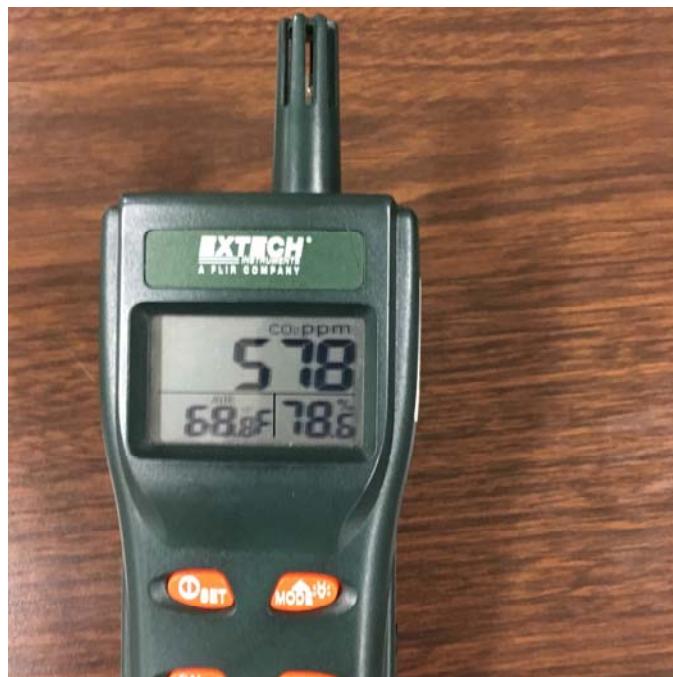
Photo 2 –Cafeteria
The humidity was elevated at 78%.

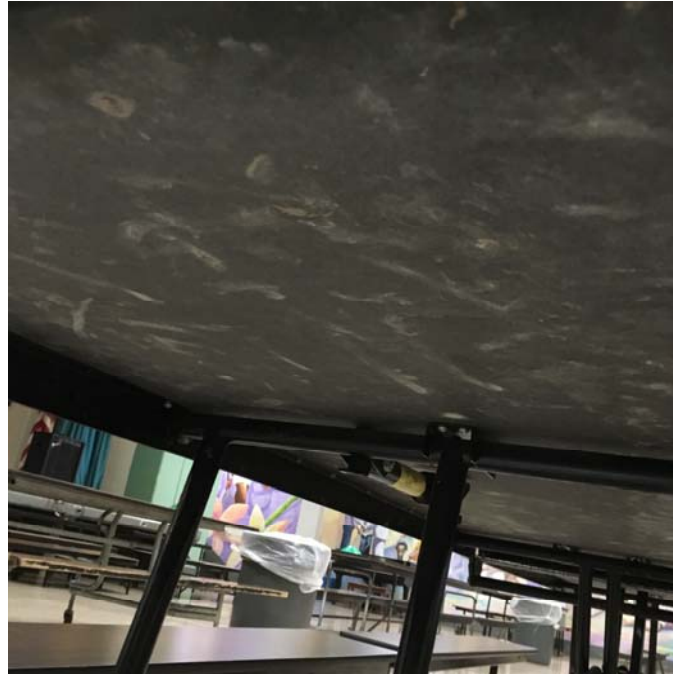
Photo 3 –Cafeteria
Mold growth was observed under the cafeteria tables.

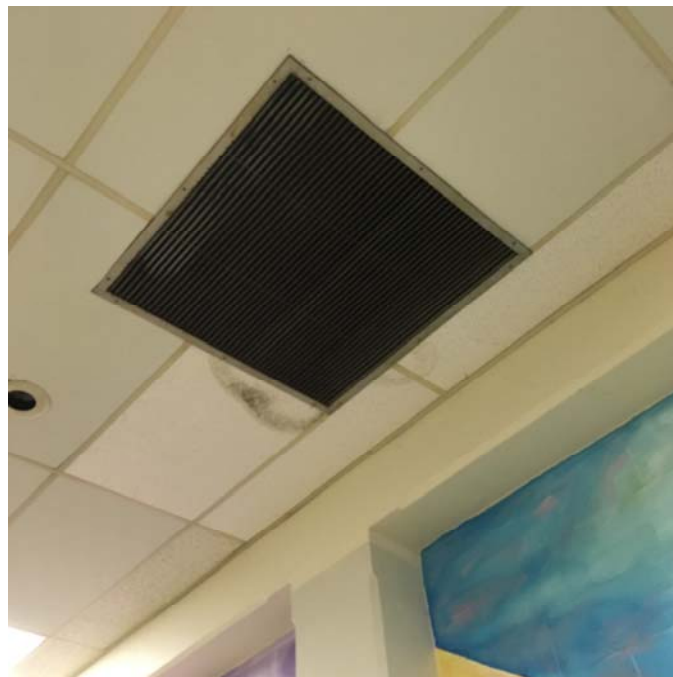
Photo 4 – Cafeteria
Particulate accumulation on the return air grille and a moldy ceiling tile was observed.

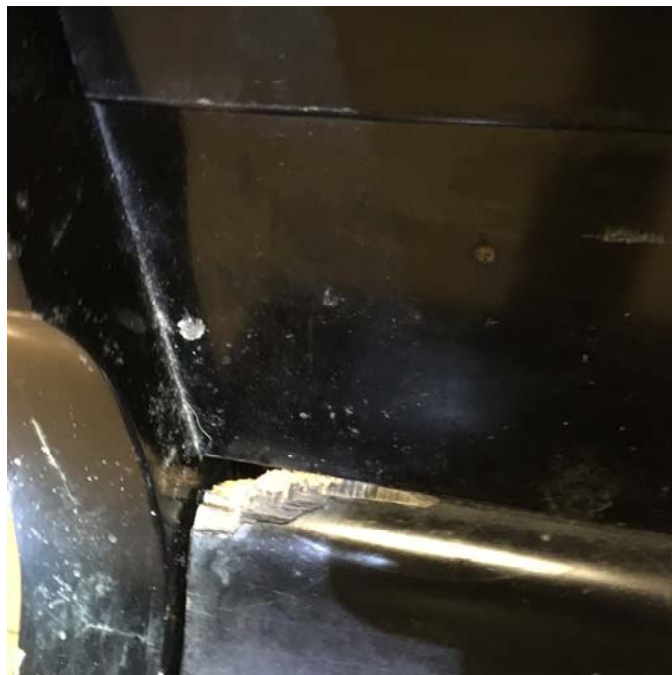
Photo 6 – Cafeteria
Mold growth was observed in crevasses of the piano.

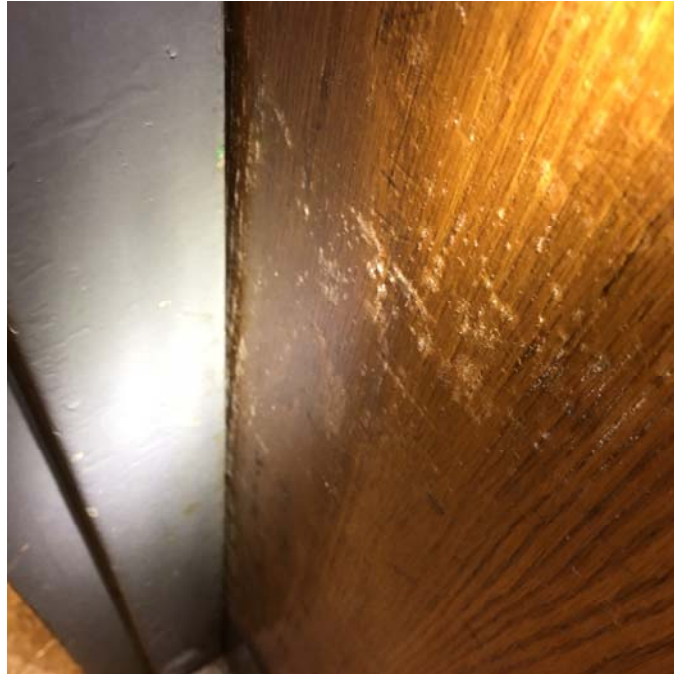
Photo 7 – Cafeteria
Mold growth was observed on the wooden doors and metal door frames.

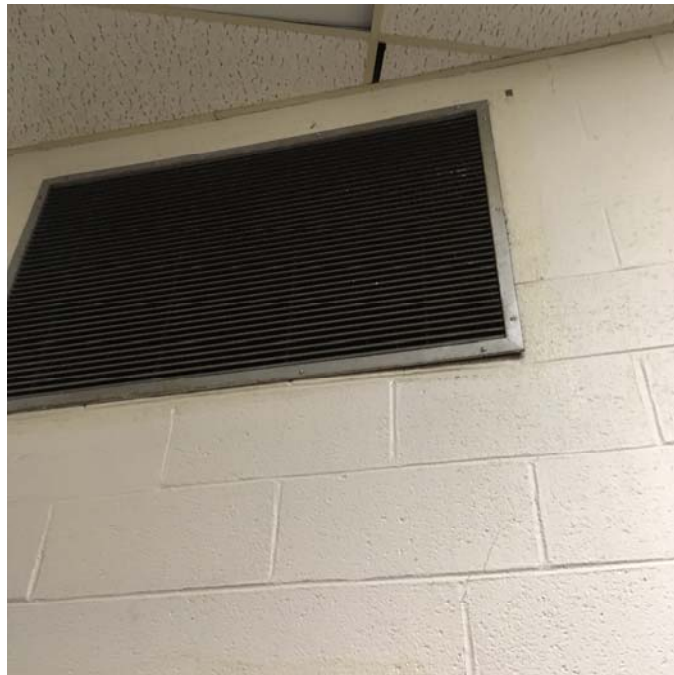
Photo 8 – Cafeteria
Particulate accumulation was observed on the return air grilles.

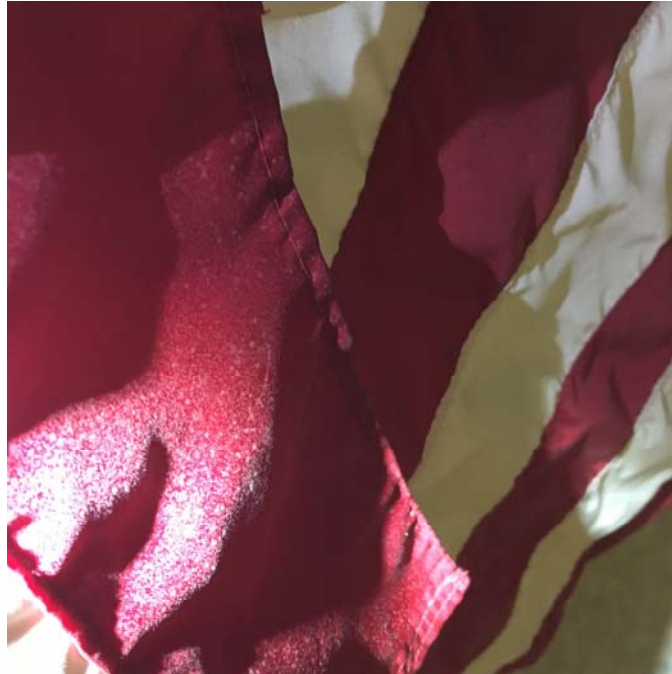
Photo 9 – Stage
Suspect mold growth was observed on the flag.

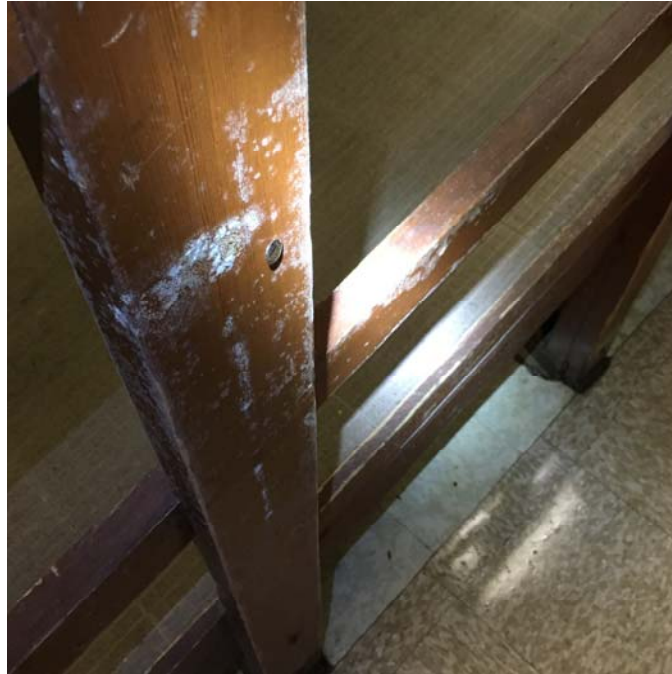
Photo 11– Cafeteria
Mold growth was observed on the handicap ramp.

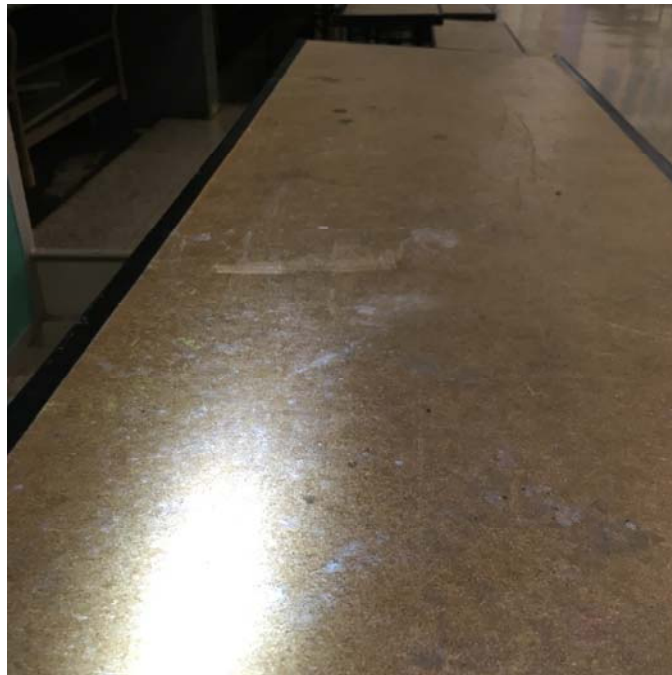
Photo 12 – Cafeteria
Mold growth was observed on the portable steps in from of the stage.

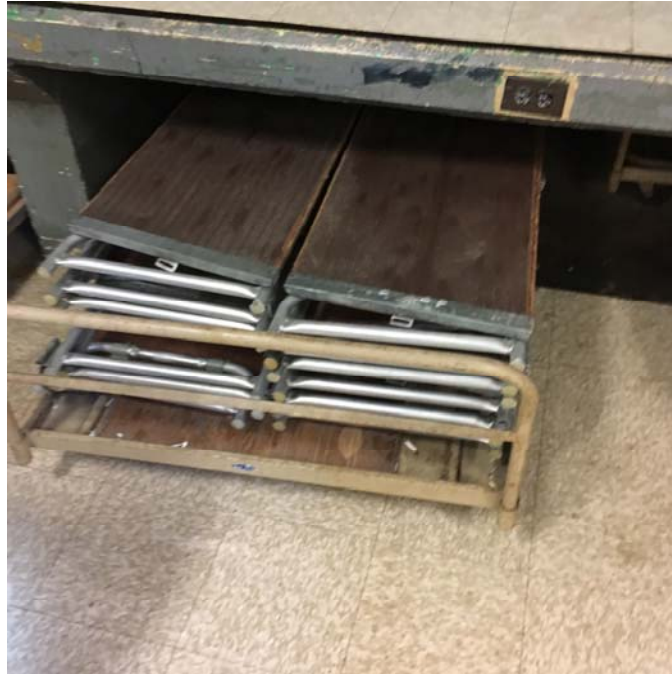
Photo 13 – Cafeteria

Mold growth was observed on the cart and storage platforms under the stage.

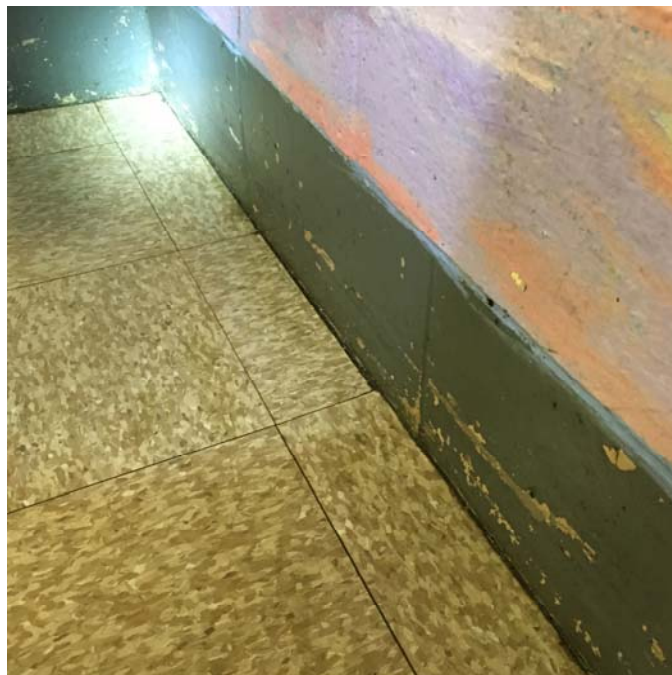
Photo 14 – Cafeteria

Mold growth was observed on section of lower cinder block walls.

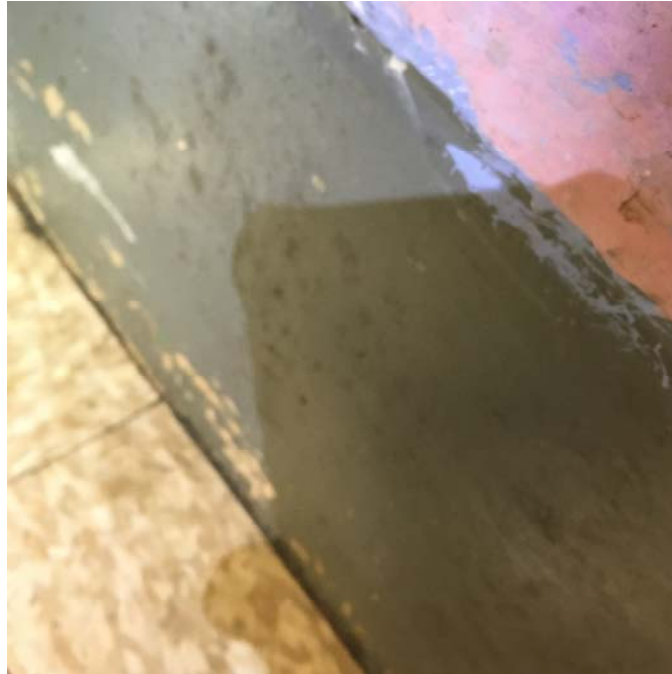
Photo 15 – Cafeteria

Mold was observed on sections of the lower cinder block walls.

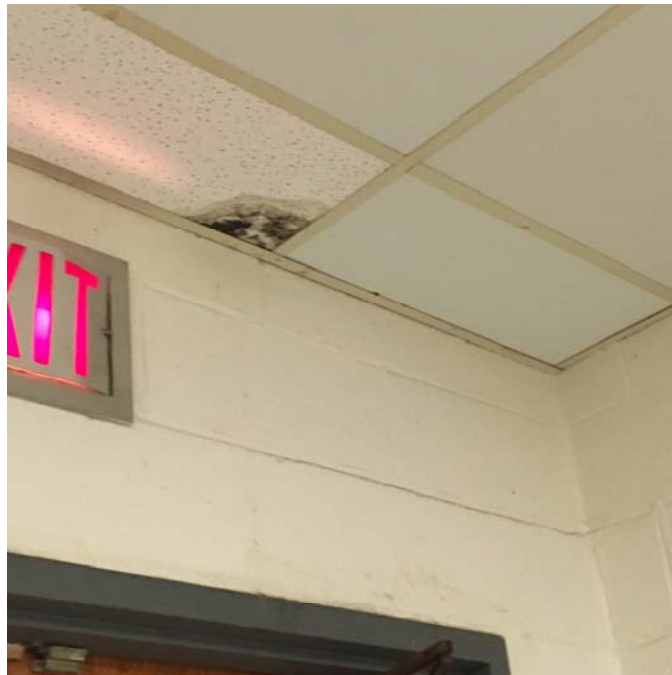
Photo 16 – Cafeteria

A mold ceiling was observed by the 2nd grade exit door.

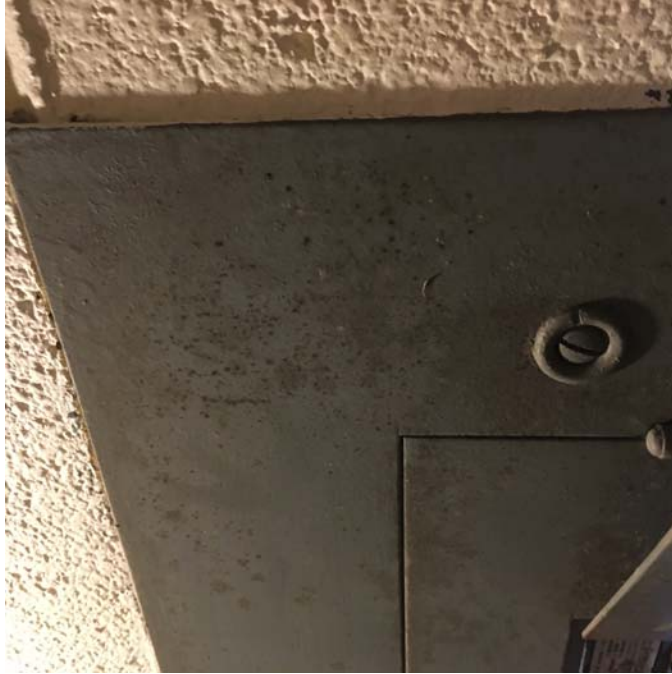
Photo 17 – Stage
Mold growth was observed on the electrical panel covers.

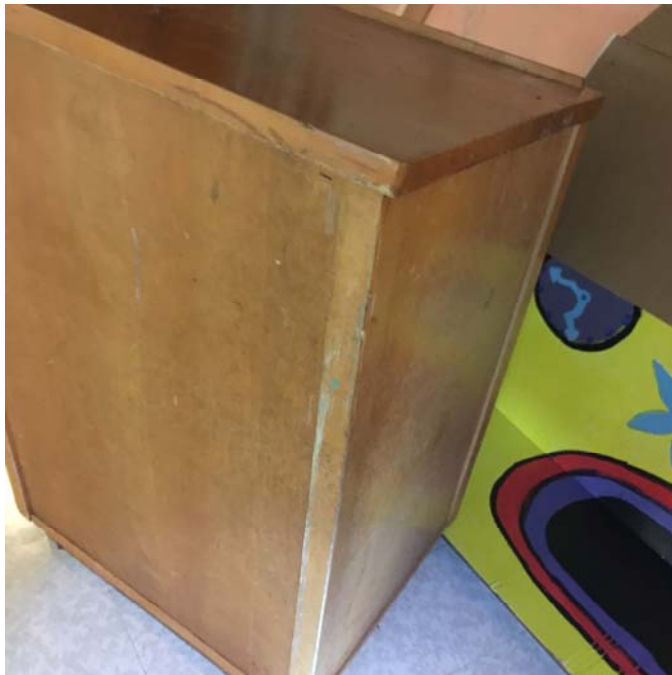
Photo 18 – Stage
Mold growth was observed on the podium.

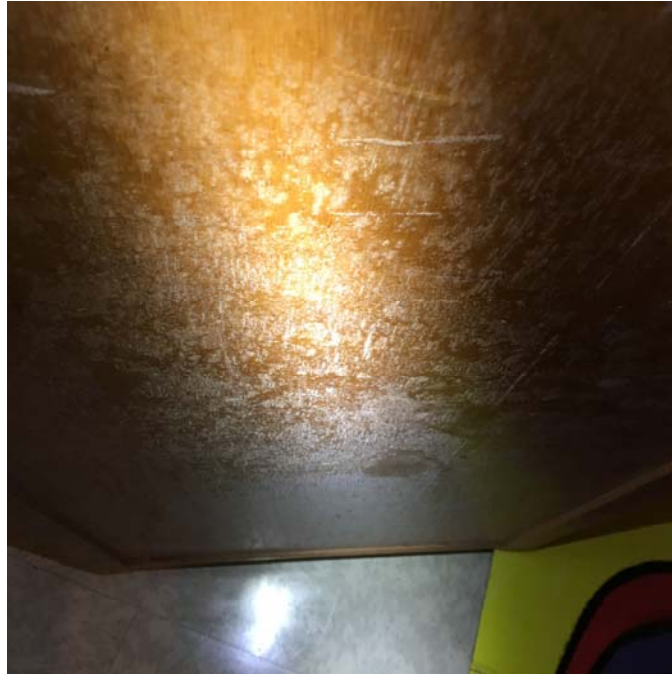
Photo 19 – Stage
Mold growth was observed on the podium.

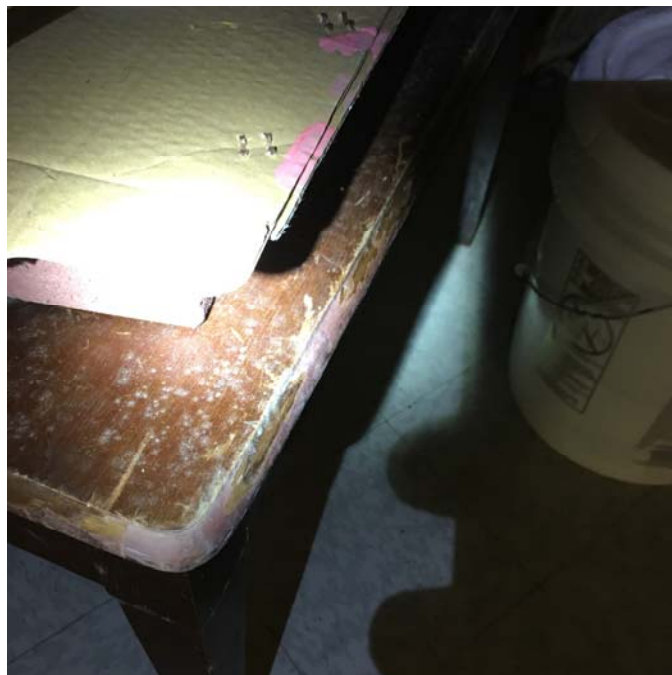
Photo 20 – Stage
Mold growth was observed on the piano seat.

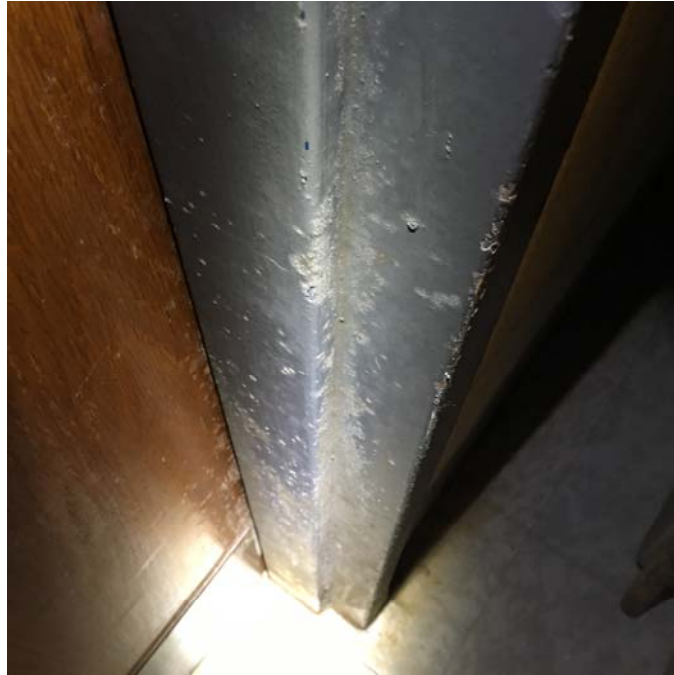
Photo 21 – Stage
Mold growth was observed on the wooden door and metal door frame.

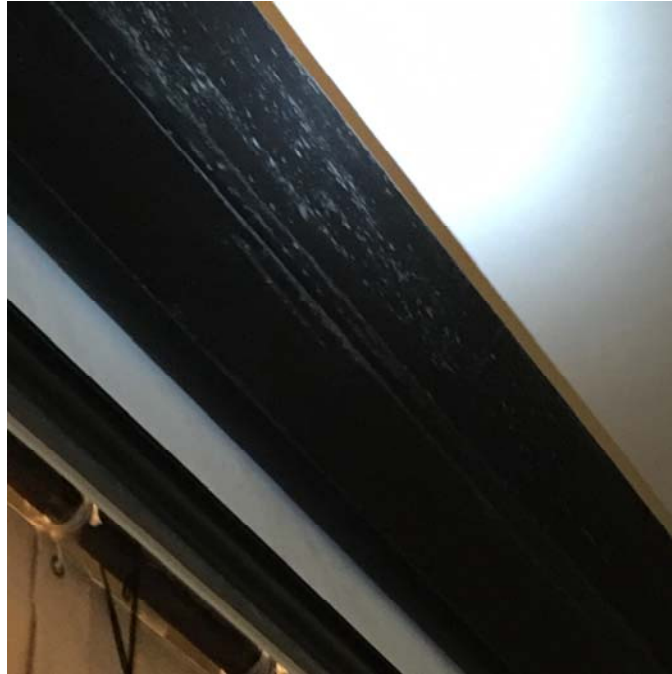
Photo 23 – Stage
Mold growth was observed on the overhead map housing and bottom of the map.

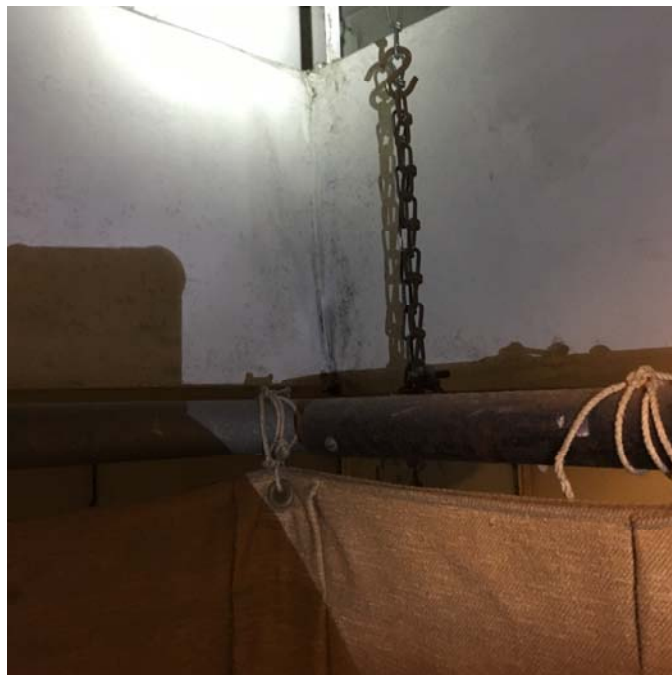
Photo 24 – Stage
Mold growth was observed on the fiberglass duct work.

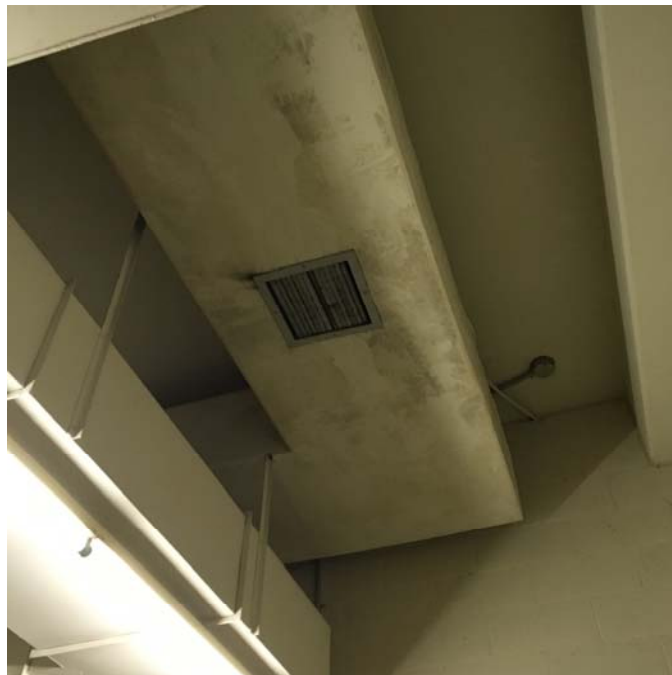
Photo 26 – Small Staff Lunch Room
Mold growth was observed on the fiberglass duct work.

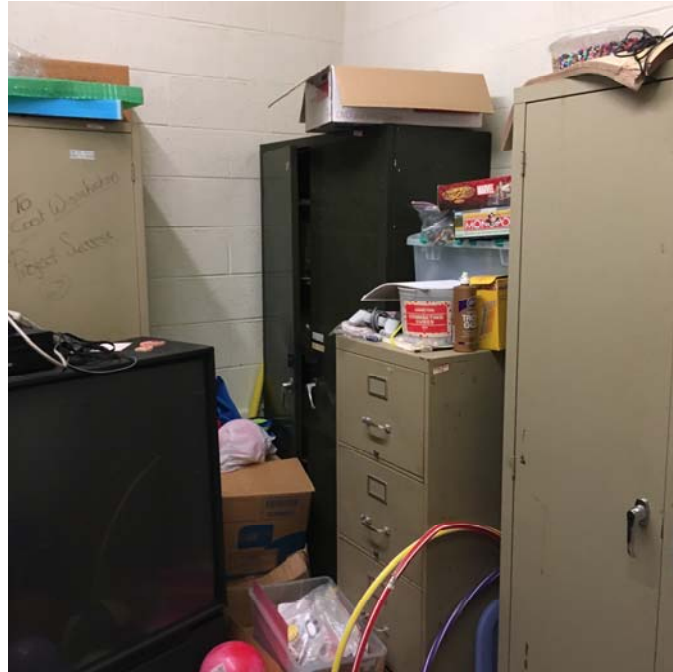
Photo 27 – Small Teacher's Storage Room
Mold growth was observed on the metal storage cabinets, shelving and TV.

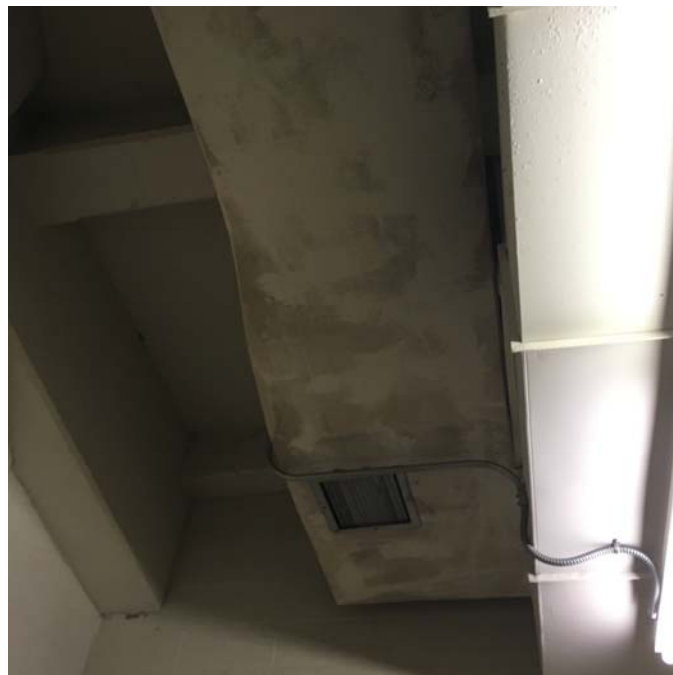
Photo 28 – Small Teacher's Storage Room
Mold growth was observed on the fiberglass duct insulation.

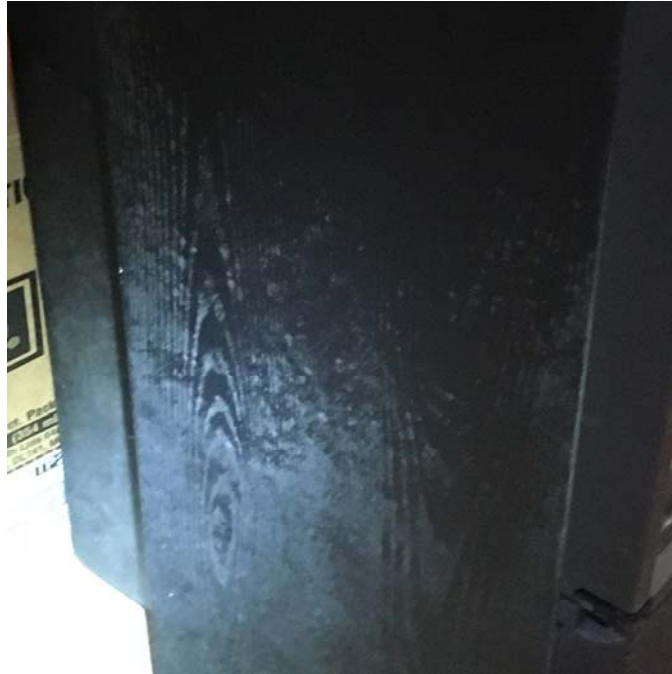
Photo 29 – Small Teacher's Storage Room
Mold growth was observed on the TV cabinet.

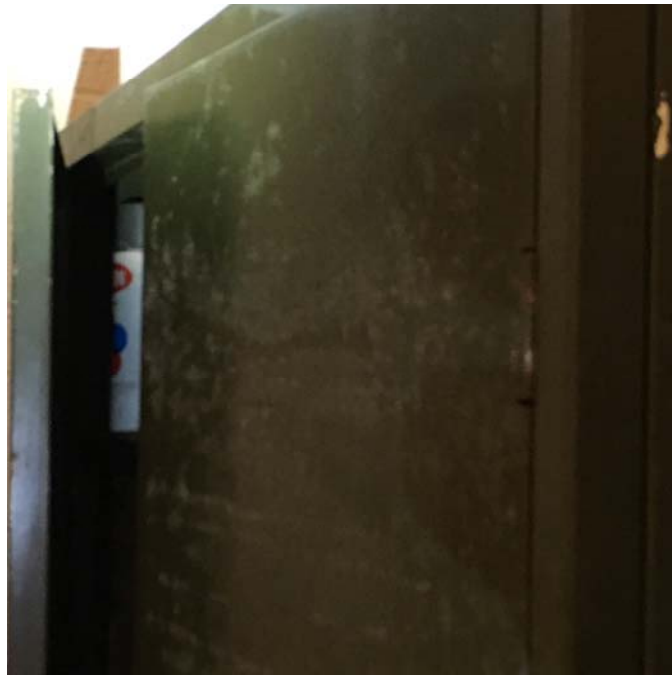
Photo 30 – Small Teacher's Storage Room
Mold growth was observed on the metal storage units.

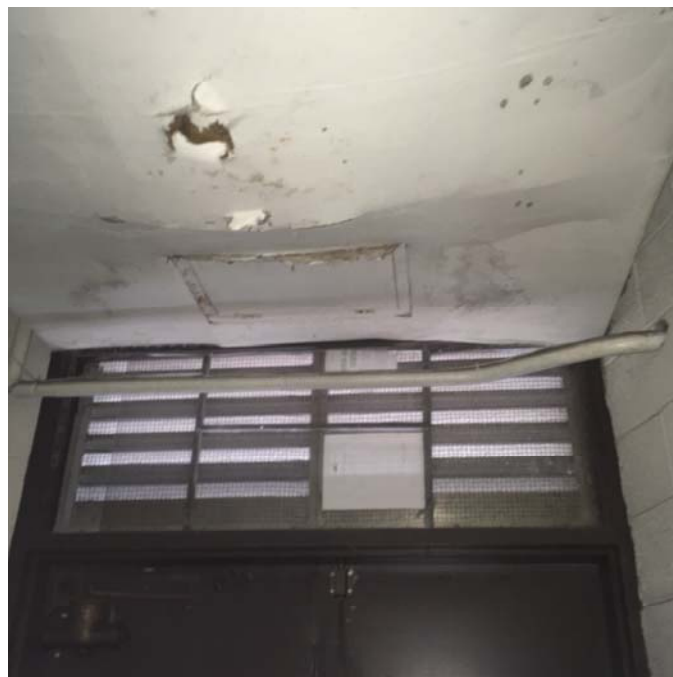
Photo 32 –Operations Storage Room
Mold growth was observed on the fiberglass duct insulation.

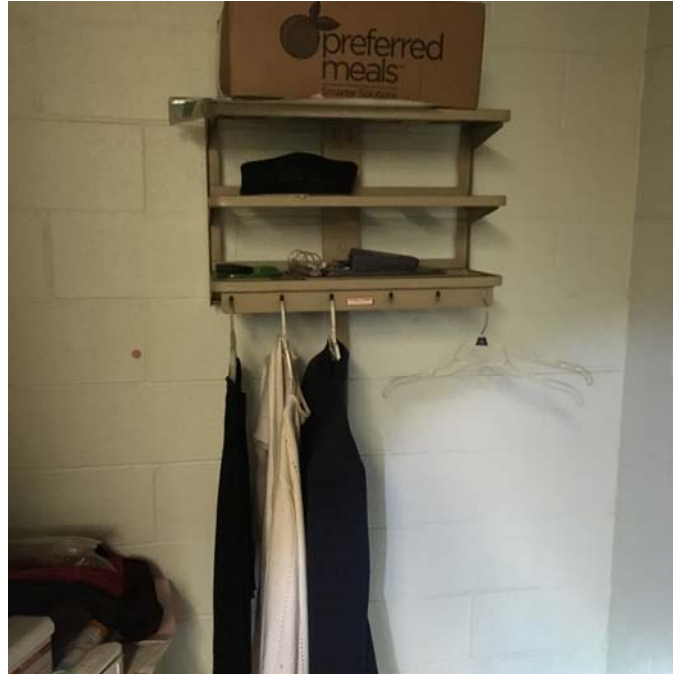
Photo 33 – Kitchen Staff Area
Mold growth was observed on the coat rack.

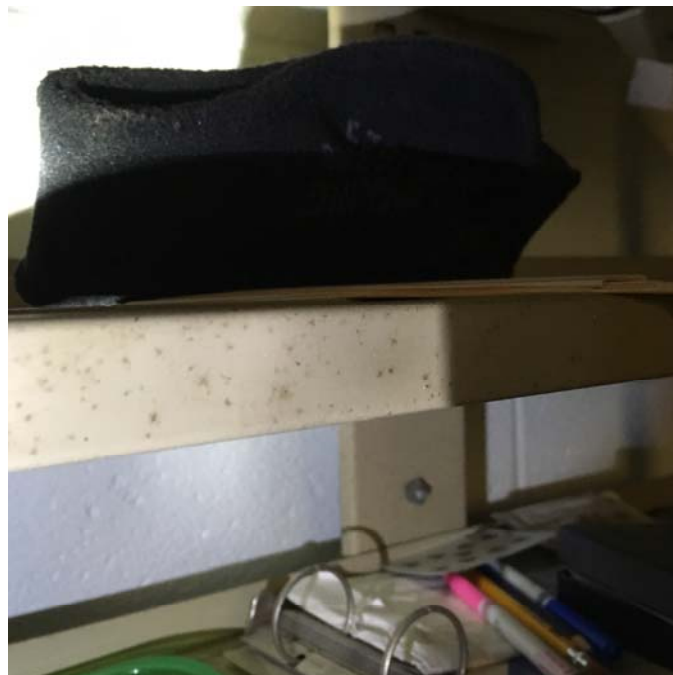
Photo 34 – Kitchen Staff Area
Mold growth was observed on the coat rack.
