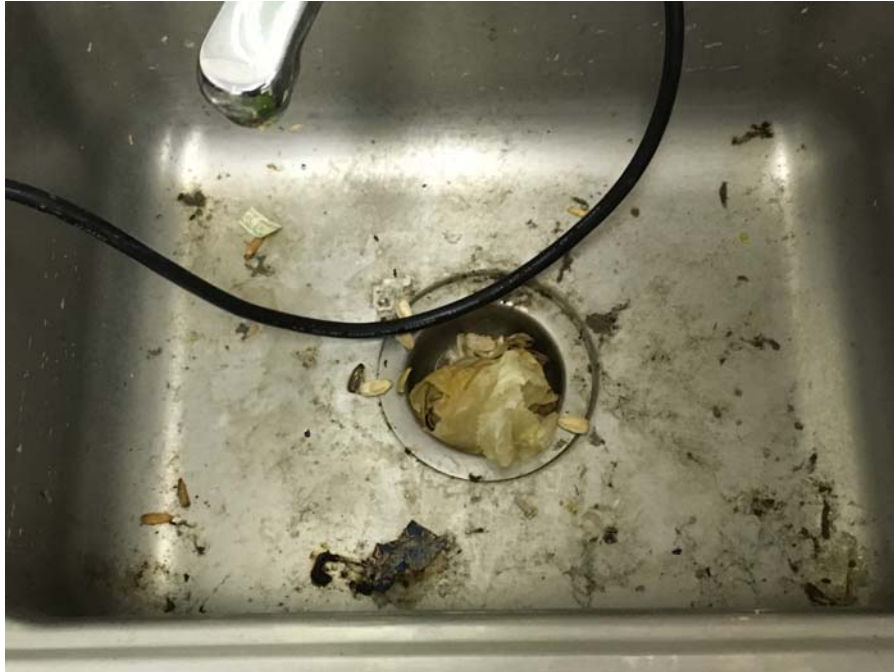
Photo 5 – Room 200  
Trash, debris, and mouse droppings were observed in the classroom sink.

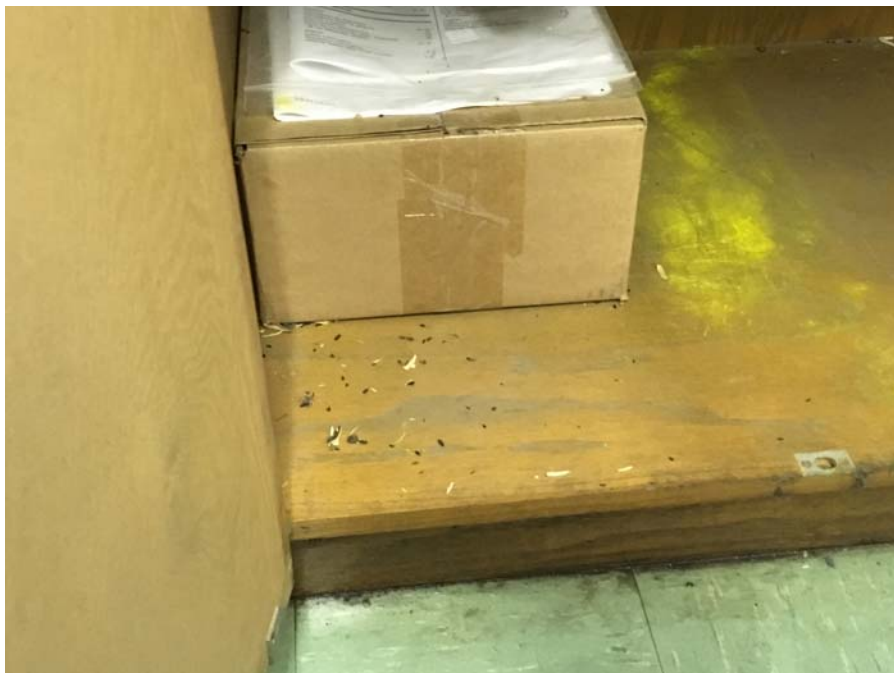
Photo 6 – Room 200  
Mouse droppings were observed in the sink cabinet.

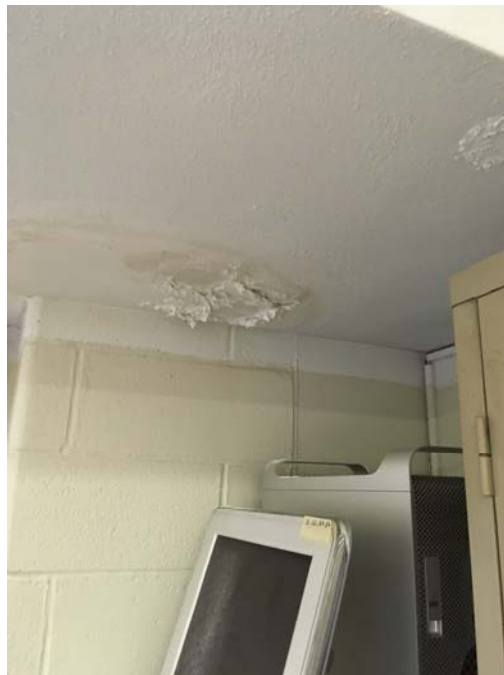
Photo 8 – Room 200  
A section of moisture damaged plaster was observed on the ceiling.

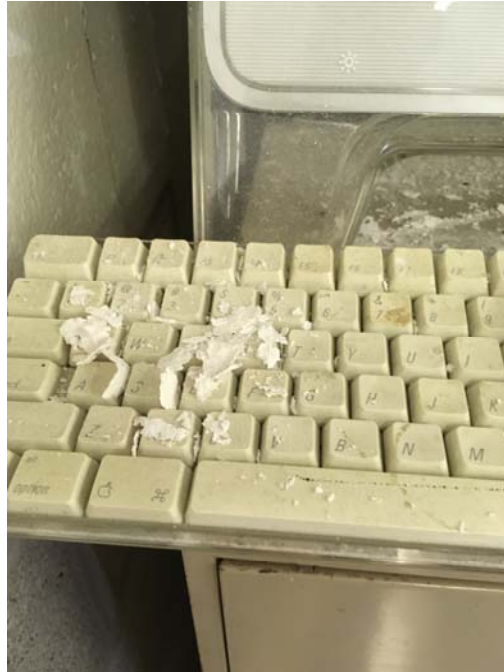
Photo 9 – Room 200  
Paint and plaster debris was observed on classroom materials.

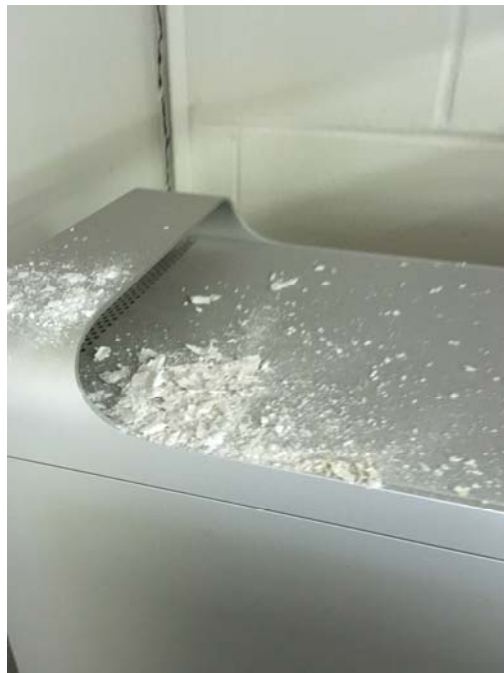
Photo 10 – Room 200  
Paint and plaster debris was observed on classroom materials.

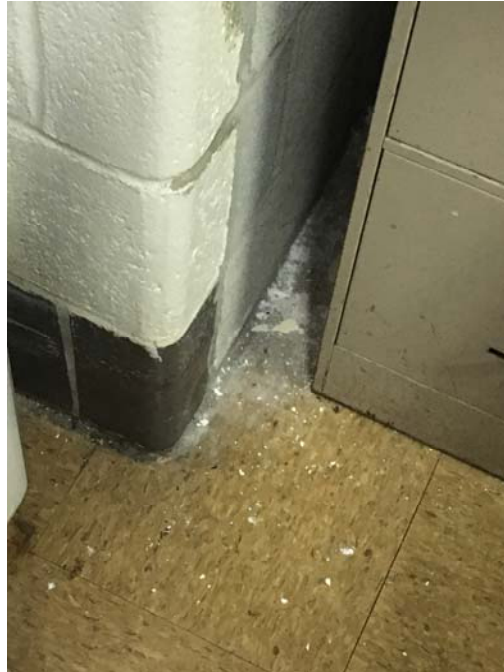
Photo 11– Room 200  
Paint and plaster debris was observed on the floor.

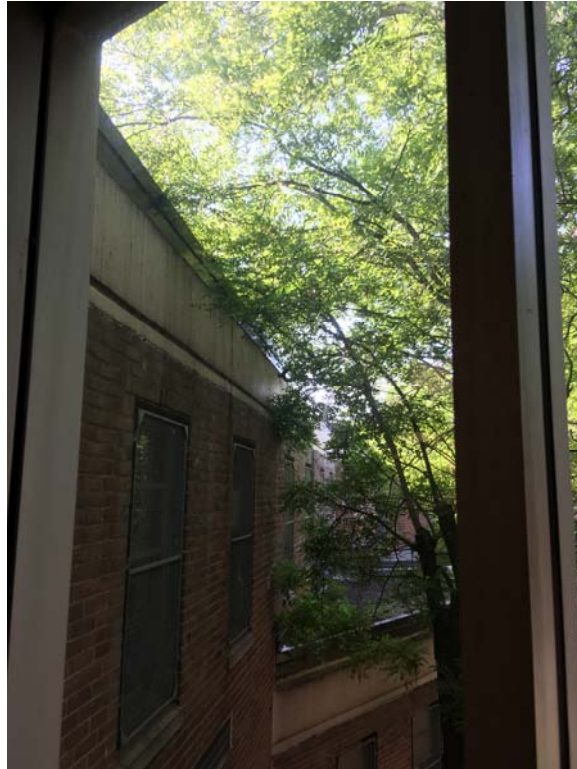
Photo 15 –Courtyard  
Tree branches were growing close to the building and over the roof.

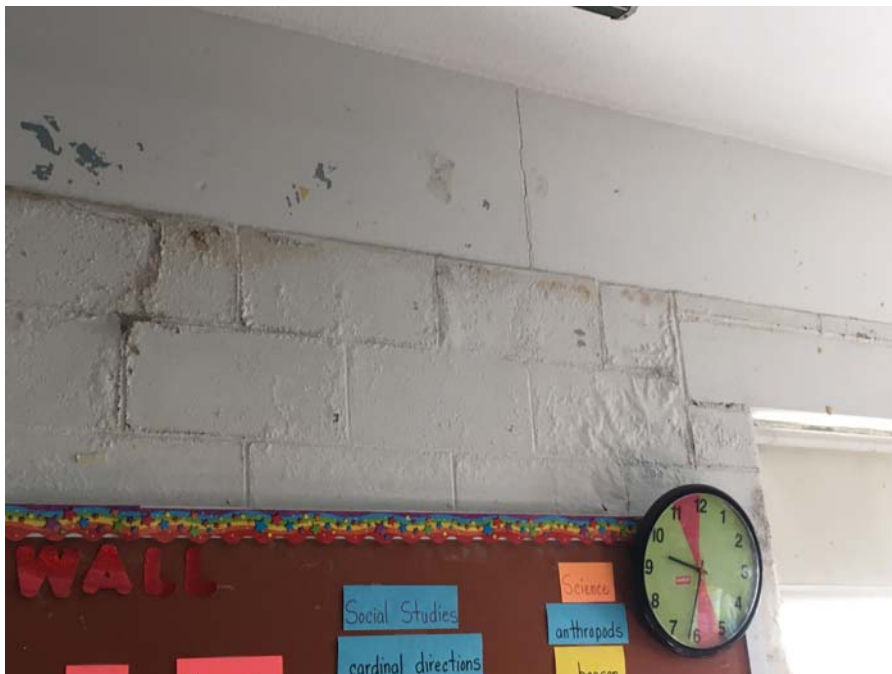
Photo 16 – Room 204  
Flaking paint and efflorescence were observed along the window wall.

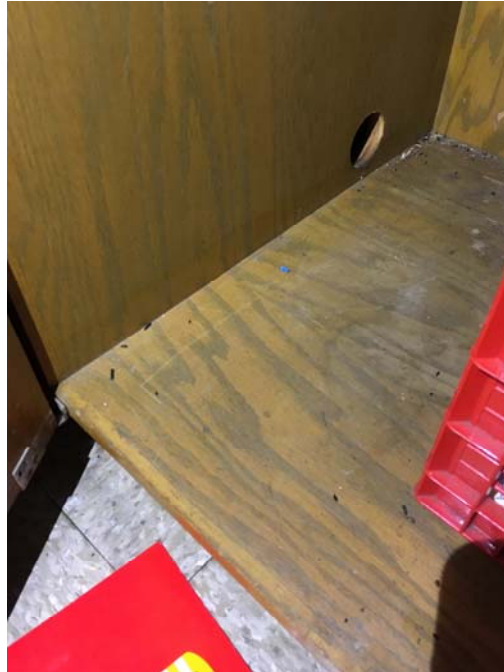
Photo 17 – Room 204  
Mouse droppings were observed in the sink cabinet.

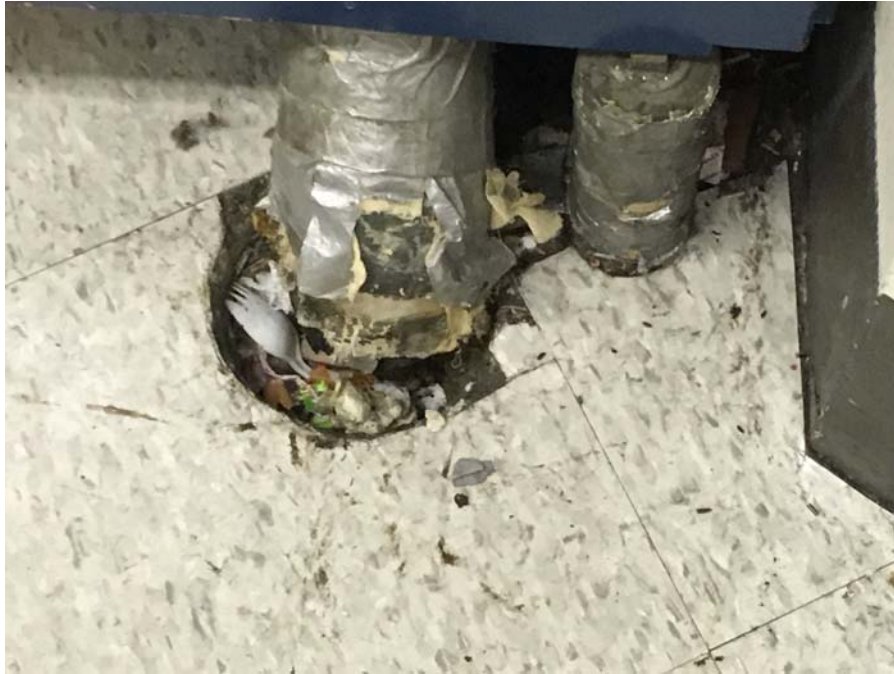
Photo 19 – Room 214

Trash and debris were observed on the floor around the pipe penetrations.

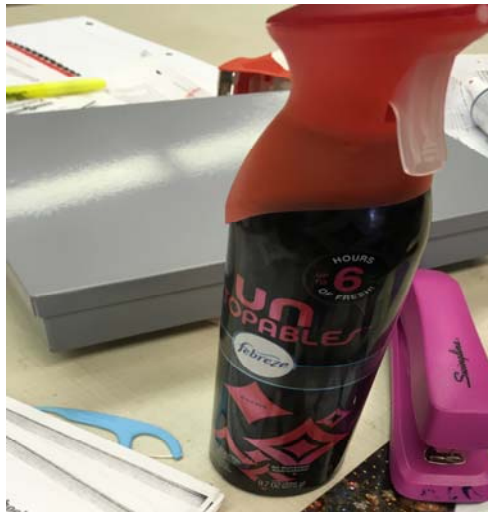
Photo 20 – Room 214

Air fresheners were observed in this room.

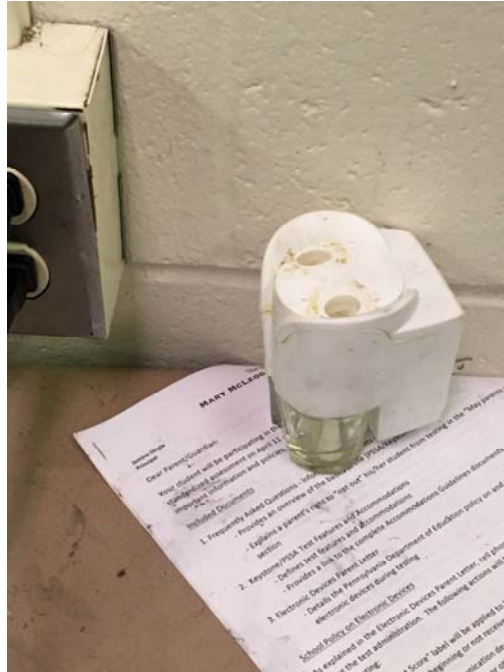
Photo 21 – Room 214  
A plug-in air freshener was observed in this room.

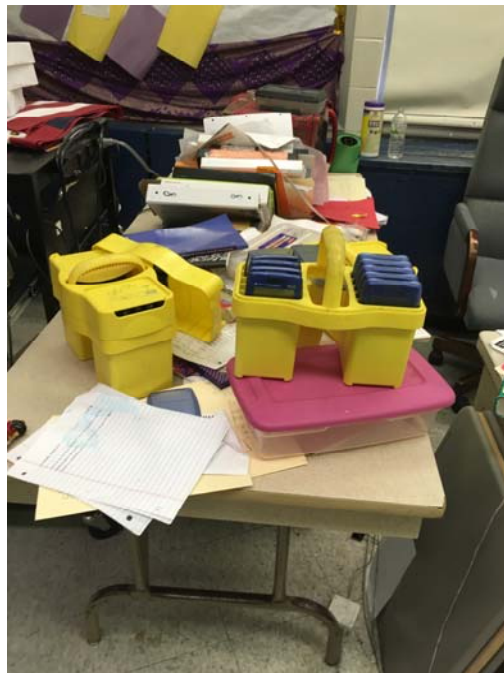
Photo 22 – Room 214  
Clutter was observed in the corner of the room.

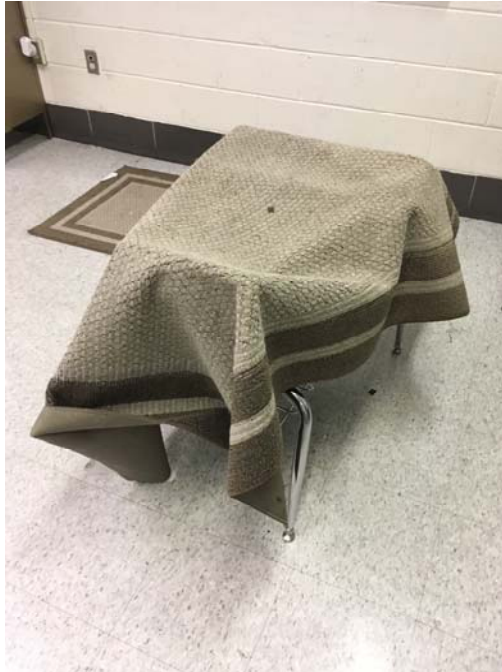
Photo 23 – Room 214  
A flood occurred in this room impacting the area carpet.

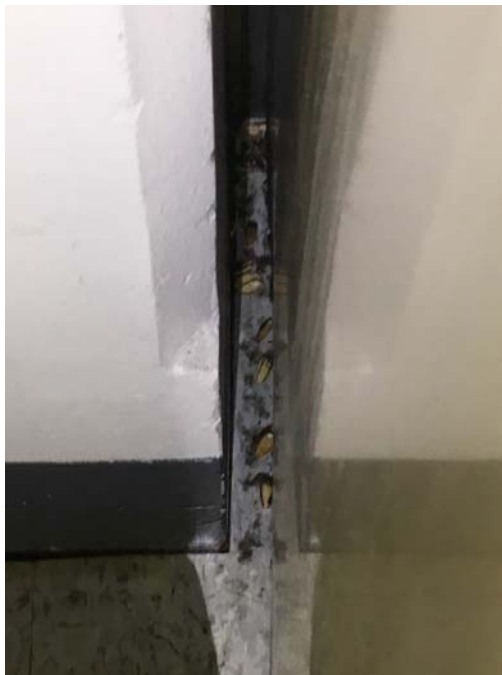
Photo 24 – Room 214  
Mouse droppings and sunflower seeds were observed between the block wall and metal cabinet.

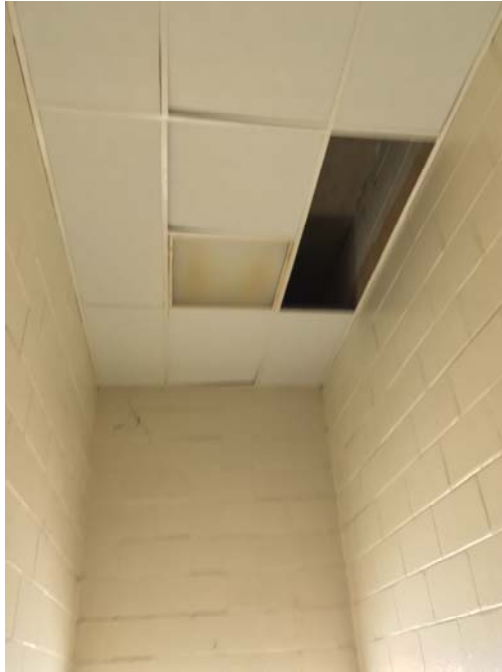
Photo 25 – Stairwell to School Yard  
Missing suspended ceiling tiles were noted.

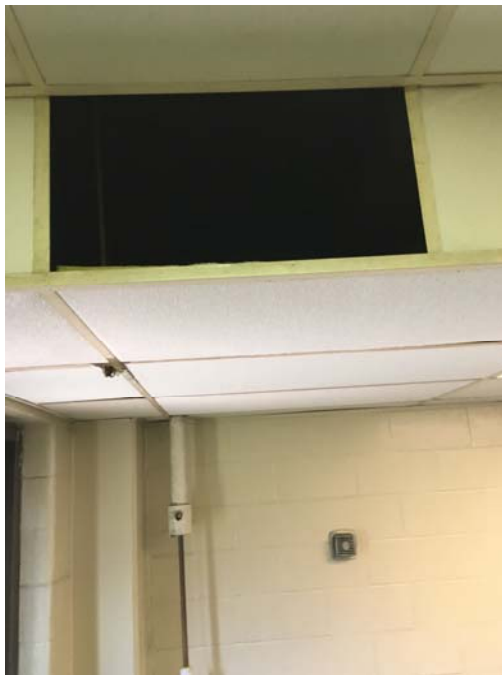
Photo 26 – Stairwell to School Yard  
Missing suspended ceiling tiles were noted.

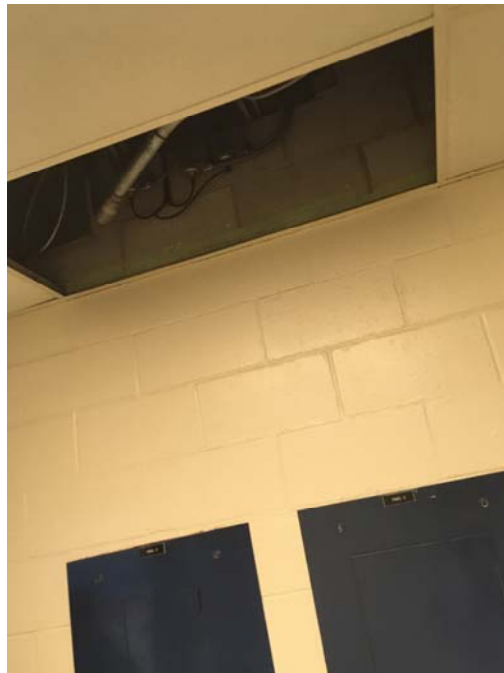
Photo 28 – Gymnasium Entry  
A missing ceiling tile was noted.

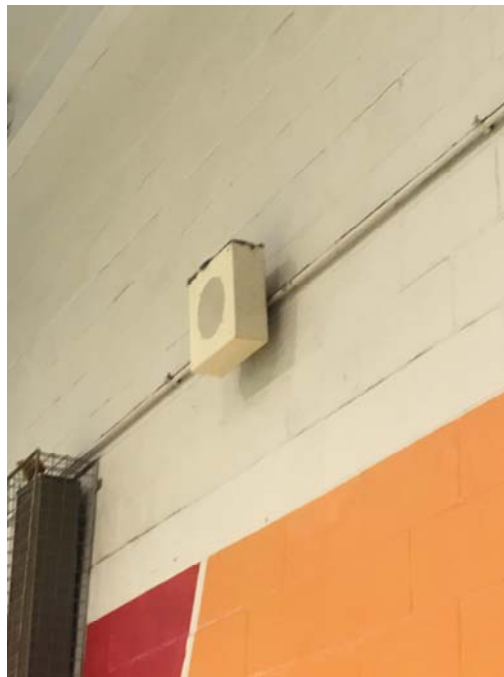
Photo 30 – Gymnasium

Dust accumulation was observed on the conduit and wall-mounted components.

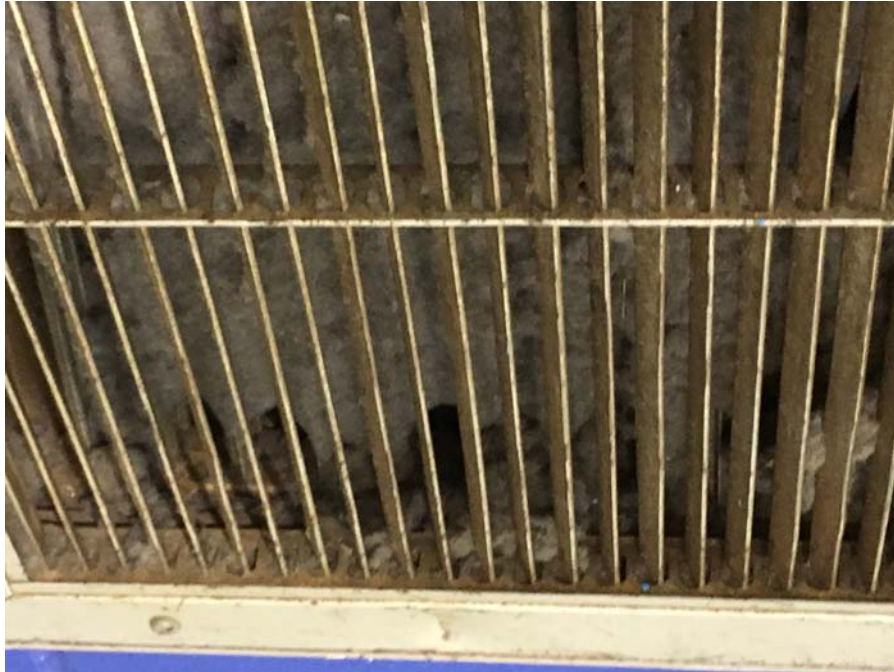
Photo 31 – Gymnasium  
Heavy particulate loading was observed on the ventilation grilles.

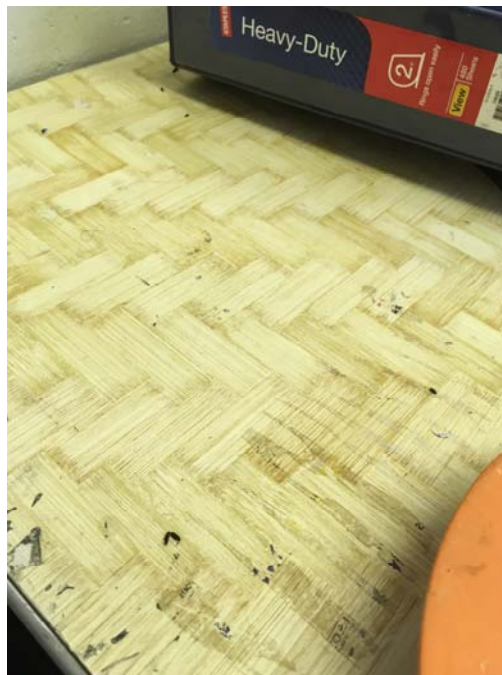
Photo 32 – Gymnasium Office  
Mouse droppings were observed in the gym office.

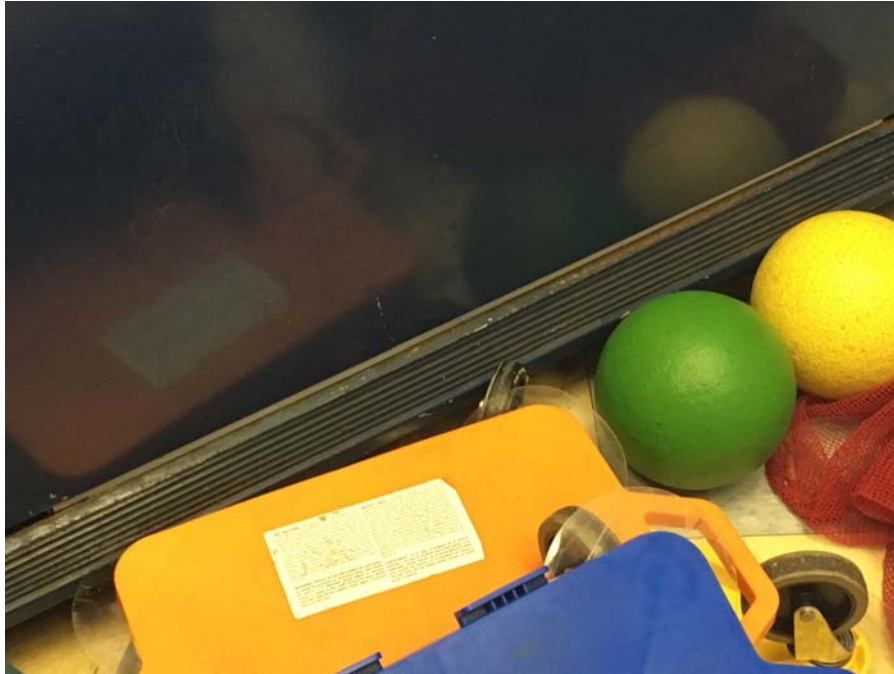
Photo 33 – Gymnasium Office  
The return air filter and tray were not properly positioned.

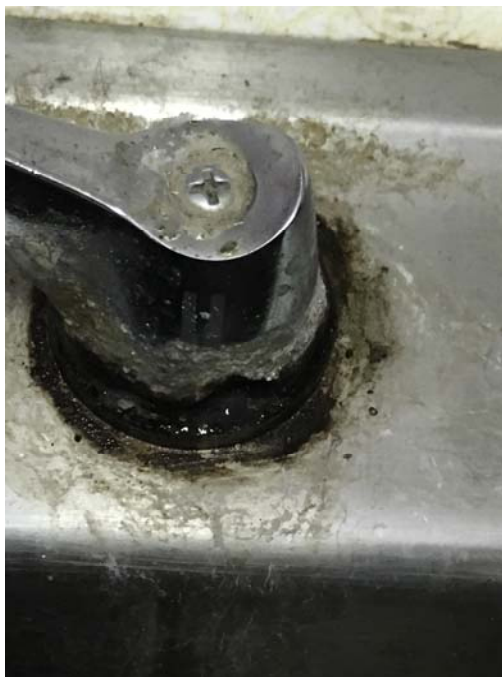
Photo 46 – Room 104

A slow leak was observed on the classroom faucet.

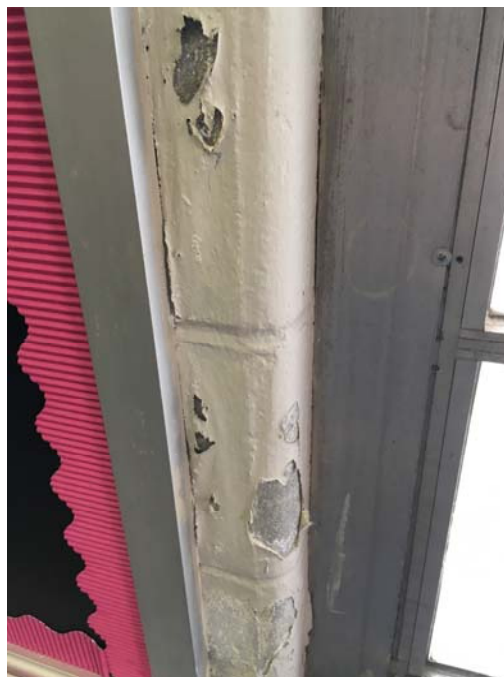
Photo 48 – Room 104

Flaking paint was observed around the windows.

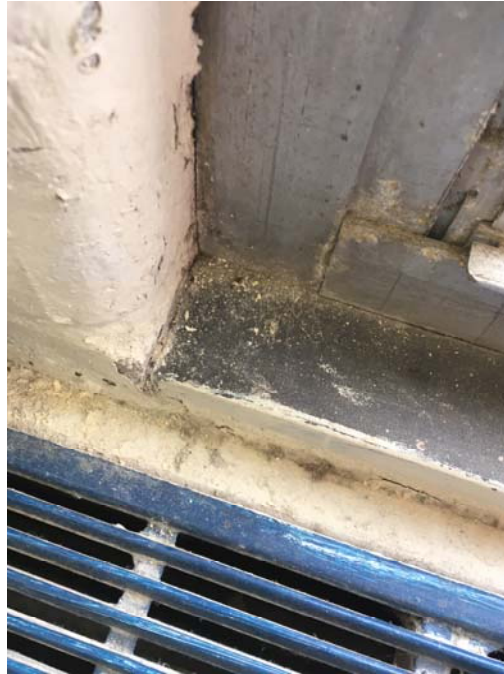
Photo 49 – Room 104  
Paint debris was observed on the window sill.

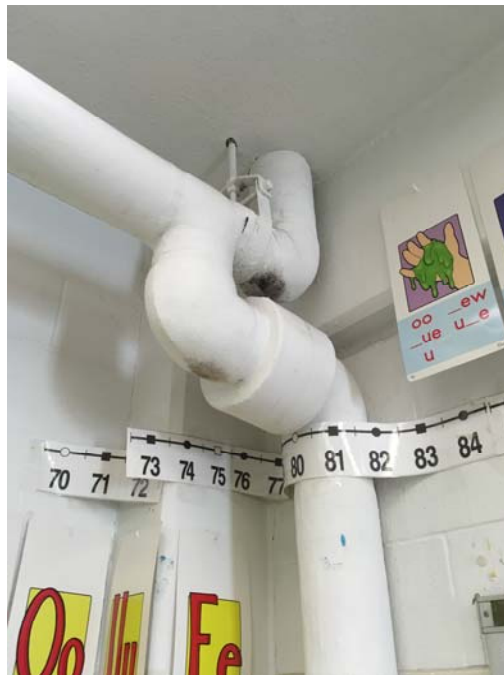
Photo 50 – Room 104  
Mold growth was observed on the pipe insulation.

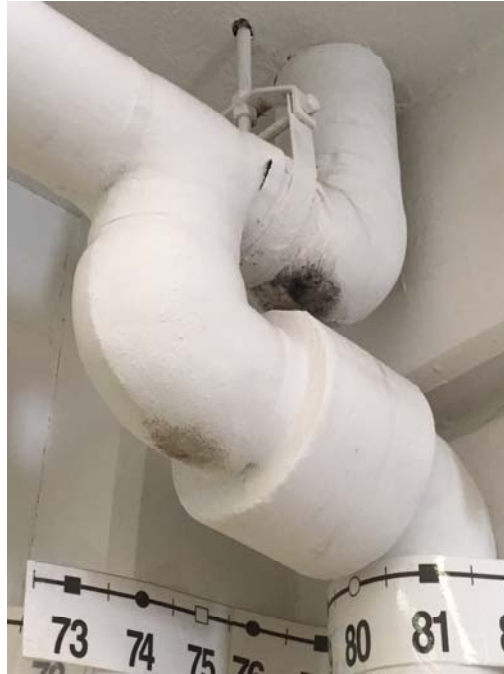
Photo 51 – Room 104  
Mold growth was observed on the pipe insulation.

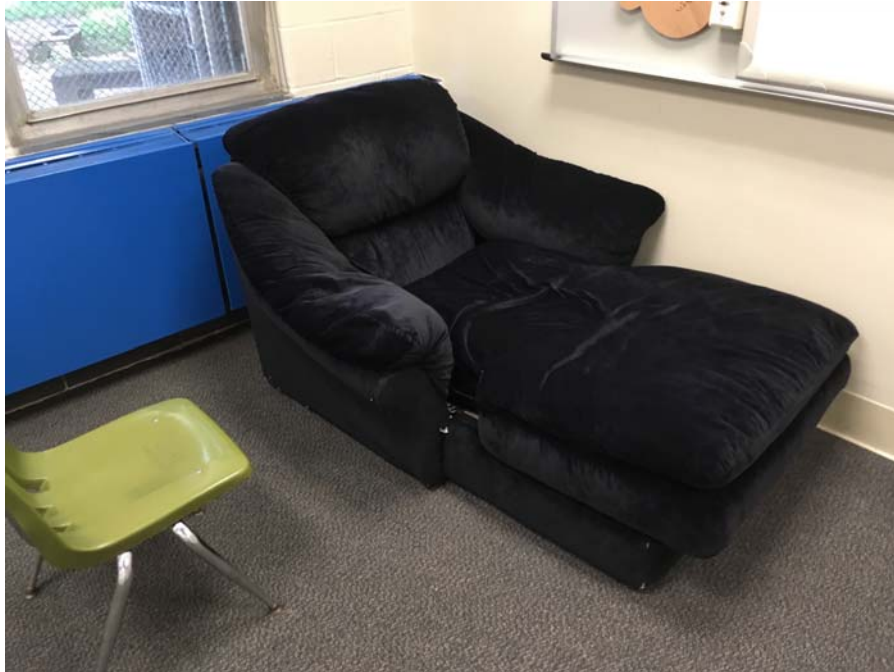
Photo 55 – IMC  
Mouse droppings were observed under the cushions.

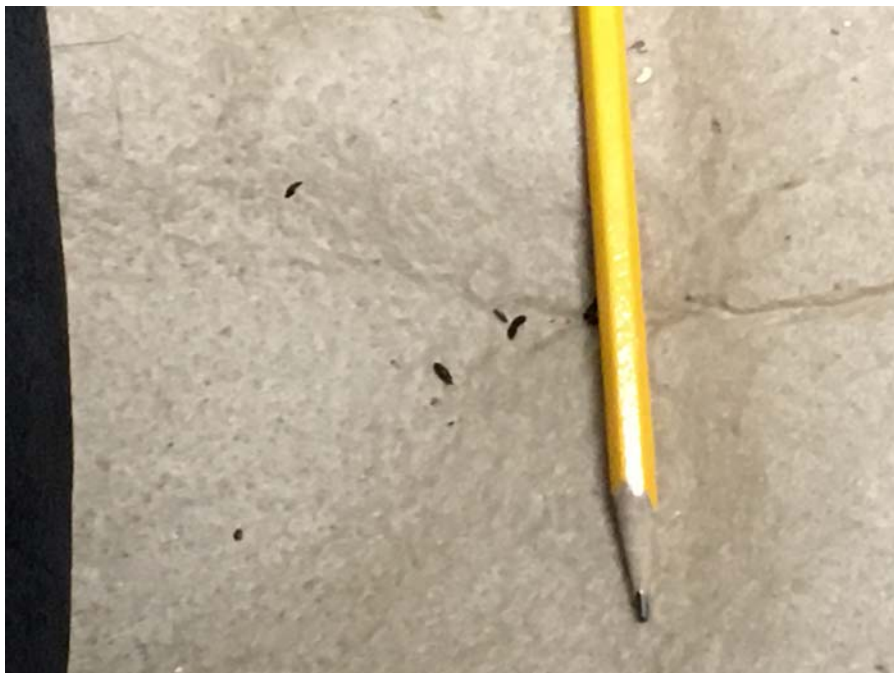
Photo 56 – IMC  
Mouse droppings were observed under the cushions.

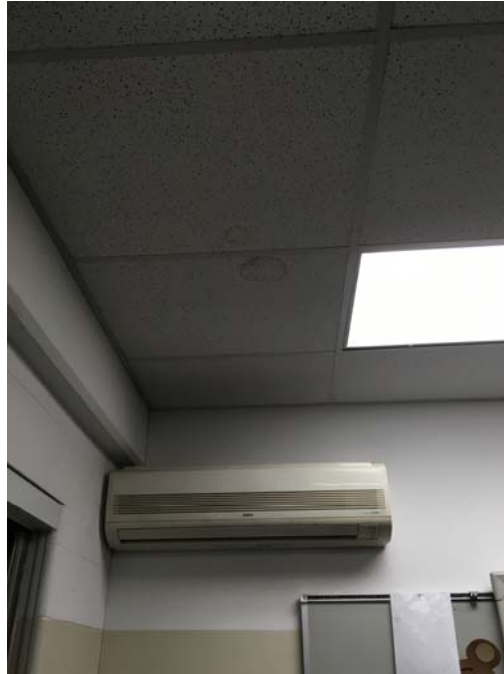
Photo 57 – IMC

Water stained ceiling tiles were observed under the lower roof.

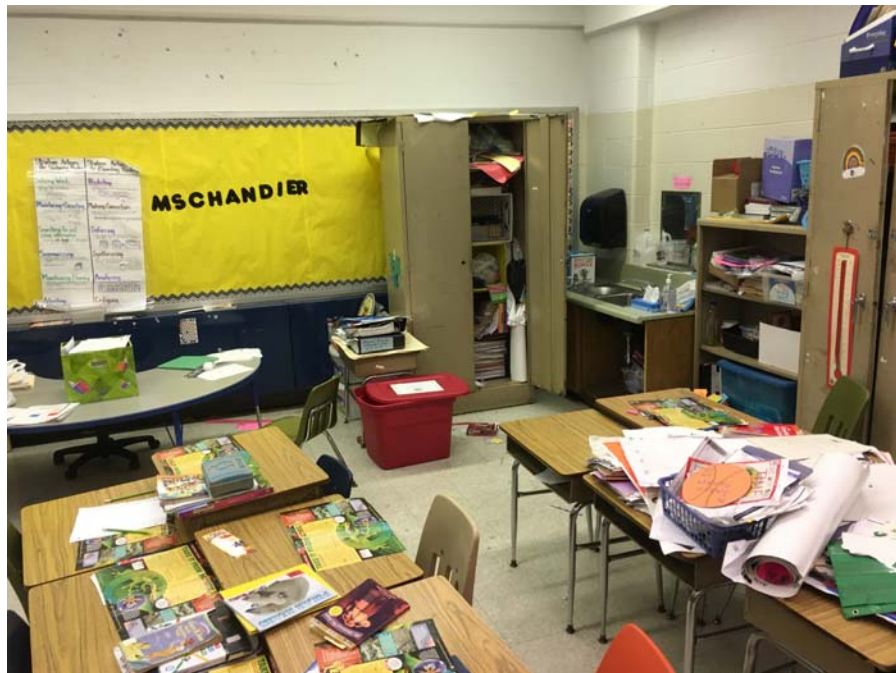
Photo 58 – Room 112

A significant amount of clutter was observed in this room.

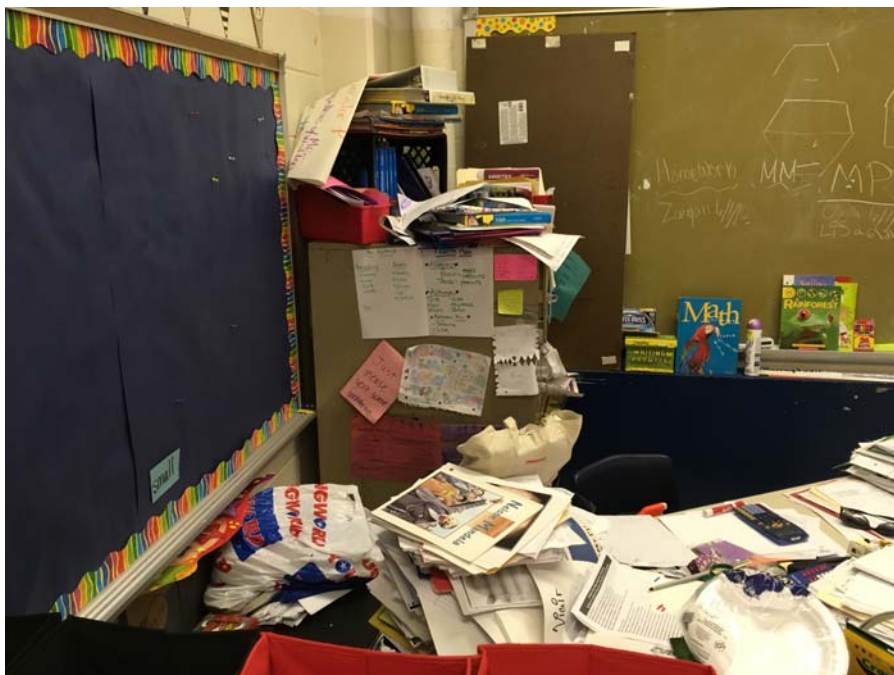
Photo 60 – Room 112

A significant amount of clutter was observed in this room.

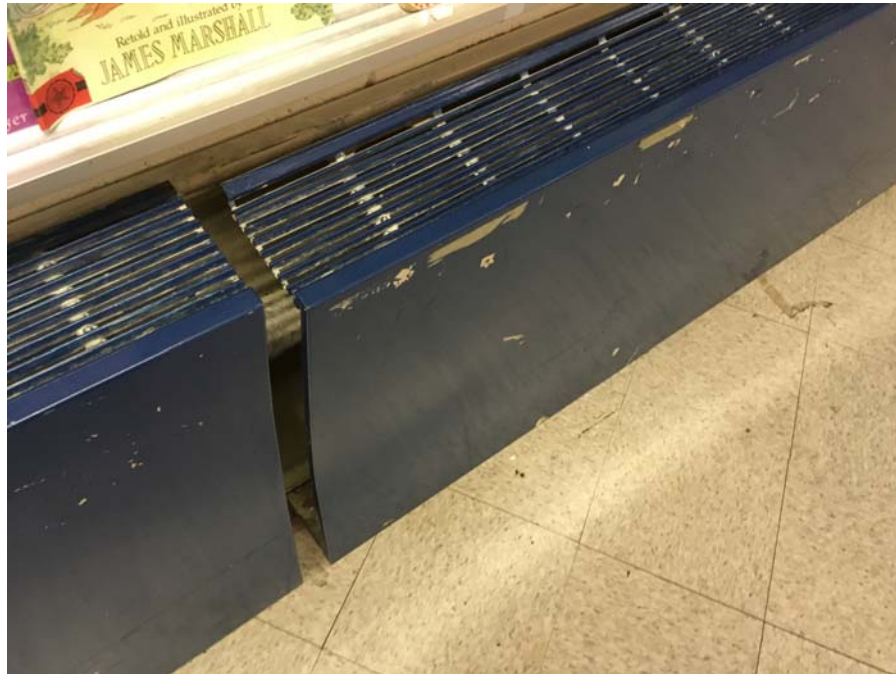
Photo 61 – Room 112  
This section of the radiator cover was not secured.

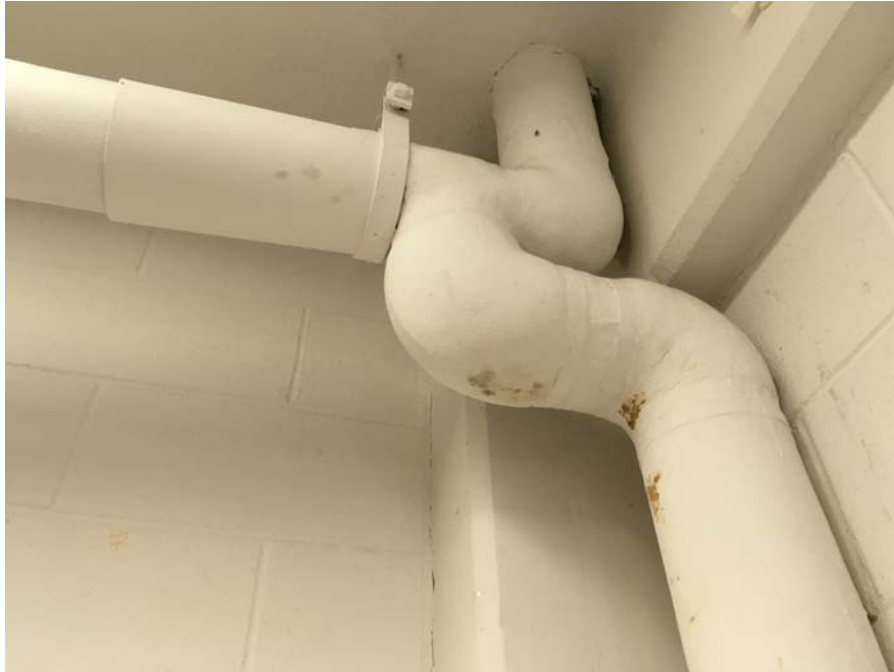
Photo 63 – Room 112  
Water staining and mold growth was observed on the pipe insulation.

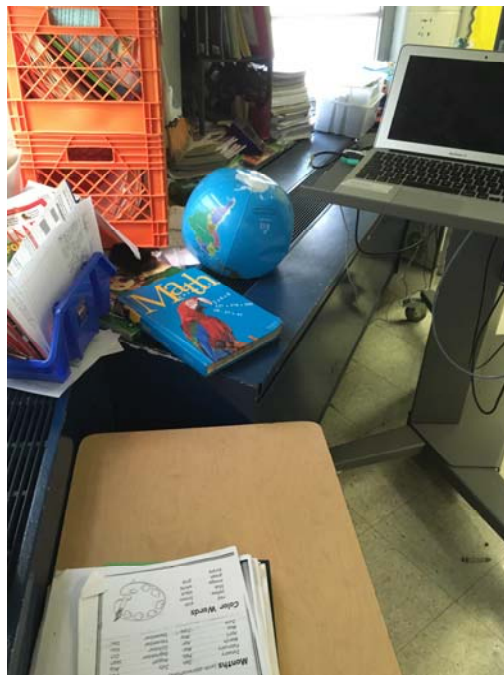
Photo 64 – Room 112  
Classroom materials were blocking the unit ventilator.

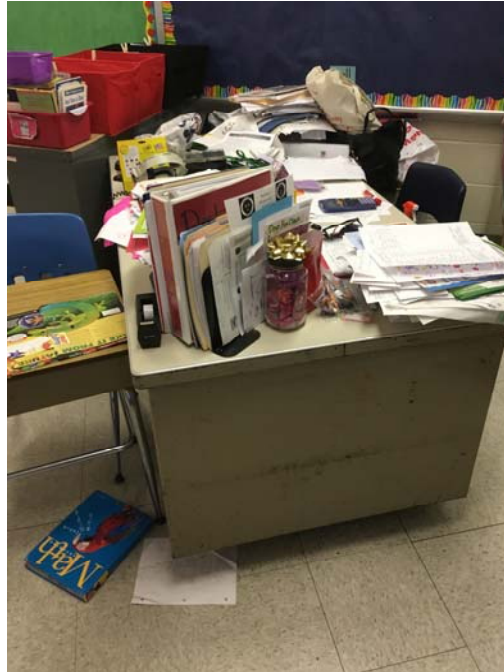
Photo 65 – Room 112  
significant amount of clutter was observed in this room.

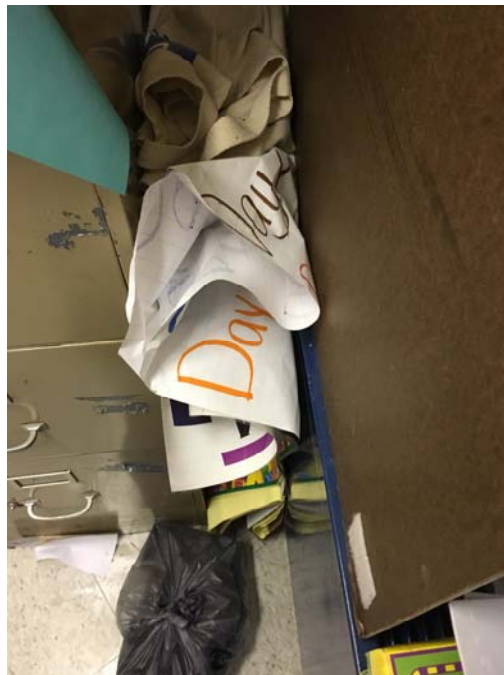
Photo 66 – Room 112  
significant amount of clutter was observed in this room.

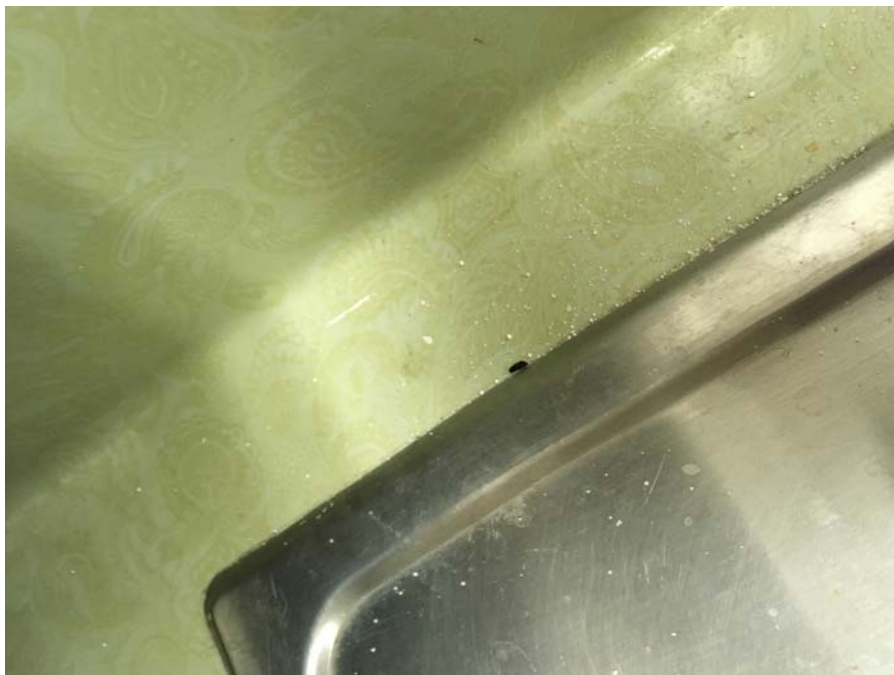
Photo 68 – Room 112  
Mouse droppings were observed near the sink.

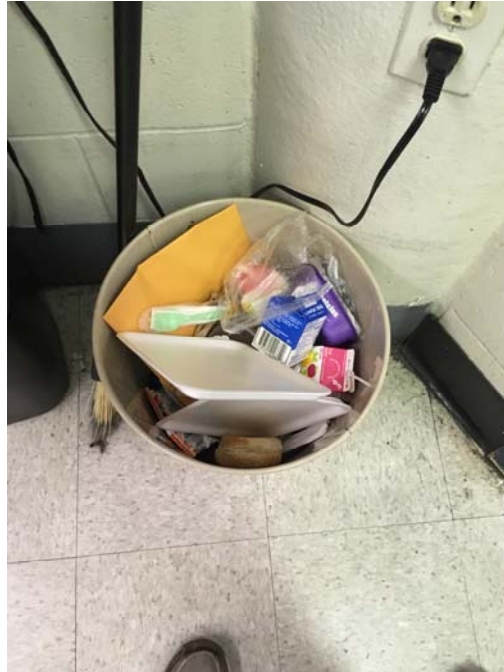
Photo 69 – Room 112  
Food waste was noted in the trash can.

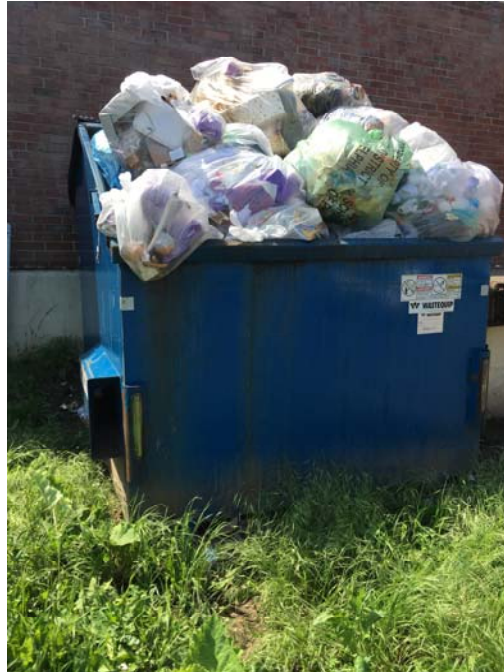
Photo 73 –Loading dock

A significant amount of trash accumulation was observed in and behind the dumpster.

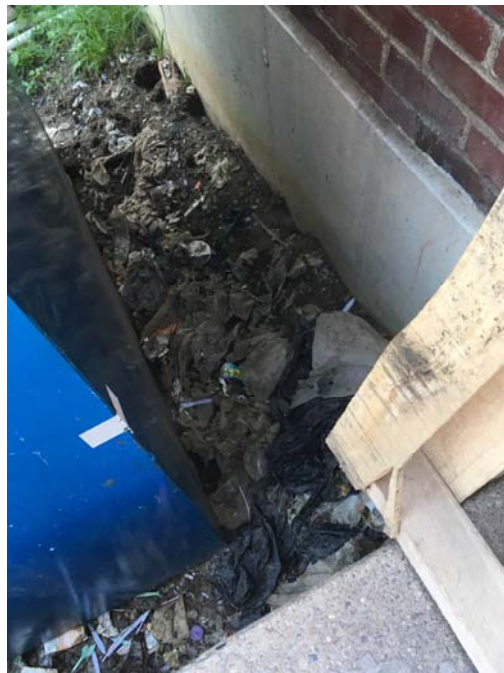
Photo 74 – Loading dock

A significant amount of trash accumulation was observed in and behind the dumpster.
