School District of Philadelphia
Office of Environmental Management Services
440 North Broad St.
Philadelphia, PA 19030

Mold Design Data Collection (DDC)

Name of Building: Hamilton Elementary School

Address: 5640 Spruce Street ULCS # 1290

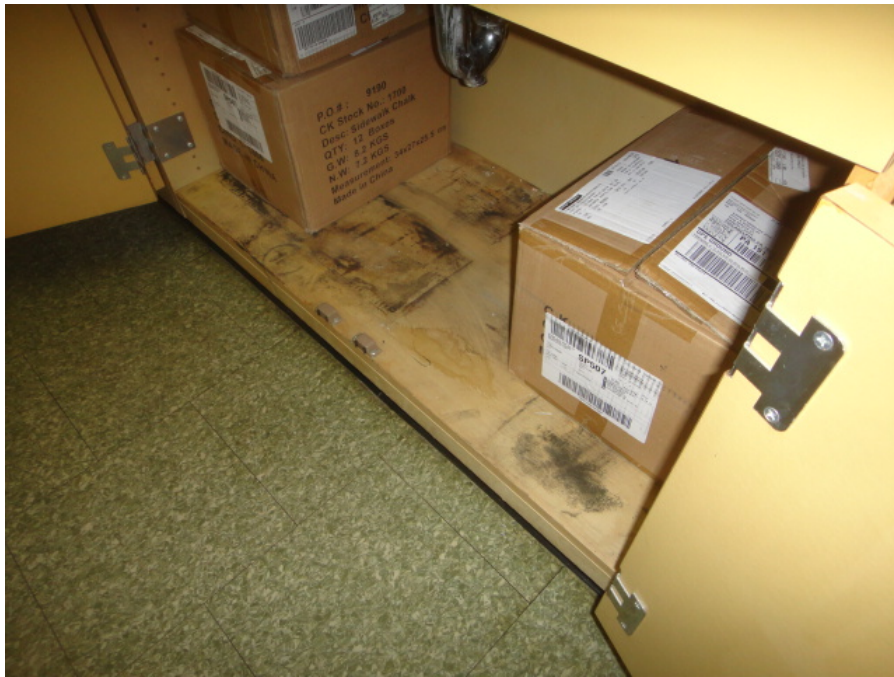
Action Item	Affected Material(s)	Total Quantity	Remediation*	Source of Moisture	Comments/Condition (i.e. dry/wet)
2	Mold growth was observed on the bottom of the sink cabinet interior.	6 SF	RMV, RPL	The source of moisture was from a leak on the sink that was repaired.	Remove the impacted section of wood. HEPA vacuum, clean and encapsulate the substrate as needed.

Photo 1 – Nurse’s Exam Room A
Mold growth was observed on the bottom of the wooden sink cabinet.

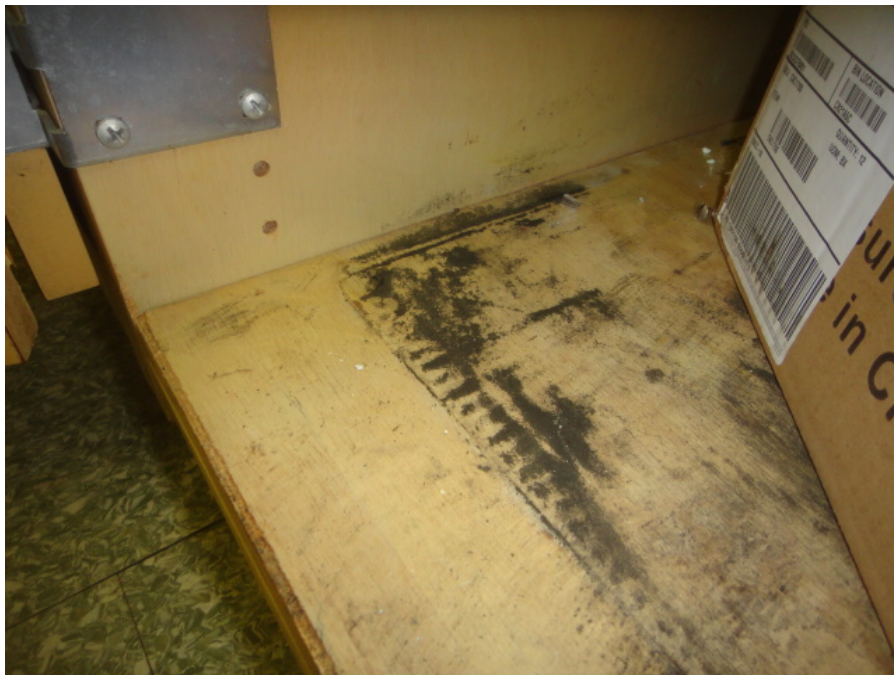
Photo 2 – Nurse’s Exam Room A
Mold growth was observed on the bottom of the wooden sink cabinet.

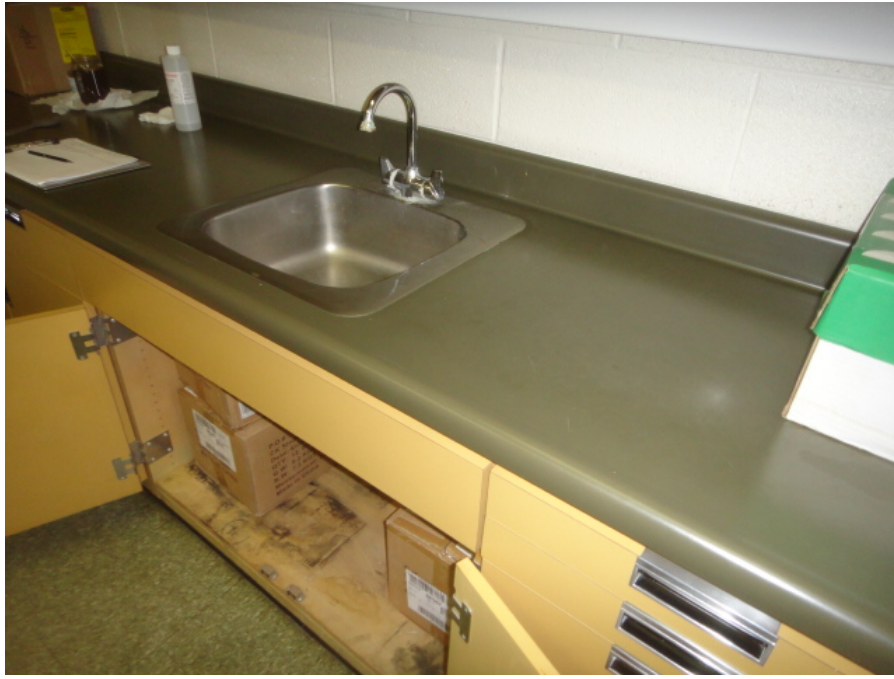
Photo 3 – Nurse's Exam Room A
Mold growth was observed on the bottom of the wooden sink cabinet.

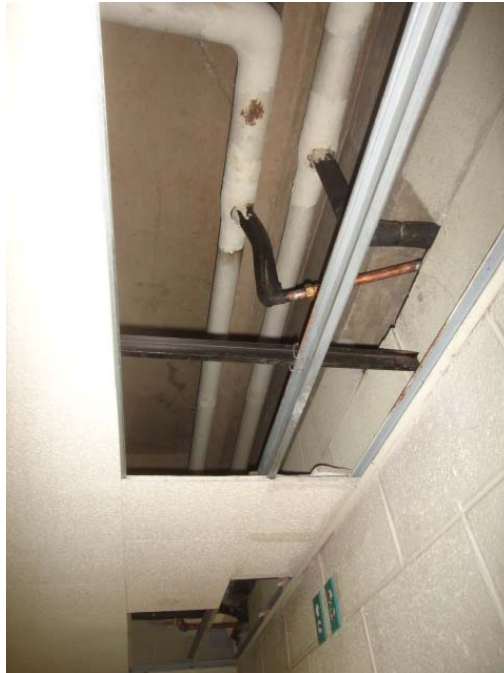
Action Item	Affected Material(s)	Total Quantity	Remediation*	Source of Moisture	Comments/Condition (i.e. dry/wet)
3	Mold growth was observed on the sections of the fiberglass pipe insulation located above the 1'x1' ceiling tiles.	20 LF	RMV, RPL	The source of moisture was from a pipe leak that was repaired.	Remove and replace the impacted fiberglass pipe insulation.

Photo 4– Room 321
Mold growth was observed on sections of the fiberglass pipe insulation.

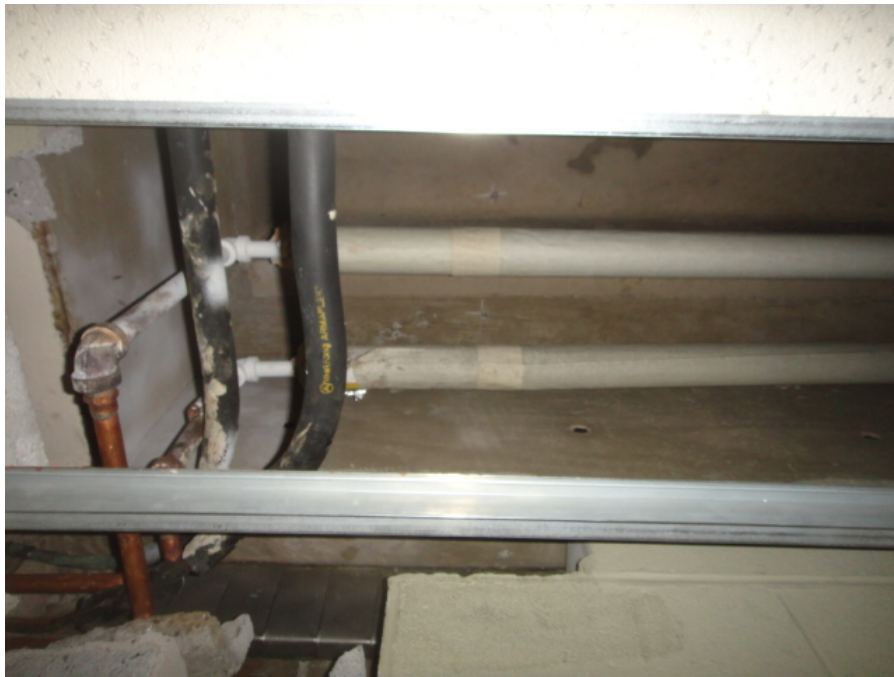
Photo 5 – Room 321
Mold growth was observed on sections of the fiberglass pipe insulation.

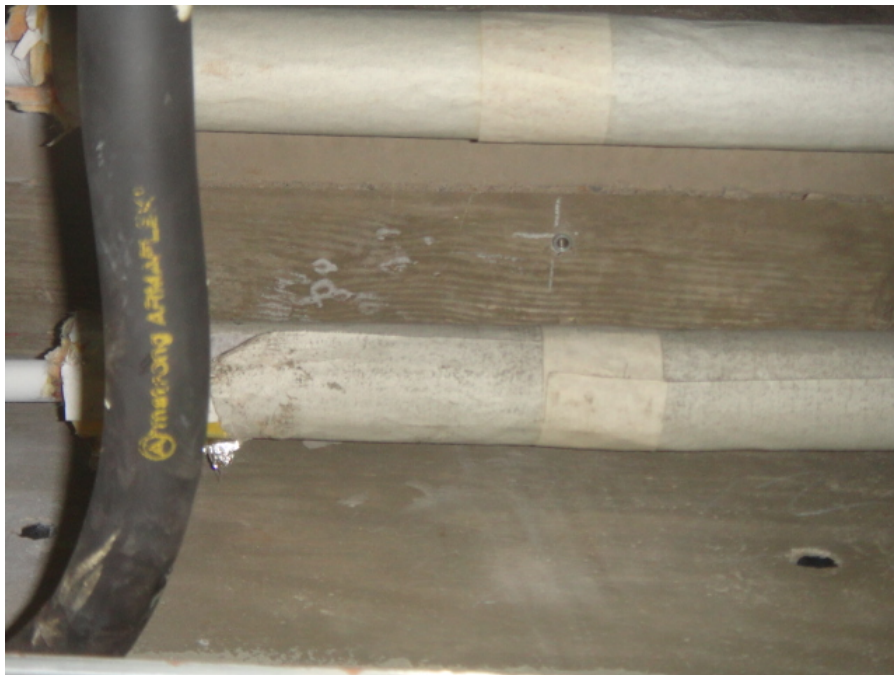
Photo 6 – Room 321
Mold growth was observed on sections of the fiberglass pipe insulation.

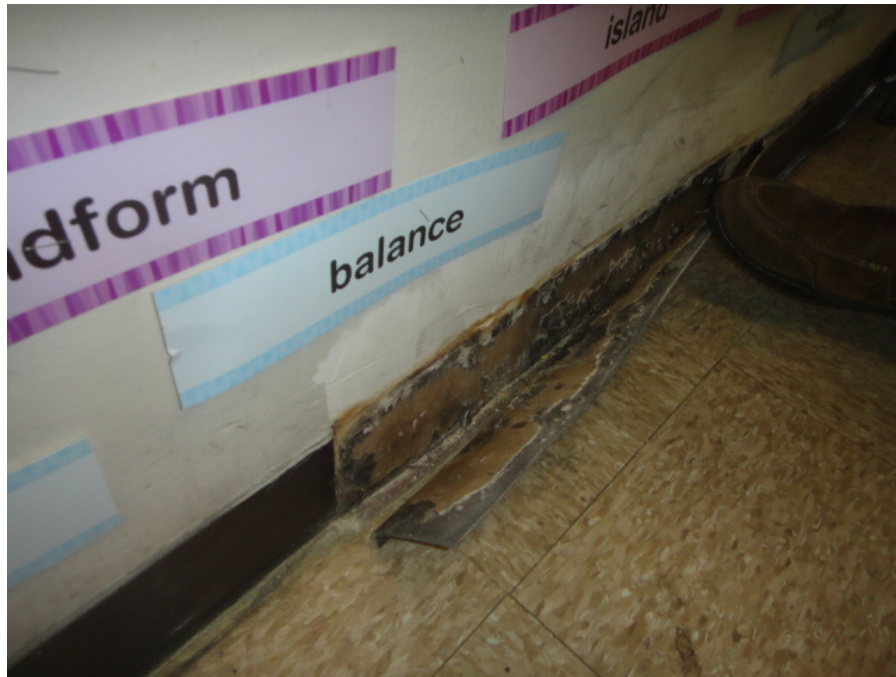
Photo 7 – Room 322

Action Item	Affected Material(s)	Total Quantity	Remediation*	Source of Moisture	Comments/Condition (i.e. dry/wet)
4	Mold growth was observed along the bottom of the gypsum wallboard.	40 SF/ or 20SF on each side.	RMV, RPL	The source of moisture appears to have been from using too much water during mopping.	Remove and replace the impacted sections of gypsum wallboard in room 323 and 324.

Mold growth was observed along the bottom of the gypsum wallboard.

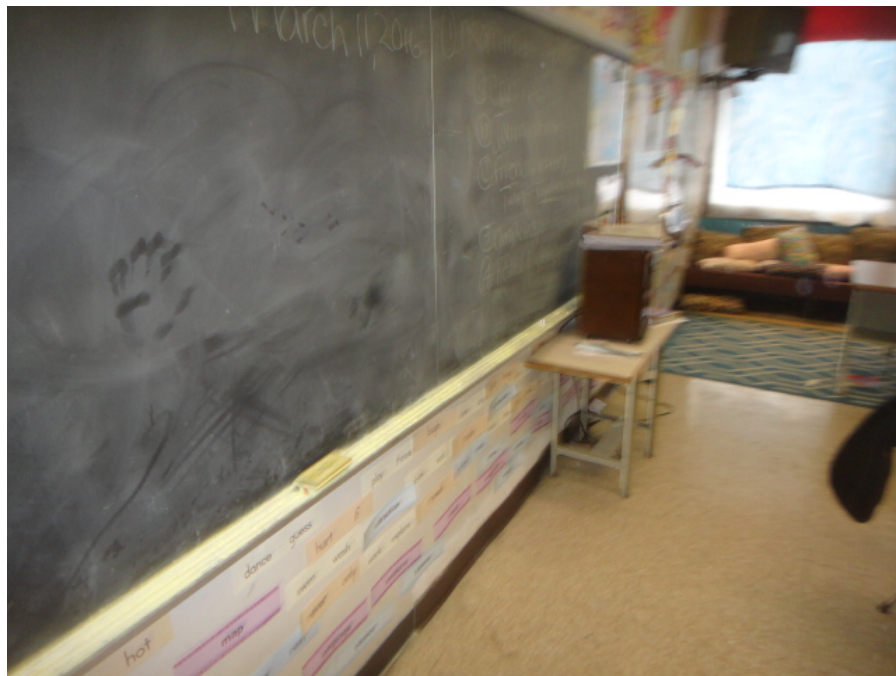
Photo 8 – Room 322

Mold growth was observed along the bottom of the gypsum wallboard.
