School District of Philadelphia
Office of Environmental Management Services
440 North Broad St.
Philadelphia, PA 19030

Mold Design Data Collection (DDC)

Name of Building: Austin Meehan Middle School Phone # 215-335-5654

Work Area Location(s): Lower Level Dance Room and Art Room 2

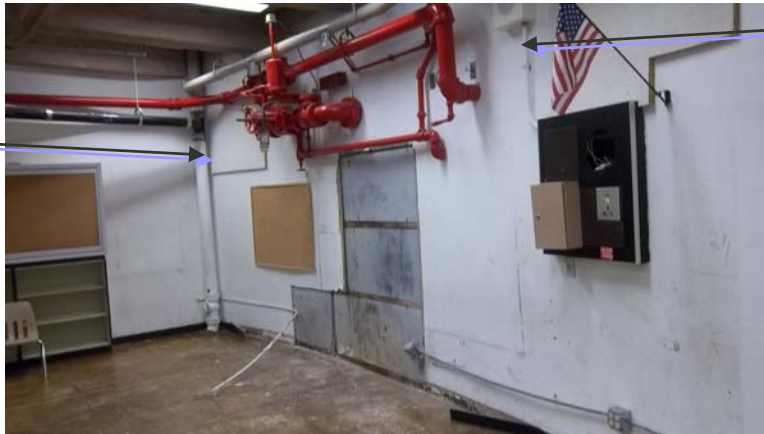
Photo 1- Dance Room on the lower level
Remove drywall, foam insulation and associated wood framing
floor to ceiling from the corner of the room where the drain line is located to the phone control panel.

Affected Material(s)	Total Quantity	Remediation*	Source of Moisture	Comments/Condition (i.e. dry/wet)
Drywall, foam insulation panels, wood framing	250 SF	REM, CLN, RPL	Moisture seepage through exterior wall	Remove drywall, foam insulation and associated wood framing, floor to ceiling from the corner where the drain line is located to the wall mounted phone box.
Water stained 1'x1' ceiling tiles throughout the room	30-40 EA	REM	Room above	Remove the water stained 1'x1' ceiling tiles located throughout the room. The AHERA Management Plan indicated the ceiling tiles were sampled and found not to contain asbestos.

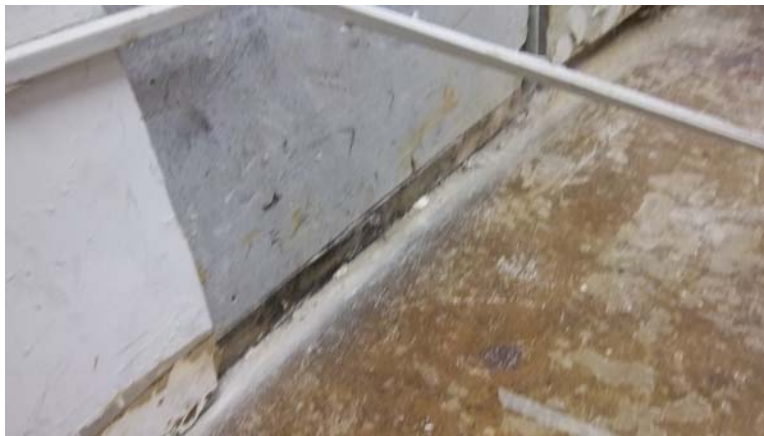
Photo 2 –Dance Room on the lower level
Mold growth on drywall, insulation panels and wood framing.

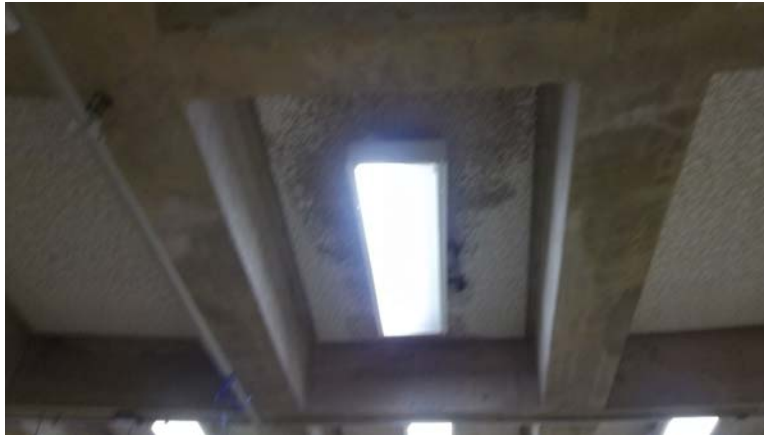
Photo 3- Dance Room on the lower level
Water stained ceiling tiles located throughout room.

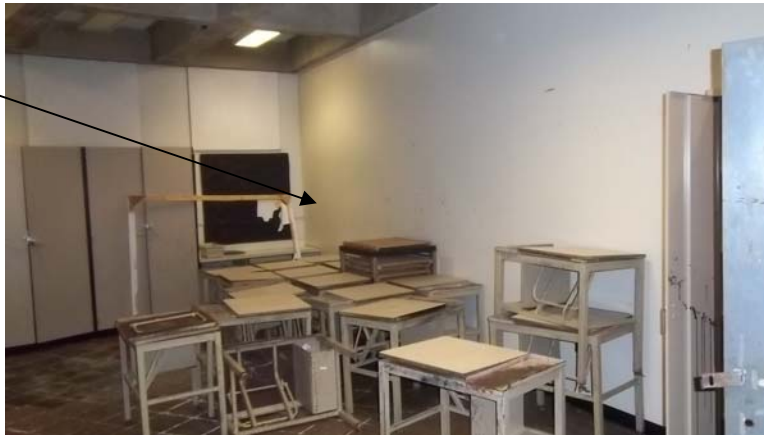
Affected Material(s)	Total Quantity	Remediation*	Source of Moisture	Comments/Condition (i.e. dry/wet)
Drywall partition between Art Rooms 1 and 2	100 SF	REM, CLN, RPL	Moisture seepage through exterior wall	Remove the lower 4 feet of the drywall partition.

Photo 4- Art Room 2 on the lower level
Elevated moisture content readings and mold growth was identified on the drywall partition.

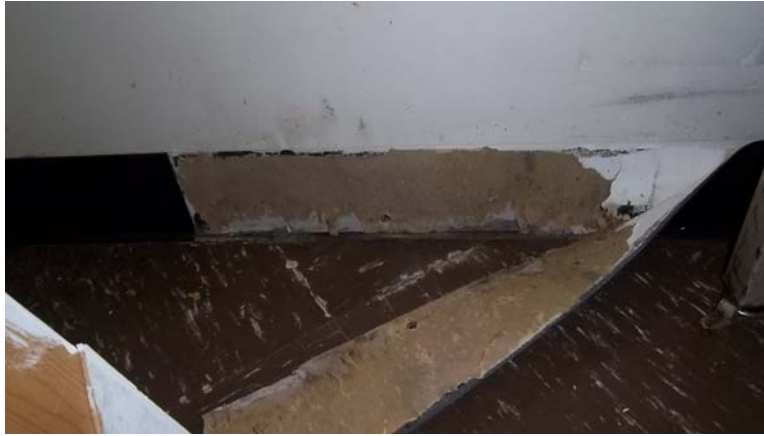
Photo 5- Art Room 2 on the lower level
Mold growth identified behind the cove base molding.
