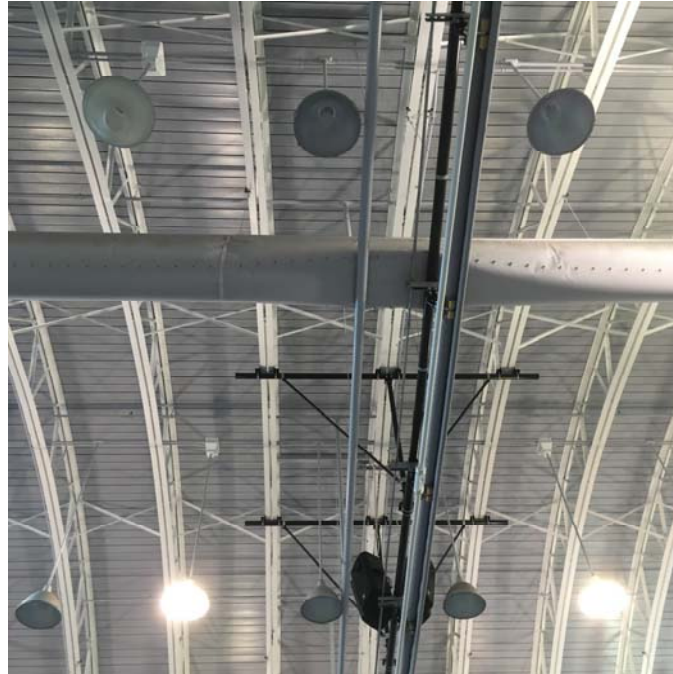
Photo 3 – Gymnasium (west)  
Water intrusion was reported from the main roof during heavy rainfall.

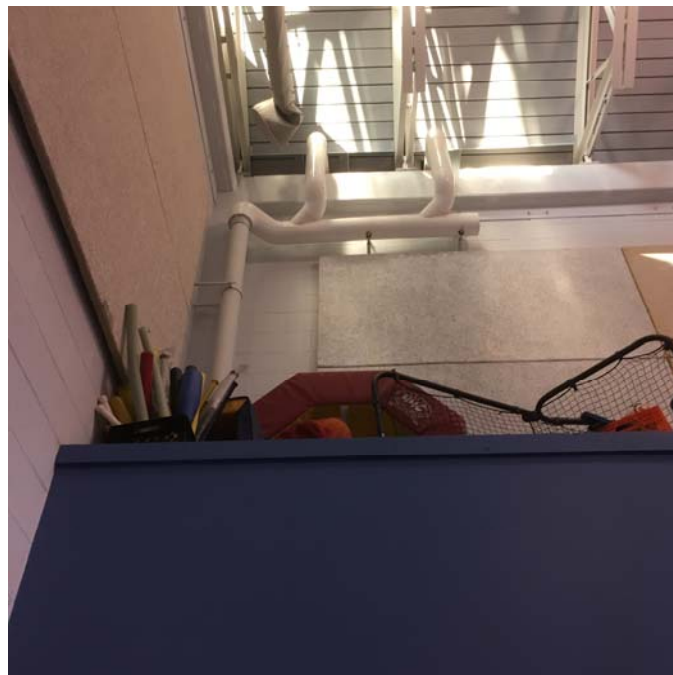
Photo 4 –Gymnasium (southwest)  
Water intrusion was reported form the southwest corner during heavy rainfall.

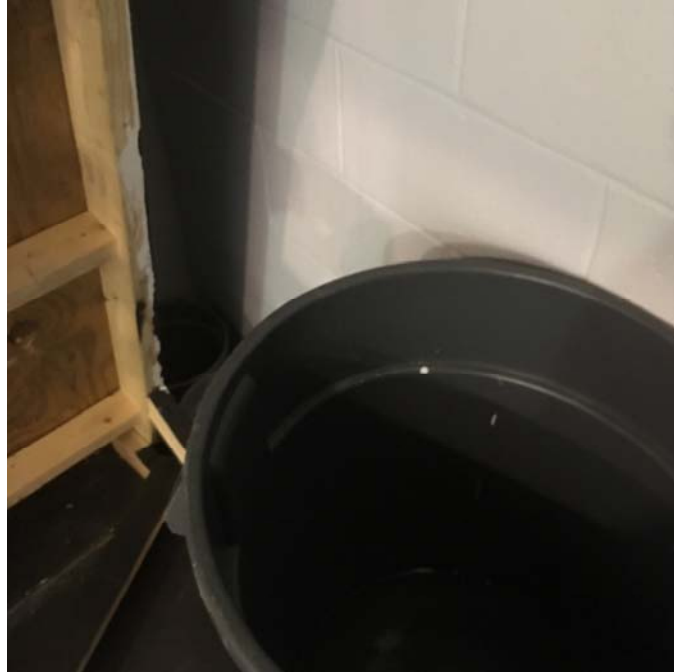
Photo 5 – Gymnasium (southwest)  
Buckets were placed in the closet to capture water.

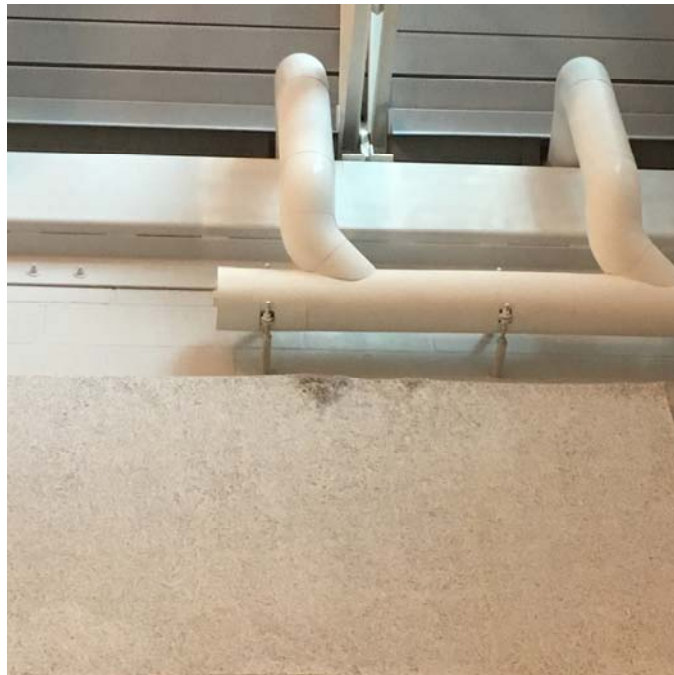
Photo 6 – Gymnasium (northwest)  
Staining and suspect mold growth was observed on the top of the acoustical panel under the roof drain.

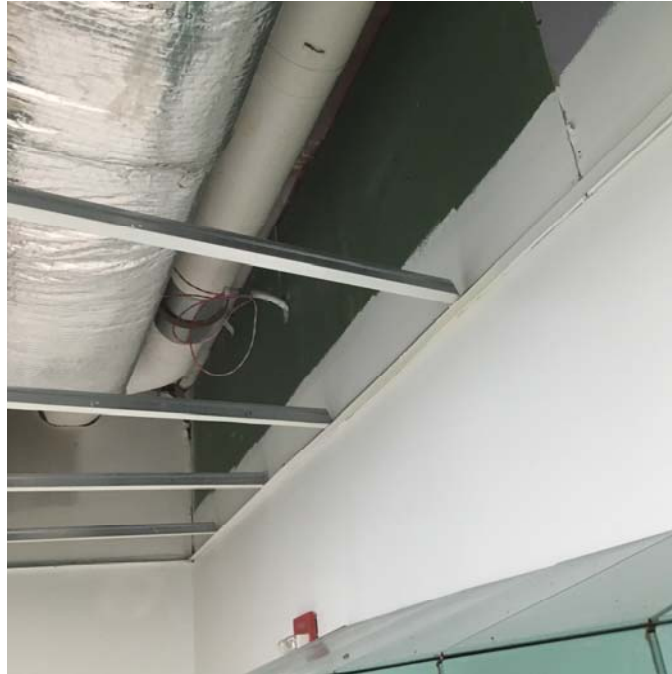
Photo 7 – Boy's Locker Room  
Missing suspended ceiling tiles were noted.

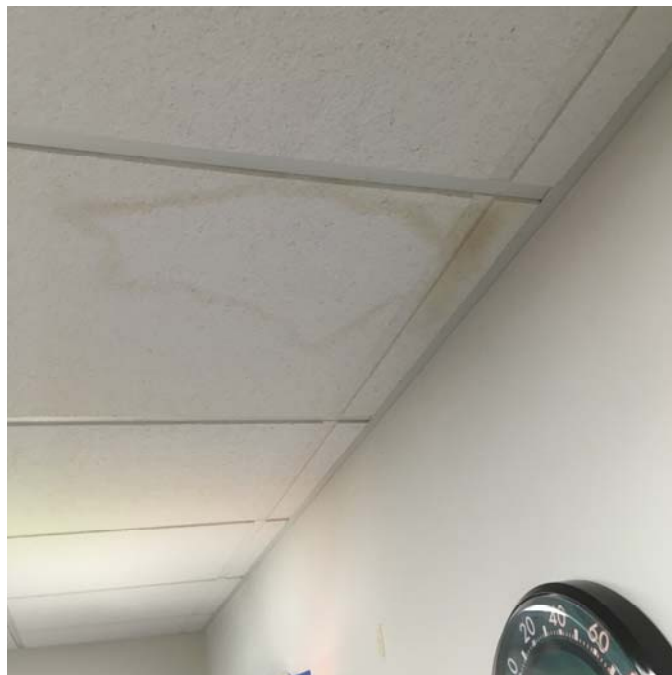
Photo 8 – Coach's Office  
Water stained ceiling tiles were observed.

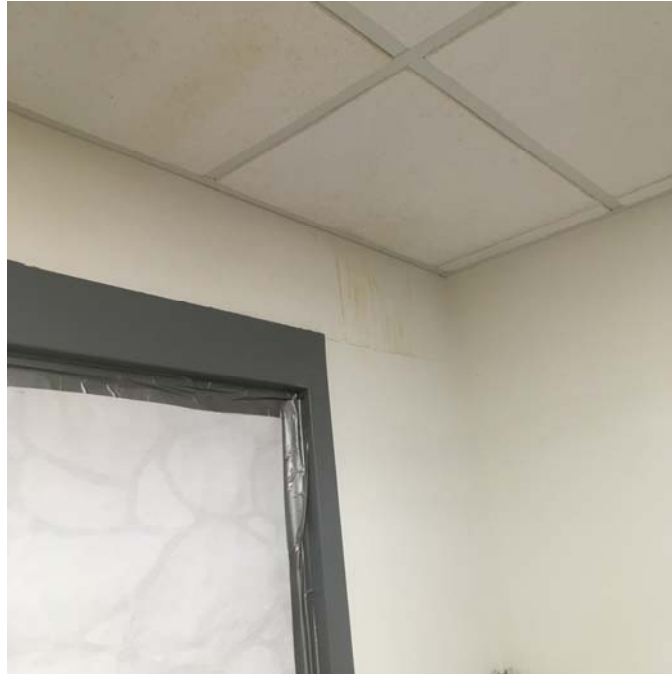
Photo 9 – Coach's Office  
Water stained ceiling tiles and gypsum wall board was observed.

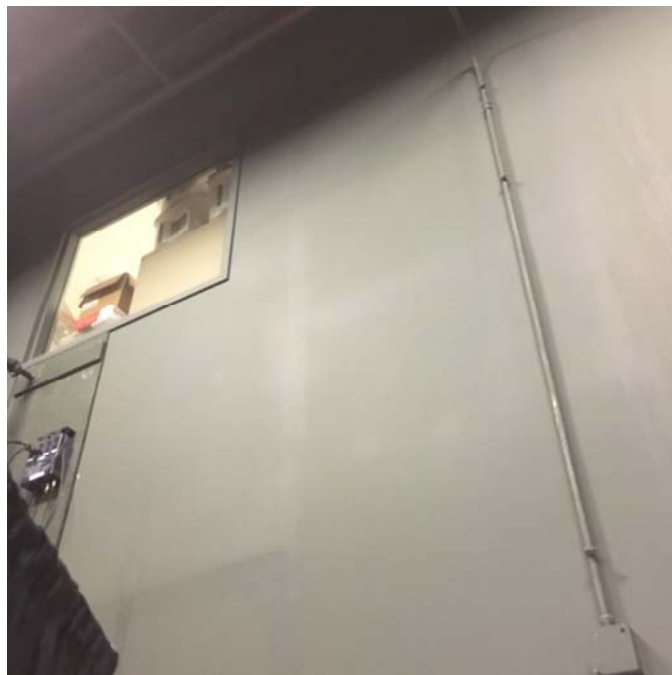
Photo 10 – Stage  
Water staining was observed on the wallboard located on the north and east wall.

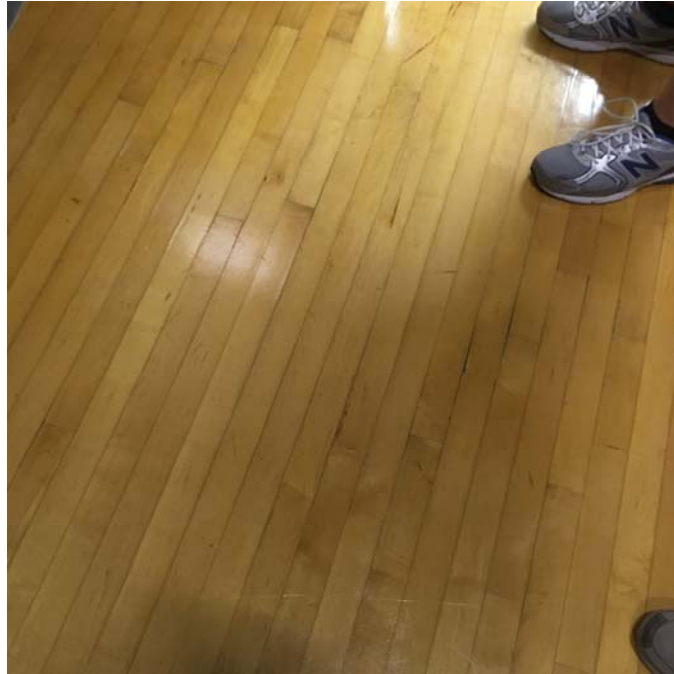
Photo 11– Stage  
Minor cupping from water intrusion was observed on a section of the hardwood floor adjacent to the north wall.

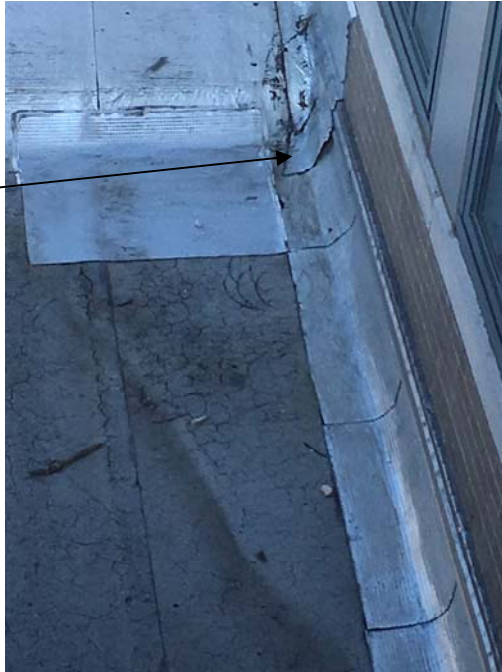
Photo 17 – Stage Roof  
An open seam was observed on the flashing
