Date
Inspected:
10/24/16

Mold Design Data Collection (DDC)

Name of Building: Penn Alexander Elementary School

Work Area Location(s): (1) Gymnasium

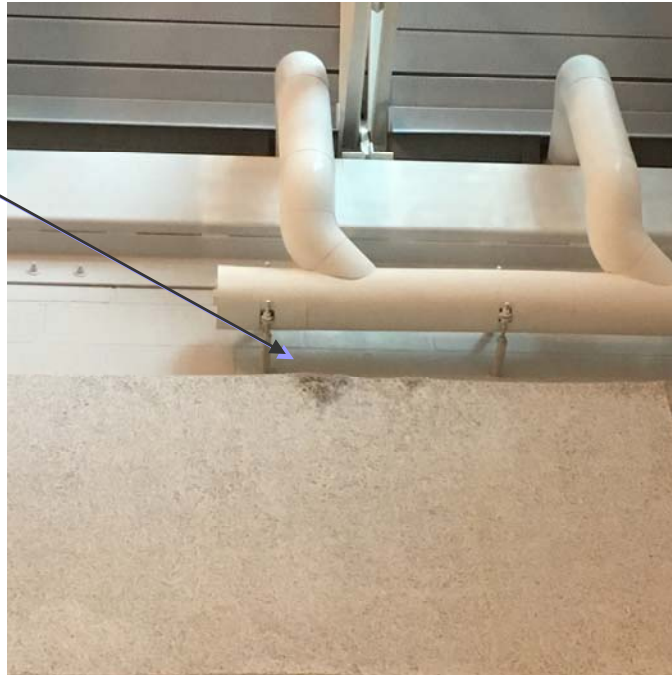
Photo 1 – Gymnasium (northwest)

Other Environmental Conditions/Comments: Active roof leaks in the gym

Action Item	Affected Material(s)	Total Quantity	Remediation*	Source of Moisture	Comments/Condition (i.e. dry/wet)
1	Water staining and suspect mold growth was observed on the acoustic wall panel in the northwest corner below the roof drain.	1 SF	CLN,ENP	Roof Leak	The impacted section of the acoustical panel should be cleaned and encapsulated.

Staining and suspect mold growth was observed on the top of the acoustical panel under the roof drain.
