Facility Condition Assessment Summary Report

Patterson School

S140001;Patterson

Site Assessment Report

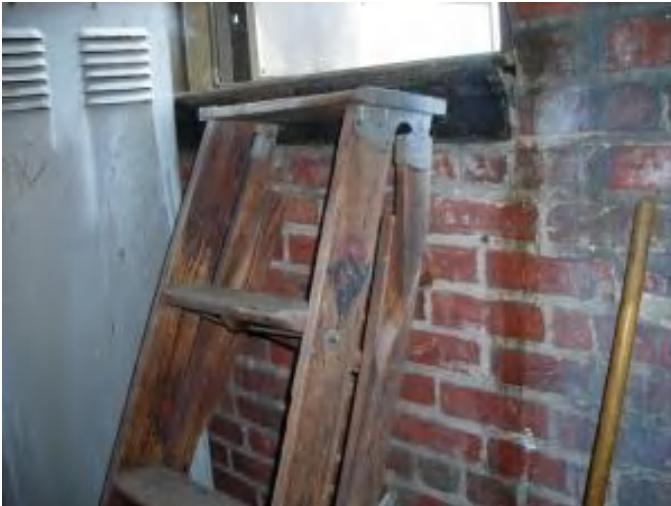
Location: Roof access

System: B2010 - Exterior Walls

Distress: Health Hazard / Risk

Notes: Install stair or ladder access to roof – none installed

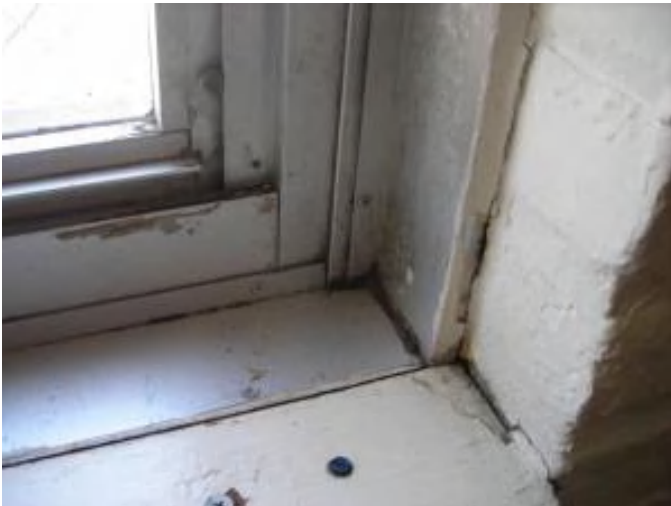
Location: Main building

System: B2020 - Exterior Windows

Distress: Energy Efficiency

Notes: Replace Plexiglas windows - hazed

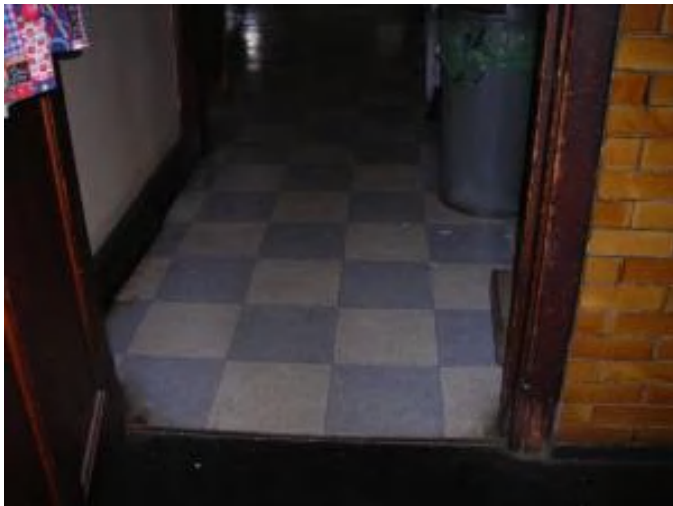
Location: Throughout

System: C1020 - Interior Doors

Distress: Damaged

Notes: Repair or replace rusted, dented, scratched doors and frames

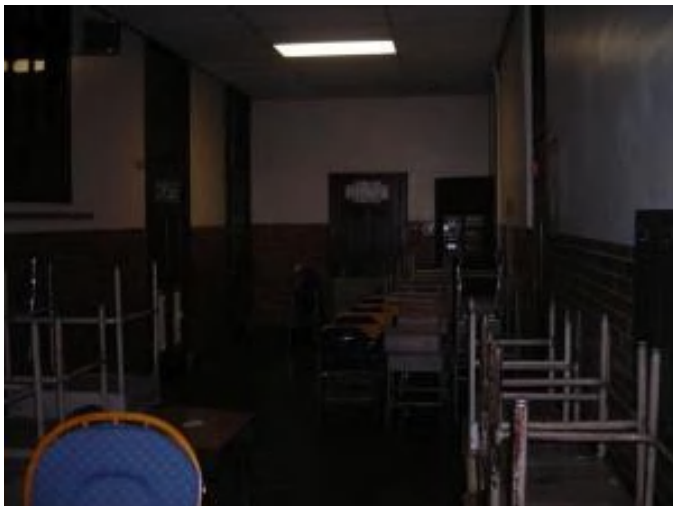
Location: Throughout

System: C1020 - Interior Doors

Distress: Accessibility

Notes: Provide ADA lever handle lock/latchsets on interior doors

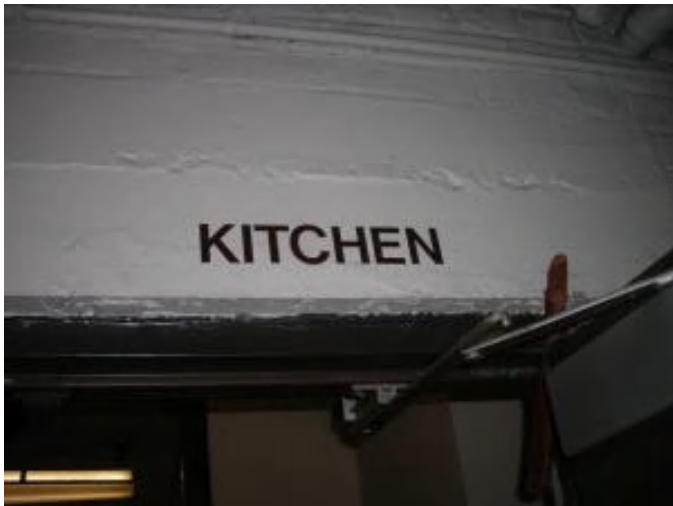
Location: Throughout

System: C1030 - Fittings

Distress: Inadequate

Notes: Install new ID signage

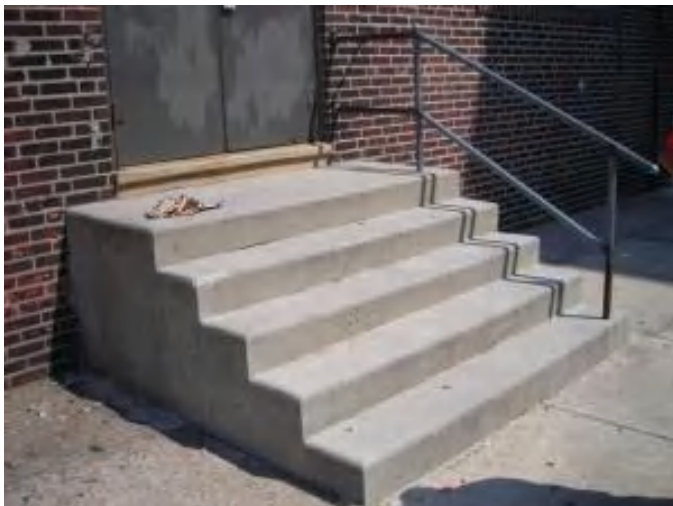
Location: Stairways

System: C2010 - Stair Construction

Distress: Building / MEP Codes

Notes: Replace railing in stairways with code compliant

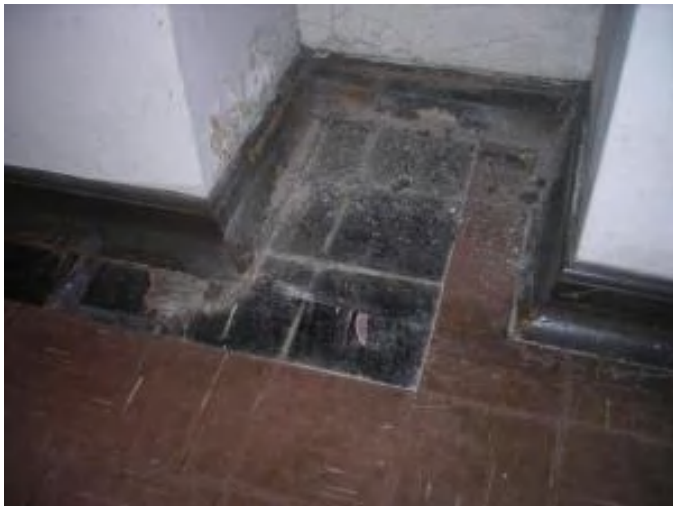
Location: 1st floor, kitchen

System: C3020413 - Vinyl Flooring

Distress: Damaged

Notes: Replace VCT - damaged and mismatched VCT and VAT floor tiles

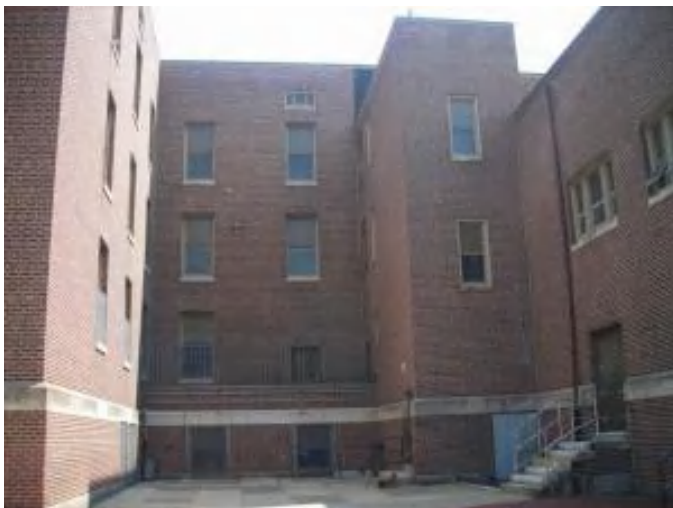
Location: TBD

System: D1010 - Elevators and Lifts

Distress: Accessibility

Notes: Install elevator for accessibility (location TBD)

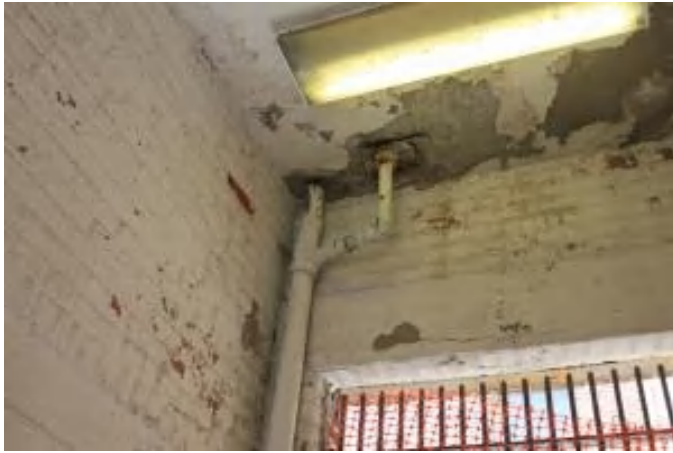
Location: Entire building

Rain water discharge pipes are threaded steel and soldered copper and run inside the building. The roof does not have overflow drains. The District should hire a qualified contractor to examine the rain water discharge piping using video cameras to locate and replace any damaged piping and to further quantify the extent of potential failures.

System: D2040 - Rain Water Drainage

Distress: Failing

Notes: Hire a qualified contractor to perform a detailed examination of the roof drain piping using visual inspection and video cameras to locate and replace any damaged piping and to further quantify the extent of potential failures.

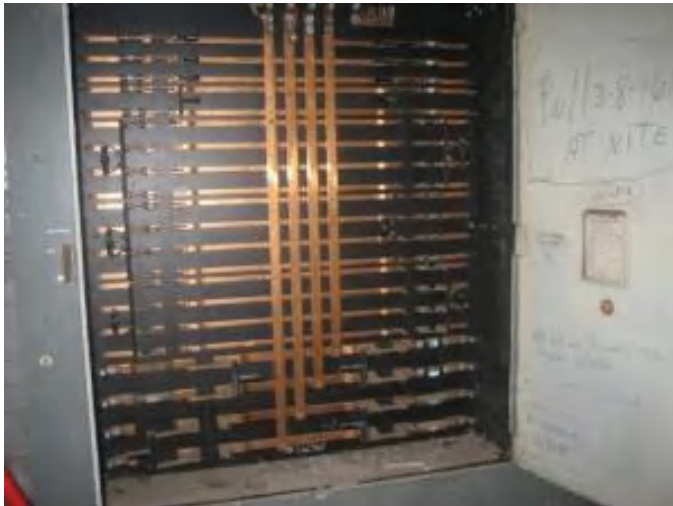
Location: Basement boiler room

System: D5010 - Electrical Service/Distribution

Distress: Inadequate

Notes: The electrical service entrance should be upgraded, using the present utility pole, and a larger transformer pit. The new service will be 480V/277V, 3 phase power, approximate 1000 Amperes and will be located in the vicinity of the existing electrical service.

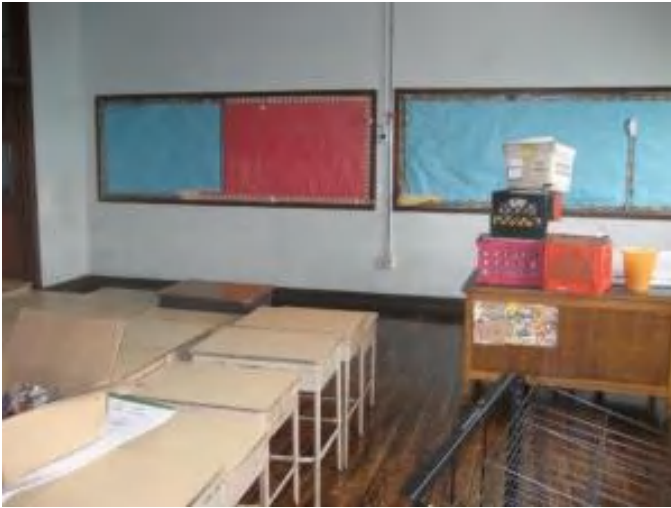
Location: Classrooms

The number of receptacles in classrooms are inadequate. Teachers use extension cords. The teacher's whiteboard wall and the opposite of it need to be provided with double compartment surface raceways the other tow wall with minimum two duplex outlets each, when feasible. The quantity of receptacles outlets in the learning education center building is adequate.

System: D5020 - Lighting and Branch Wiring

Distress: Inadequate

Notes: Provide (2)25FT of surface raceways with 24" receptacles on center and two-duplex wall mount receptacles. Approximate 560 receptacles.

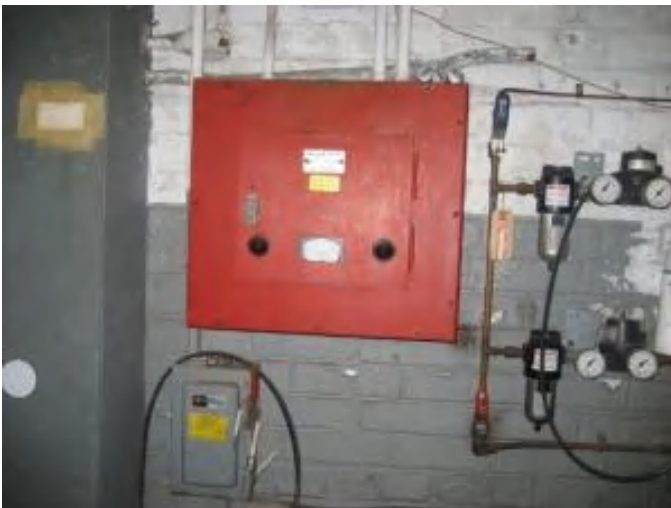
Location: Entire school

System: D5030 - Communications and Security

Distress: Obsolete

Notes: Replace old fire alarm system with addressable type with audio/visual devices at corridors and classrooms. Approximate 98 devices.

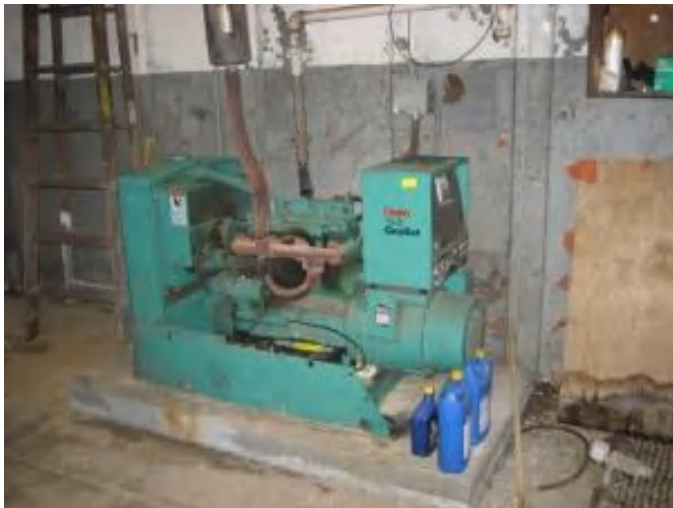
Location: Outdoor

System: D5090 - Other Electrical Systems

Distress: Beyond Service Life

Notes: Provide 70KW, outdoor, diesel powered generator.

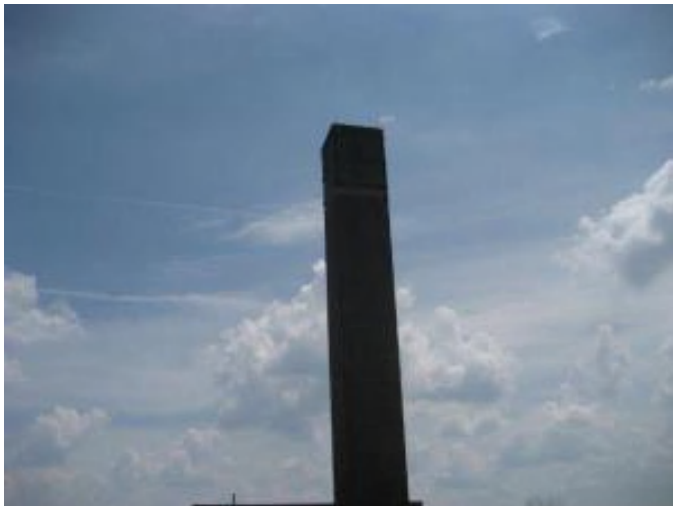
Location: Roof

System: D5090 - Other Electrical Systems

Distress: Inadequate

Notes: Prepare a study to determine if existing lightning protection system provide the proper coverage to the school building.

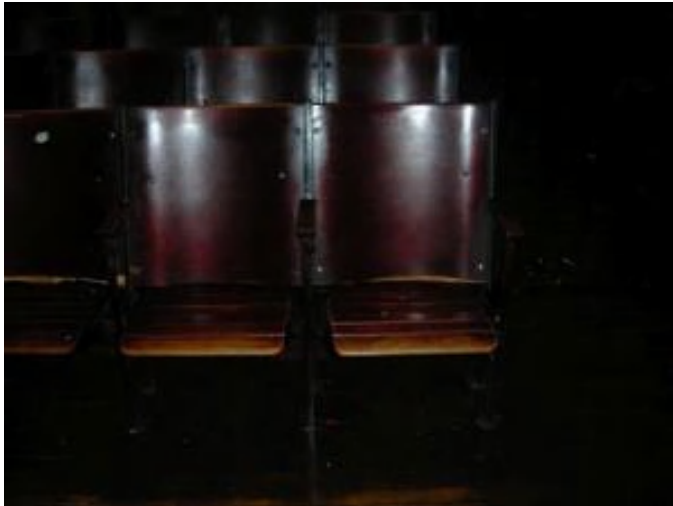
Location: Auditorium

System: E2010 - Fixed Furnishings

Distress: Beyond Service Life

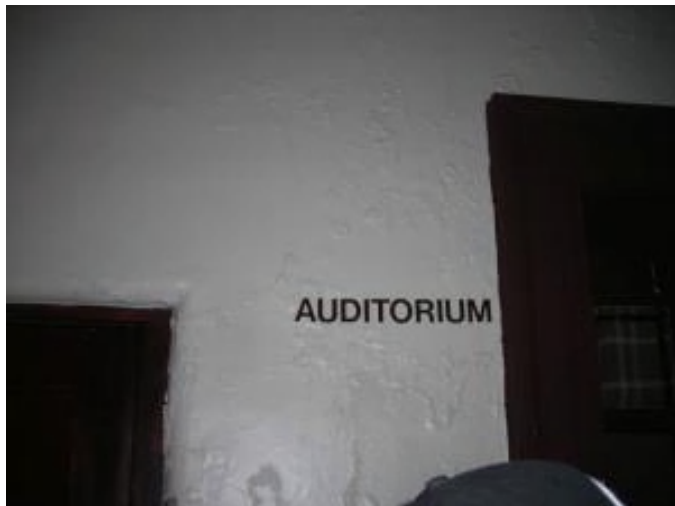
Location: Main building

System: C3010230 - Paint & Covering

Distress: Damaged

Notes: Repair and repaint interior walls (30% of wall surface)

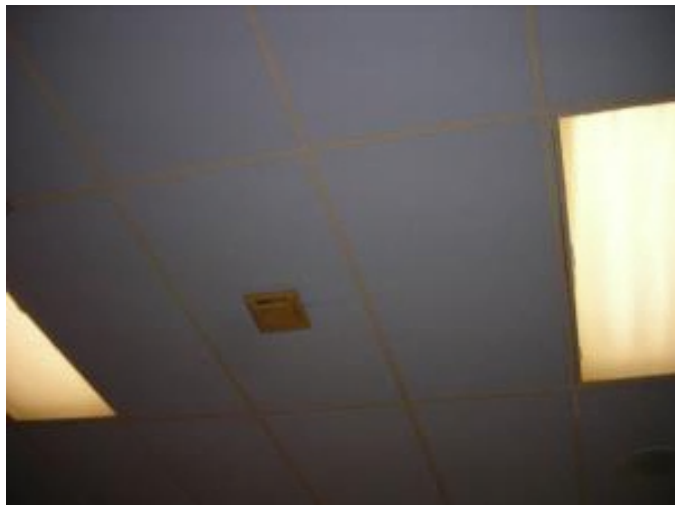
Location: Kitchen, floors 1-3

System: C3030 - Ceiling Finishes

Distress: Failing

Notes: Replace suspended ceiling grids – failing and past useful life

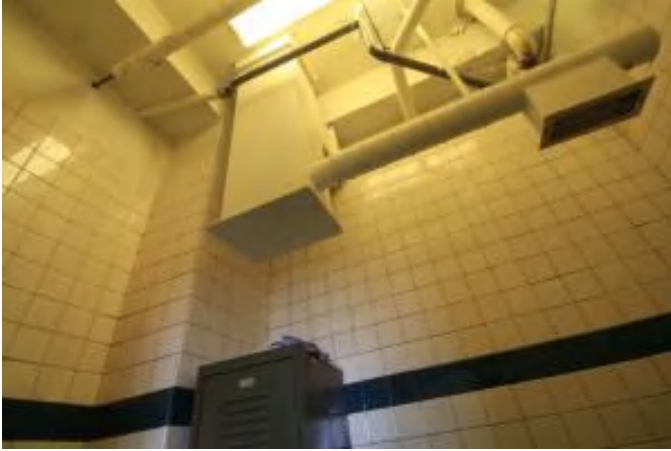
Location: Entire building

The sanitary sewer piping is cast iron pipe with hubless fittings joined with banded couplings and soldered copper in sections. There is no sewage ejector. The engineer did not report problems with the sanitary waste piping systems. However, the sewer piping age is unknown and will require more frequent attention from the maintenance staff as time passes. . The District should hire a qualified contractor to examine the sanitary waste using video cameras to locate and replace any damaged piping and to further quantify the extent of potential failures.

System: D2030 - Sanitary Waste

Distress: Beyond Service Life

Notes: Hire a qualified contractor to perform a detailed examination of the sanitary waste using visual inspection and video cameras to locate and replace any damaged piping and to further quantify the extent of potential failures.

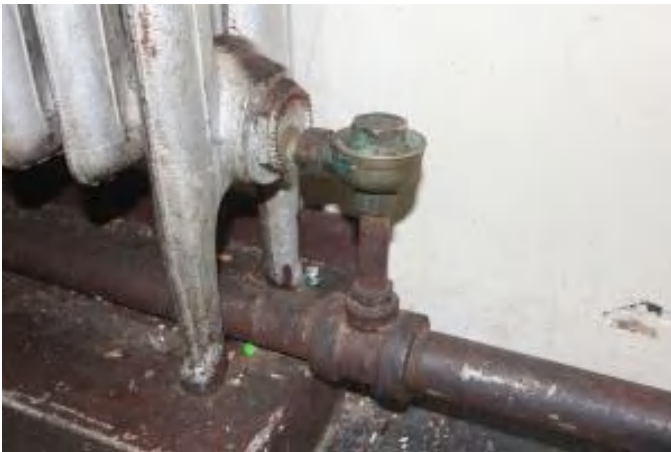
Location: Entire building

Steam piping is black steel with welded and threaded fittings. The condensate piping is black steel with threaded fittings. Steam and condensate piping mains from the basement level run up through the building to the terminal units on all three floors. The annex building receives steam from the main building and the engineer stated the underground steam pipes need repair. The District should hire a qualified contractor to examine the steam and condensate piping and perform additional testing to locate and replace any damaged piping and to further quantify the extent of potential failures. The District should budget for replacing all steam and condensate piping over the next 10 to 15 years.

System: D3040 - Distribution Systems

Distress: Beyond Service Life

Notes: Hire a qualified contractor to examine the steam and condensate piping and perform additional testing to locate and replace any damaged piping and to further quantify the extent of potential failures.

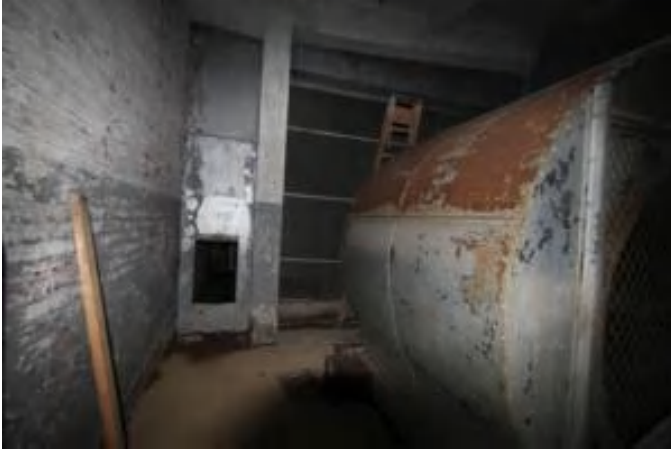
Location: Fan room

System: D3040 - Distribution Systems

Distress: Obsolete

Notes: Replace existing air handler including heating, cooling, humidification, and dehumidification.

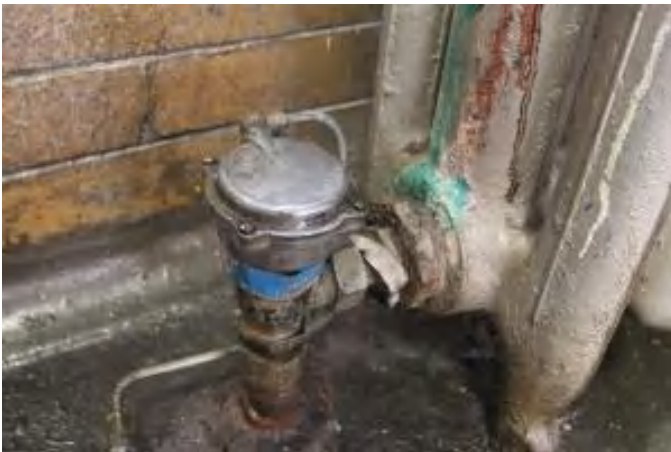
Location: Entire building

The original pneumatic systems still provide basic control functions. Pneumatic room thermostats control steam flow valves on the radiators. Central duct dampers are manually adjustable only. The pneumatic systems are beyond their service life. These controls should be converted to DDC and automatically controllable dampers installed when metal ducts are replaced.

System: D3060 - Controls & Instrumentation

Distress: Energy Efficiency

Notes: Replace the pneumatic controls for the HVAC systems with modern DDC modules, valves and actuators to improve reliability and energy efficiency. Provide a new building automation system (BAS) with communication interface to the preferred system in use throughout the District.

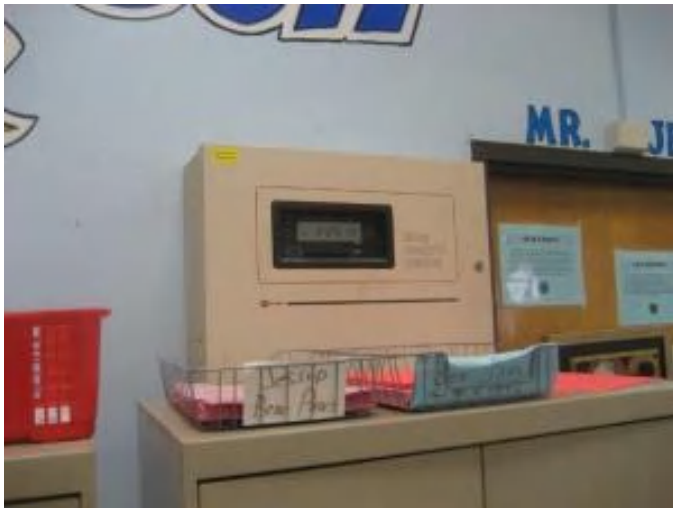
Location: Entire school

System: D5030 - Communications and Security

Distress: Beyond Service Life

Notes: Provide a new clock system, wireless battery operated. Approximate 60 clocks.

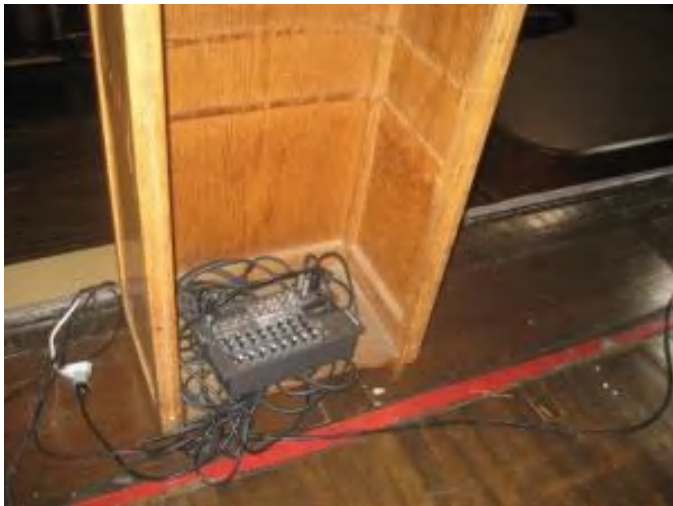
Location: Auditorium

System: D5030 - Communications and Security

Distress: Obsolete

Notes: Provide a sound system to the auditorium.

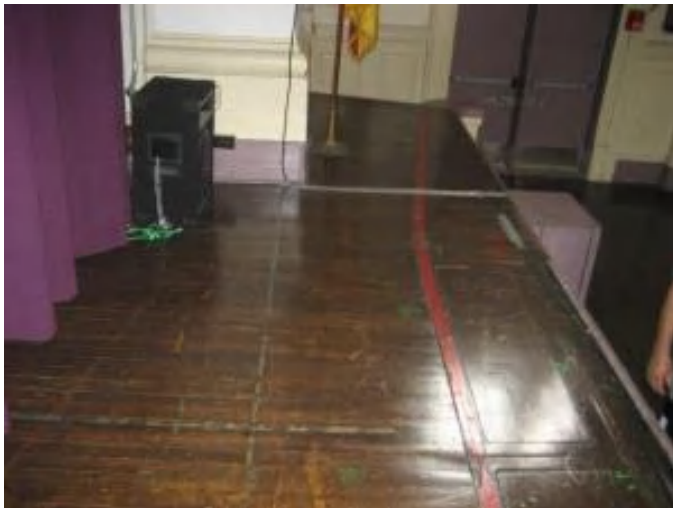
Location: Auditorium

The stage lighting controller is old and has exceeded its service life. Theatrical lighting system is ON/OFF from local panel-board. The entire system should be replaced.

System: E1020 - Institutional Equipment

Distress: Obsolete

Notes: Provide a dimming and theatrical lighting.

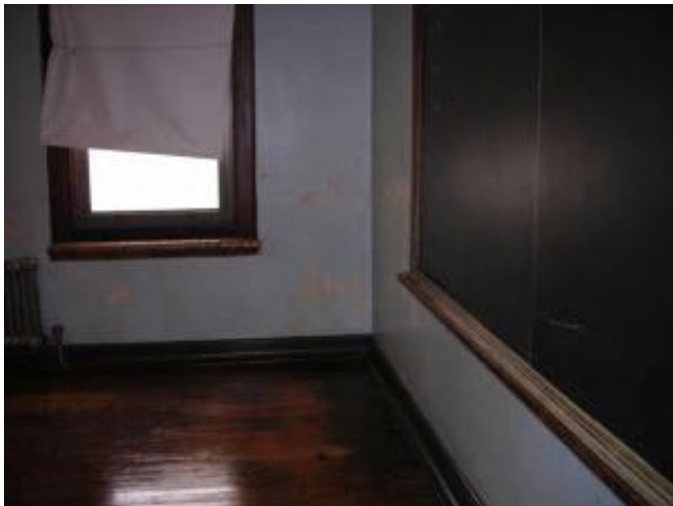
Location: Classrooms

System: E2010 - Fixed Furnishings

Distress: Not Reliable

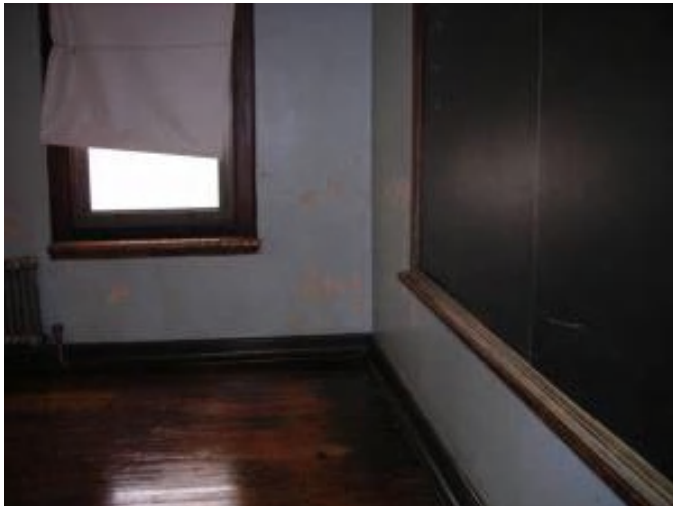
Location: Classrooms, Auditorium

System: C3020414 - Wood Flooring

Distress: Appearance

Notes: Repair and refinish hardwood flooring (40% incl. auditorium and stage)

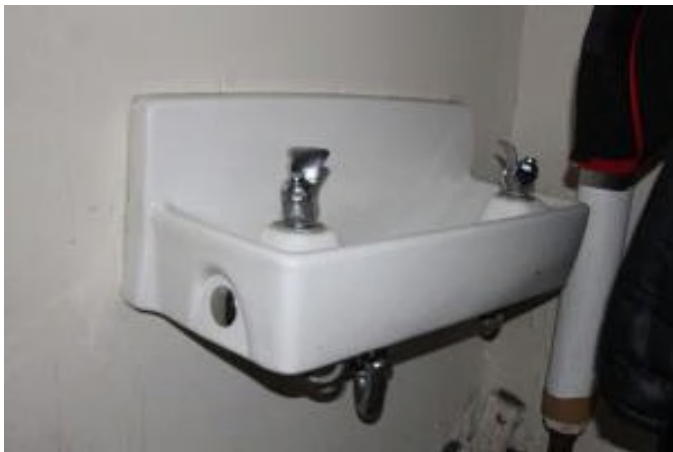
Location: Corridors

Drinking fountains in the corridors are wall hung, most with integral refrigerated coolers. They are well beyond their service life and should be replaced with accessible type.

System: D2010 - Plumbing Fixtures

Distress: Accessibility

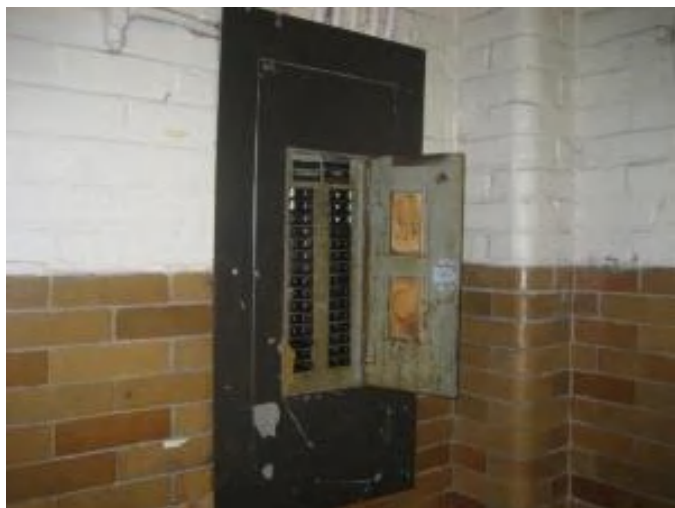
Location: Corridors

System: D5010 - Electrical Service/Distribution

Distress: Inadequate

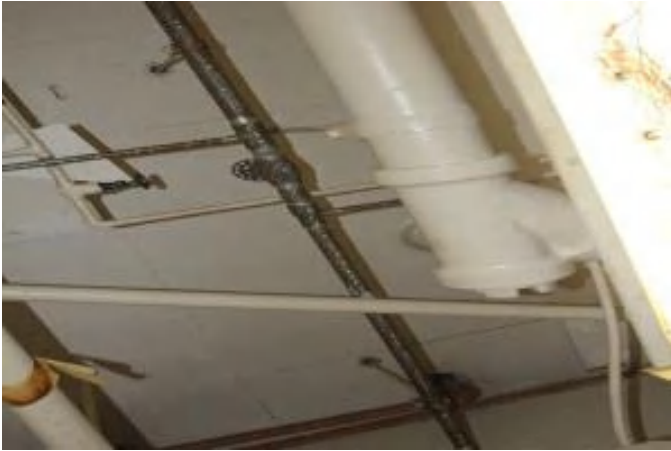
Location: Entire building

basement level near the kitchen. The domestic hot and cold water distribution piping is copper piping and soldered connections. The maintenance staff reports no significant problems with domestic piping and the supply is adequate to the fixtures. However, the domestic water piping is well beyond its service life and should be replaced to eliminate joints made with lead solder.

System: D2020 - Domestic Water Distribution

Distress: Beyond Service Life

Notes: Replace the original copper domestic water piping to eliminate joints made with lead solder.

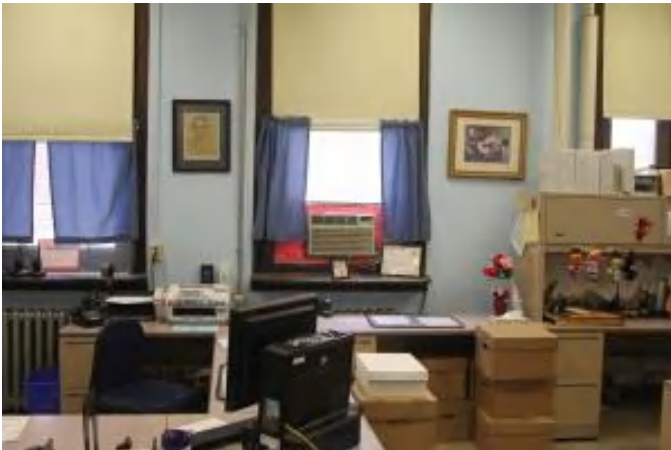
Location: Entire building

Some of the classrooms and offices in the school building have window air conditioning units that have an anticipated service life of only 10 years. Installing a 180 ton air-cooled chiller on the roof with pumps located in the fan room on the basement level and chilled water would supply more reliable and more efficient air conditioning for the building with a much longer service life. The annex building has two rooftop condensing units serving direct expansion coils in attic mounted air handlers.

System: D3030 - Cooling Generating Systems

Distress: Energy Efficiency

Notes: Remove the window air conditioning units and install a 180 ton air-cooled chiller on the roof with chilled water pumps located in fan room on the basement level to supply more reliable air conditioning for the building with a much longer service life.

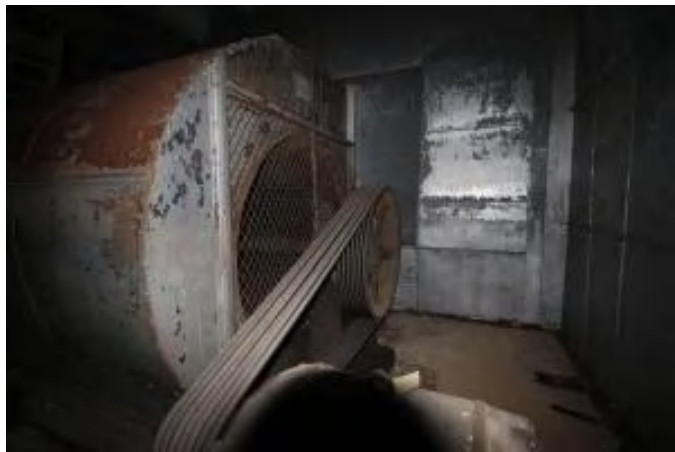
Location: classrooms

System: D3040 - Distribution Systems

Distress: Building / MEP Codes

Notes: Replace the obsolete ventilation system for the classrooms with fan coil units and a dedicated OA unit.

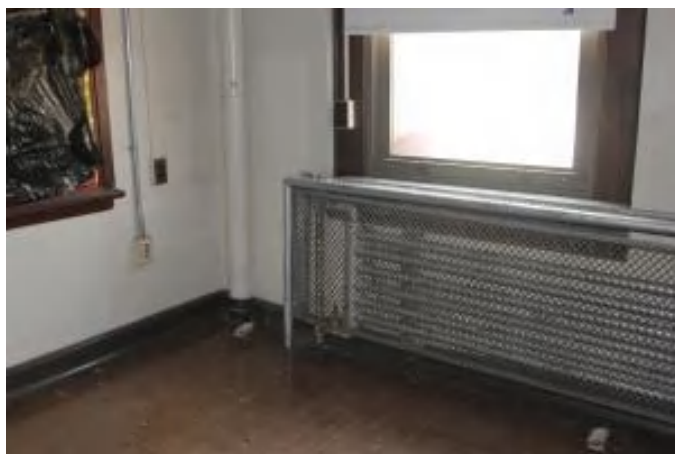
Location: Entire building

System: D3040 - Distribution Systems

Distress: Beyond Service Life

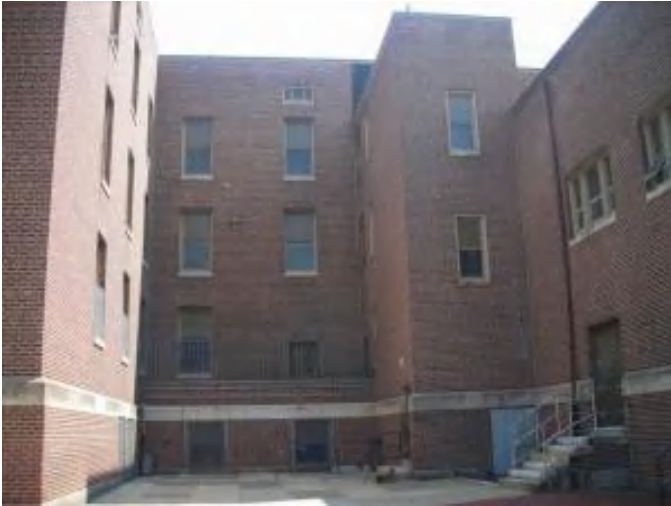
Location: Entrance

System: G2030 - Pedestrian Paving

Distress: Accessibility

Notes: Provide ADA compliant ramp at one entrance (location TBD)

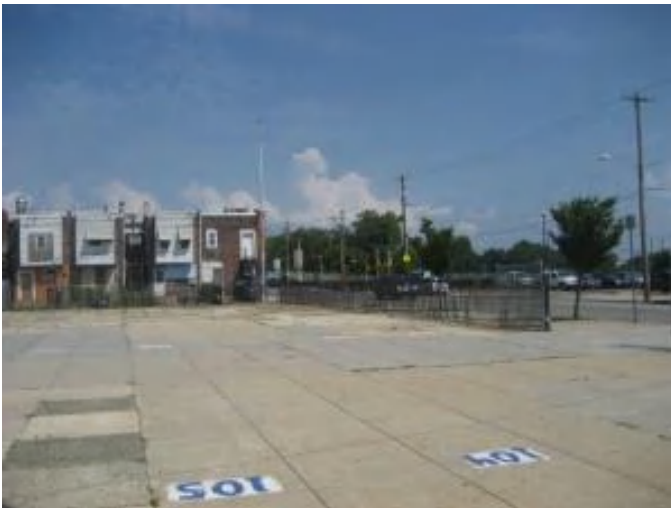
Location: Parking lot

System: G4020 - Site Lighting

Distress: Security Issue
