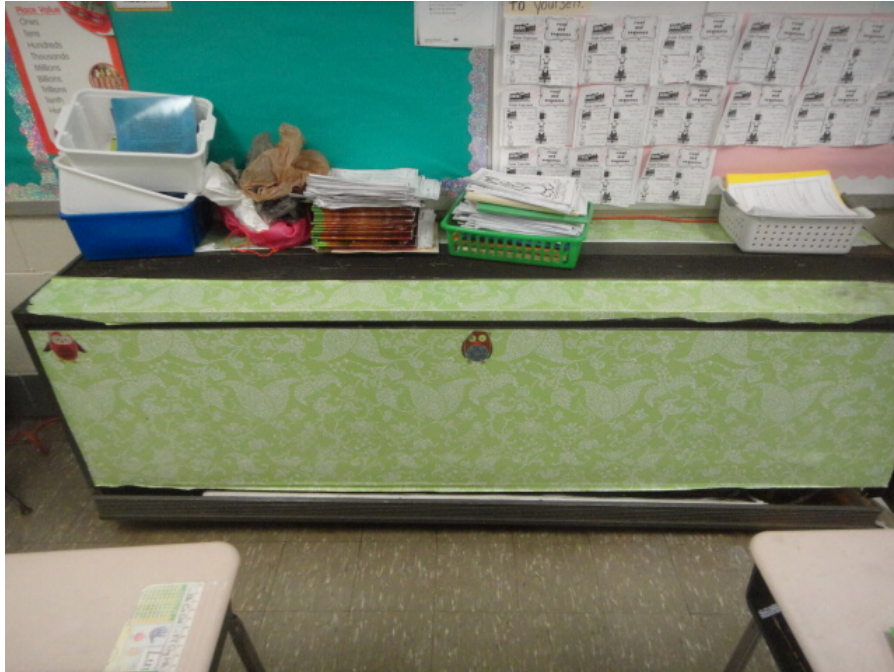
Photo 1 – Room 102

A freeze-up occurred on the classroom unit ventilator resulting in the loss of heat and water intrusion.

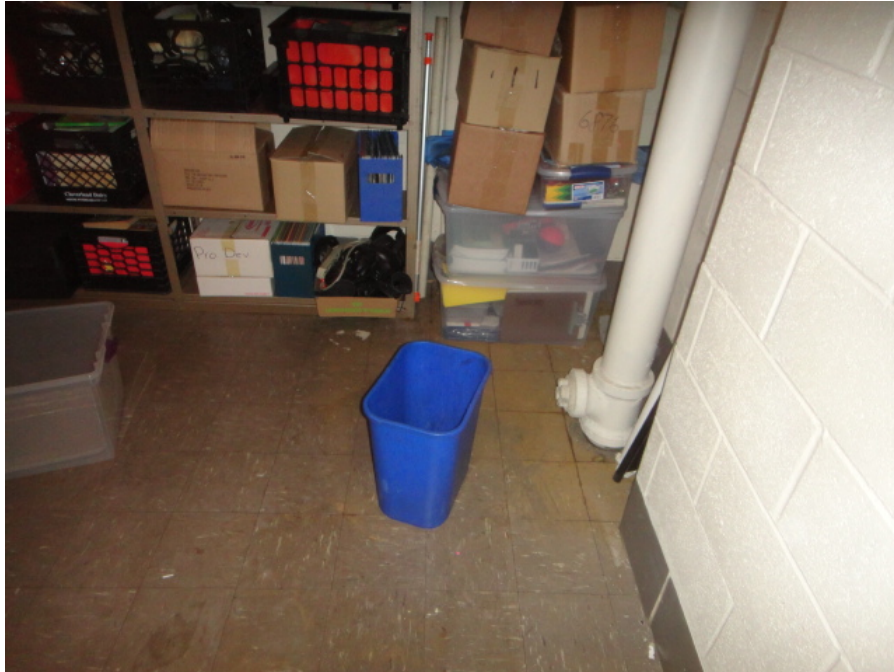
Photo 3 – Reading Intervention Room  
Water leaked through the ceiling resulting in delaminated 9"x9" floor tile.

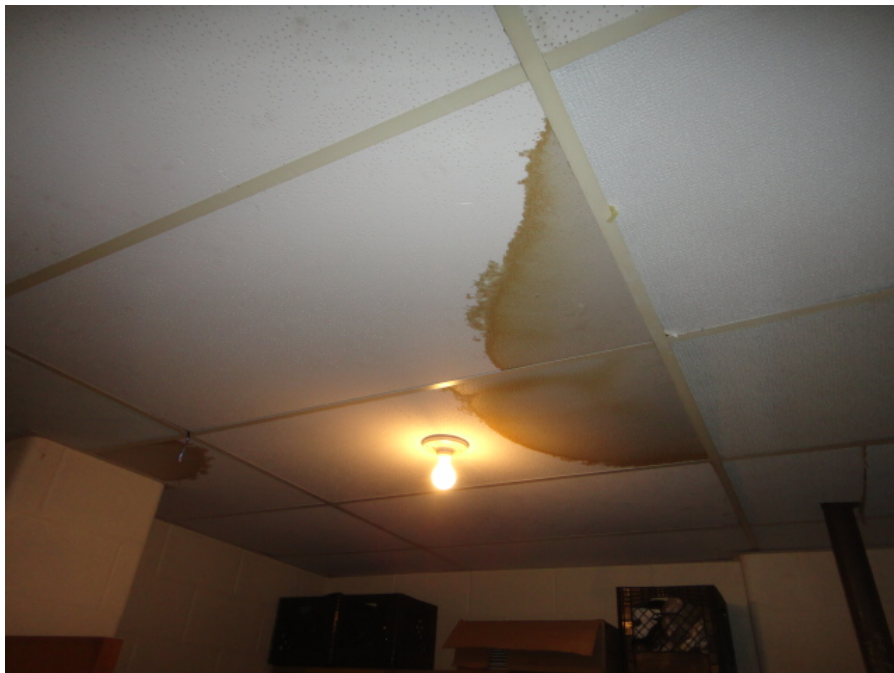
Photo 4 – Reading Intervention Room  
Water stained ceiling tiles were observed.

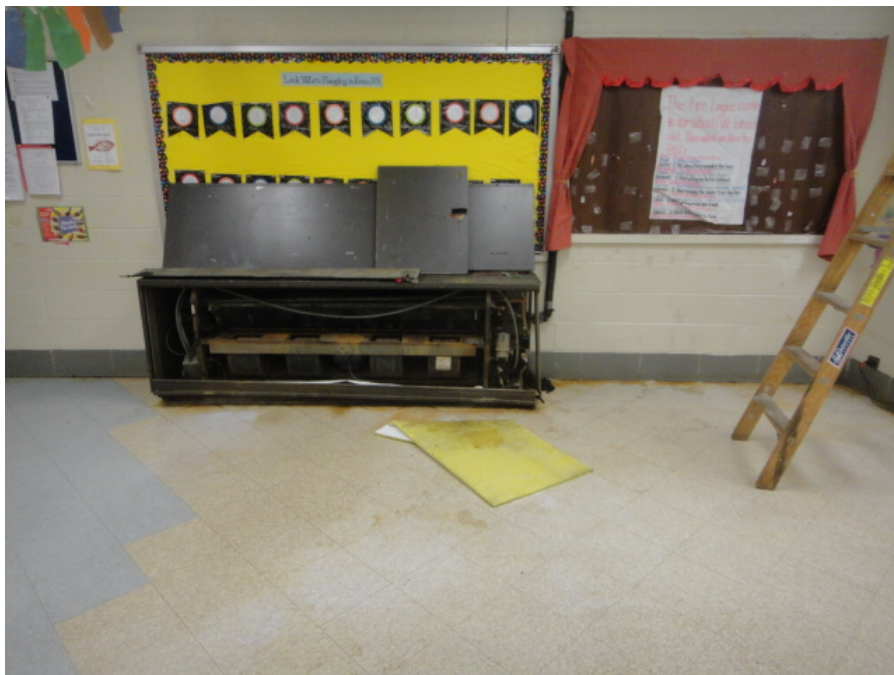
Photo 6 – Room 101

A freeze-up occurred on the classroom unit ventilator resulting in the loss of heat and water intrusion.

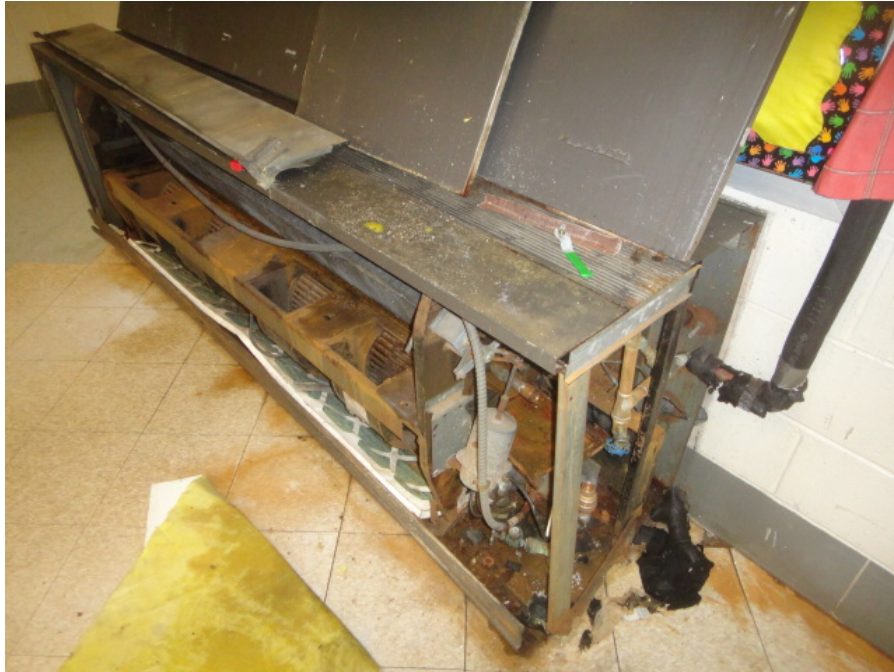
Photo 7 – Room 101

A freeze-up occurred on the classroom unit ventilator resulting in the loss of heat and water intrusion.

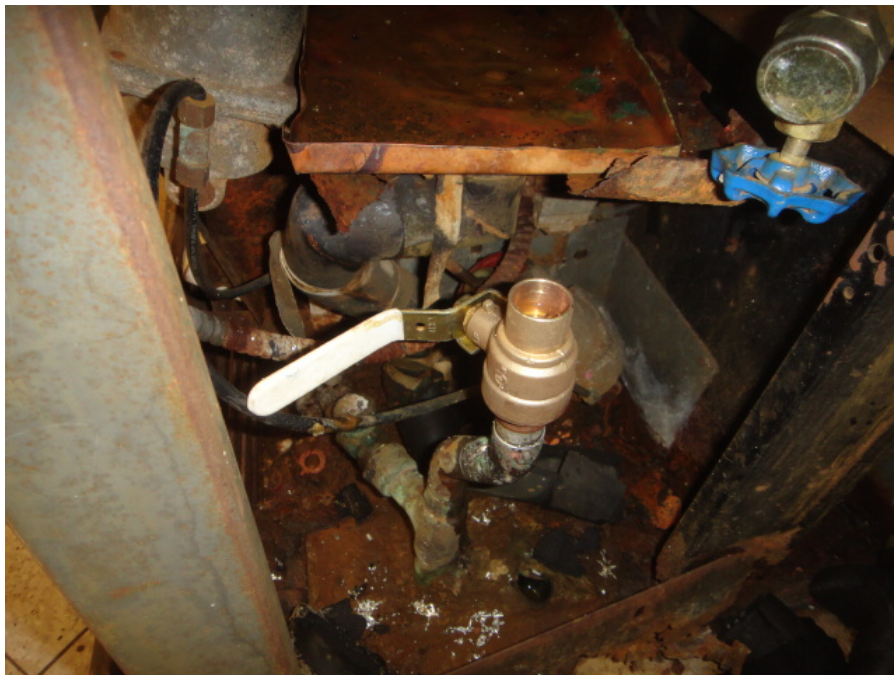
Photo 8 – Room 101

A freeze-up occurred on the classroom unit ventilator resulting in the loss of heat and water intrusion.

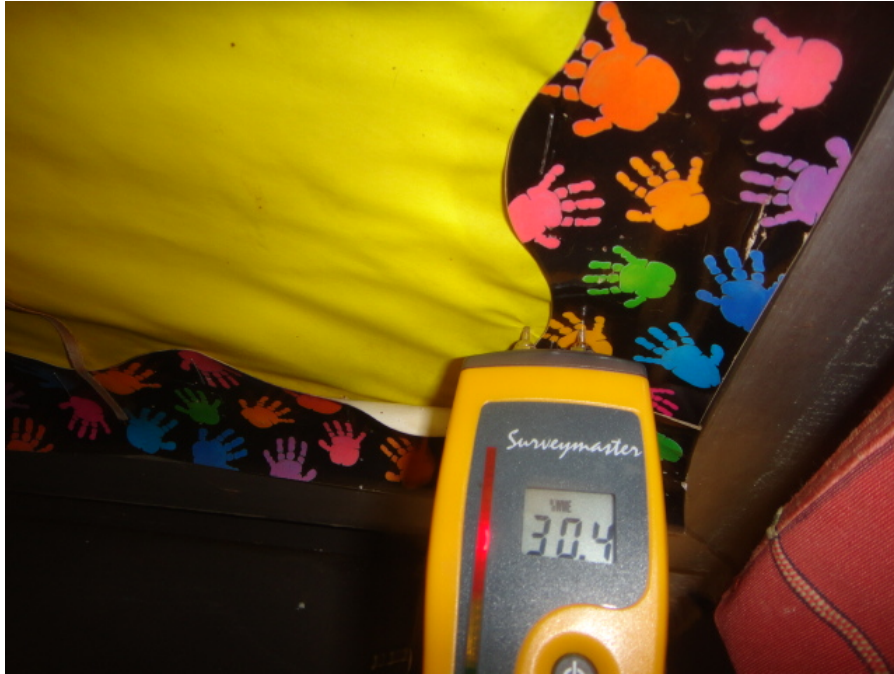
Photo 9 – Room 101  
Elevated moisture content was measured on the classroom bulletin board.

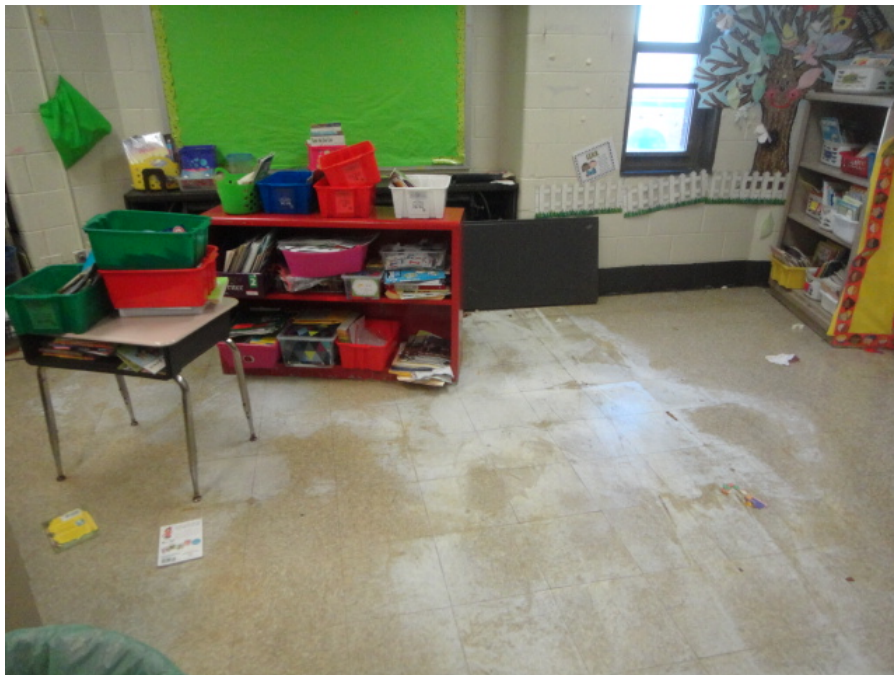
Photo 10 – Room 200  
A freeze-up occurred on the classroom unit ventilator resulting in the loss of heat and water intrusion.

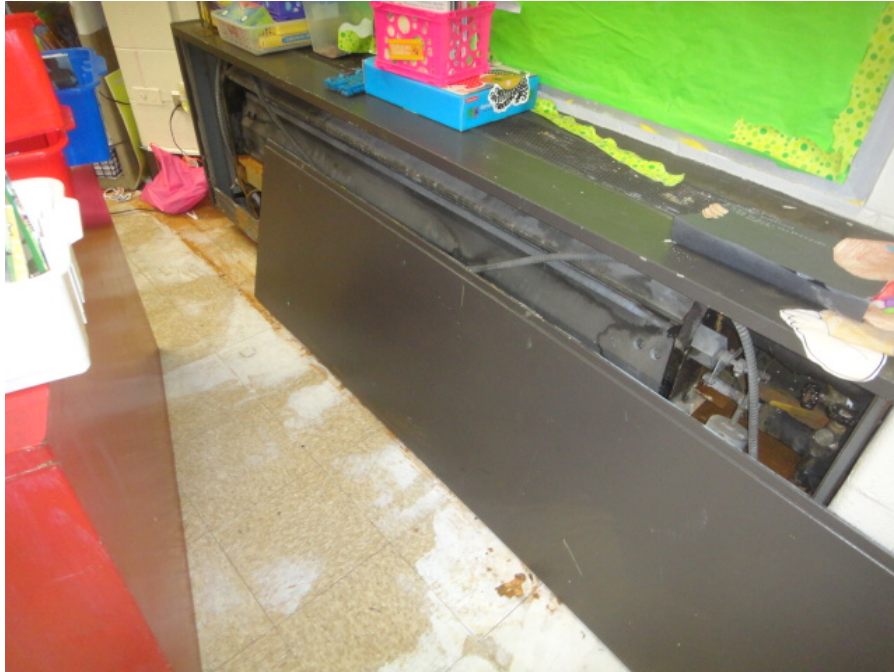
Photo 11– Room 200  
Delaminated sections of 12”x12” floor tile were observed from the water intrusion.

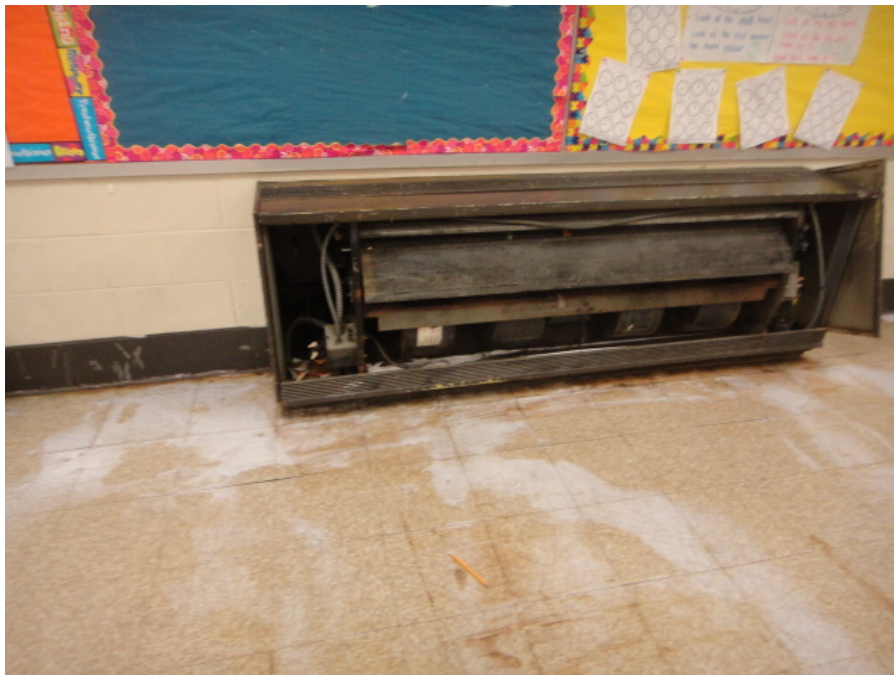
Photo 12 – Room 205  
Delaminated sections of 12”x12” floor tile were observed from the water intrusion.
