School District of Philadelphia
Office of Environmental Management Services
440 North Broad St.
Philadelphia, PA 19030

Asbestos Design Data Collection (DDC)

Name of Building: Bethune Elementary School

Address: 3301 Old York Road ULCS # 7510

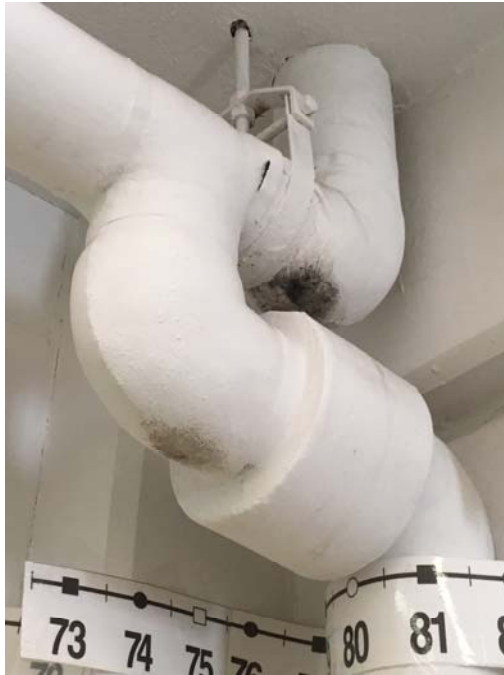
Photo 1 – Room 104

Work Location (1): Room 104				Imminent Hazard : Yes <input type="checkbox"/> No: <input checked="" type="checkbox"/>			
Material(s) Requiring Abatement	Confirmed or Assumed (if assumed follow the assumed material directive)	Total Amount Present (LF or SF)	Amount with Damage (LF or SF)	Suggested Amount for Abatement Action (LF or SF)	Type of Abatement* (codes below)	Friable or Non- Friable Removal	Reason for Abatement
ACPFI	assumed	unknown	2 EA/LF	2 EA/LF	RMV	FRI	Mold growth
Visible Debris (Yes or No)	Water or Steam Leak	Water or Steam Leak Isolated (Yes or No)	Student / Teacher Occupied (Yes or No)	Confined Space (Yes or No)	Work Area Securable (Yes or No)	Height of Ceiling (feet)	Height of Material (feet)
No	No	N/A	Yes	No	No	9	8
Type of Ventilation	Type of Ceiling	Type of Floor Substrate	Multiple Layers	Pipe Diameter (inches)	Fixed Objects	Movable Objects	Time Accessible
Unit Ventilator	concrete	Floor tile over concrete	N/A	3"	N/A	Contents	3 PM

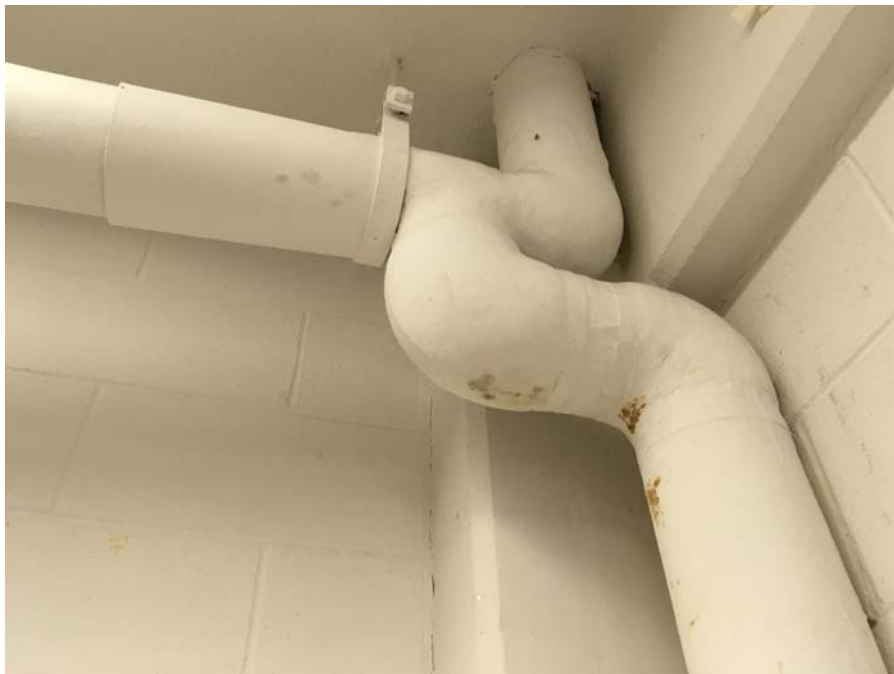
Photo 2 – Room 112

Work Location (1): Room 112				Imminent Hazard : Yes <input type="checkbox"/> No: <input checked="" type="checkbox"/>			
Material(s) Requiring Abatement	Confirmed or Assumed (if assumed follow the assumed material directive)	Total Amount Present (LF or SF)	Amount with Damage (LF or SF)	Suggested Amount for Abatement Action (LF or SF)	Type of Abatement* (codes below)	Friable or Non-Friable Removal	Reason for Abatement
ACPI	assumed	unknown	1 EA/LF	1 EA/LF	RMV	FRI	Mold growth
Visible Debris (Yes or No)	Water or Steam Leak	Water or Steam Leak Isolated (Yes or No)	Student / Teacher Occupied (Yes or No)	Confined Space (Yes or No)	Work Area Securable (Yes or No)	Height of Ceiling (feet)	Height of Material (feet)
No	No	N/A	Yes	No	No	9	8
Type of Ventilation	Type of Ceiling	Type of Floor Substrate	Multiple Layers	Pipe Diameter (inches)	Fixed Objects	Movable Objects	Time Accessible
Unit Ventilator	concrete	Floor tile over concrete	N/A	3"	N/A	Contents	3 PM
