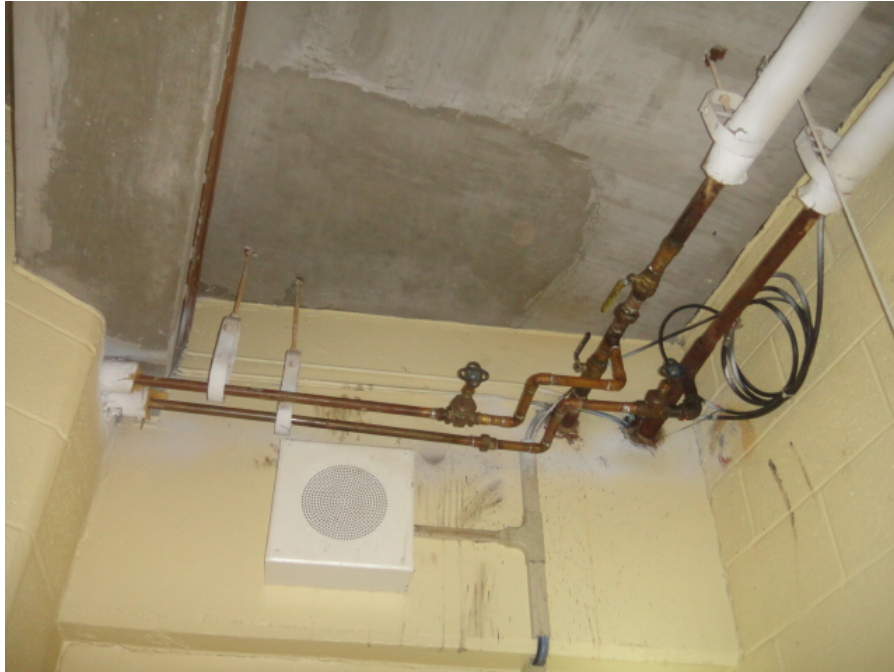
Photo 1 – Dressing Room D
The pipe leak was repaired; however, the insulation was not replaced.

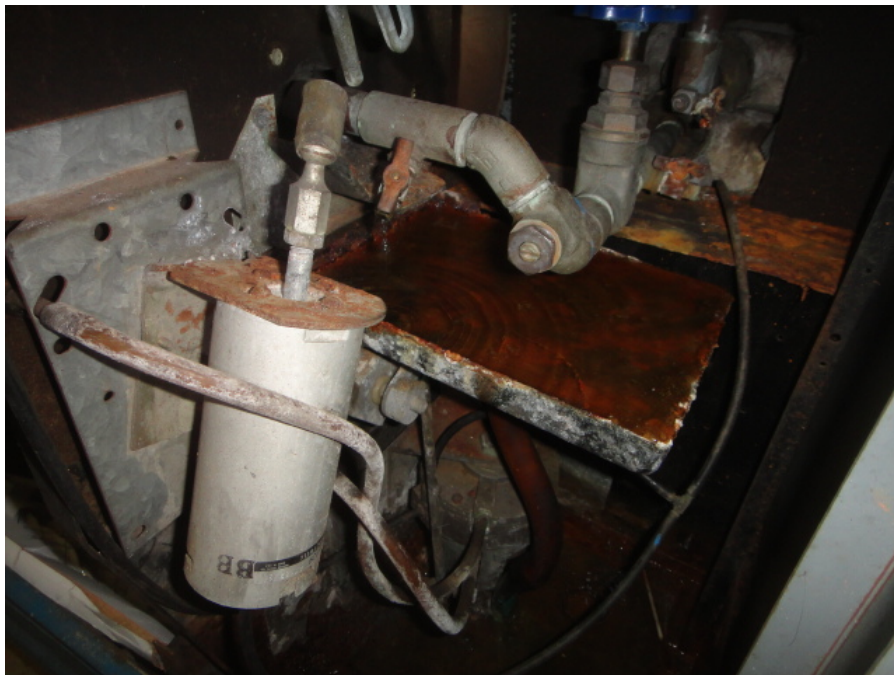
Photo 2 – Dressing Room D
A leak was observed on the unit ventilator bleed valve and the condensate pan was blocked and overflowing with water.

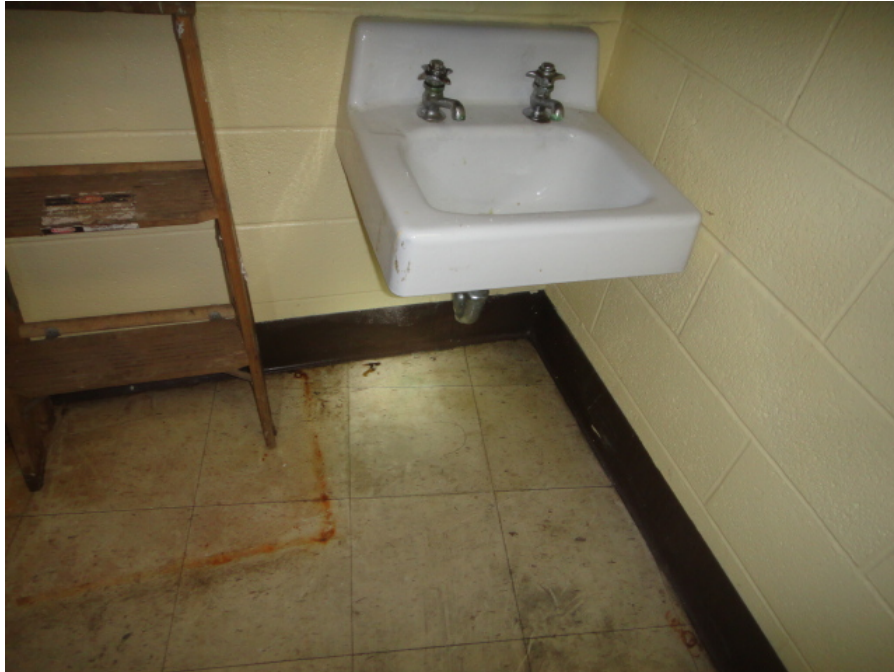
Photo 3 – Dressing Room C
A leak was observed at the shut-off valve on the hot side of the sink.

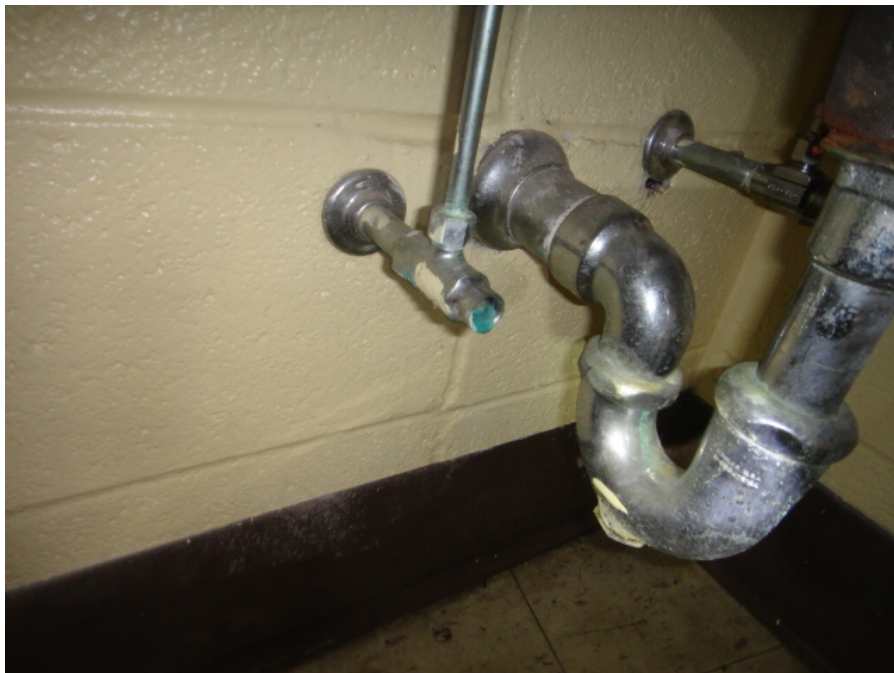
Photo 4 – Dressing Room C
A leak was observed at the shut-off valve on the hot side of the sink.

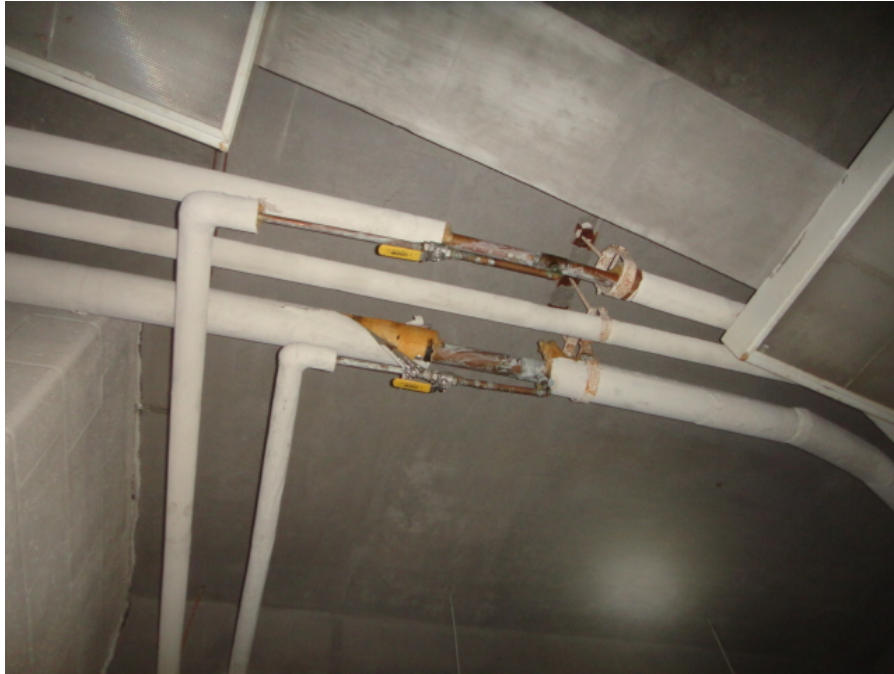
Photo 5 – Dressing Room B

A missing section of fiberglass pipe insulation was observed.

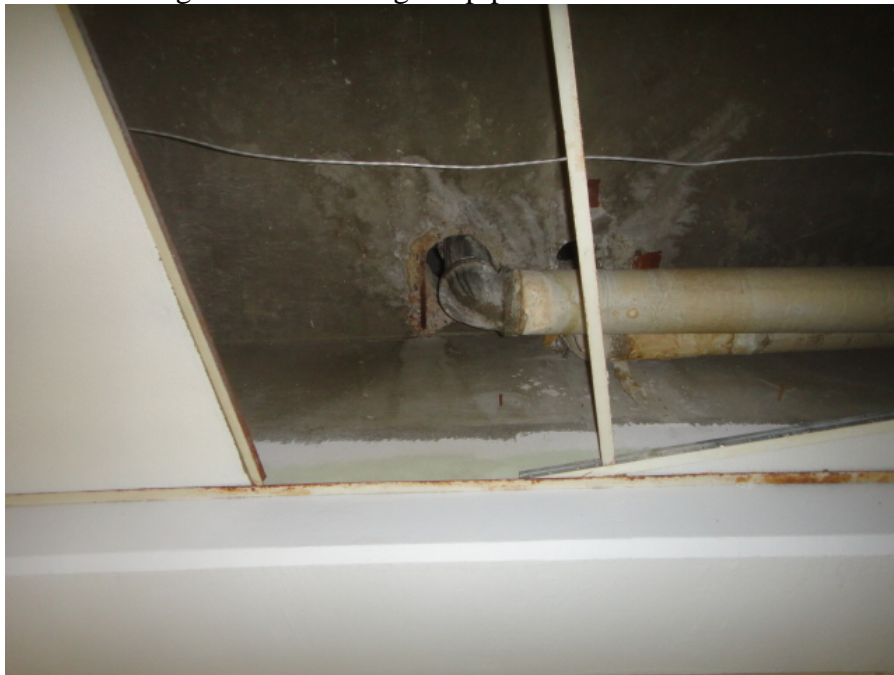
Photo 6 – IMC

An active leak was observed at the roof drain located above the suspended ceiling. It was not clear if the drain line was leaking or if water was leaking from another location and running down the pipe chase.

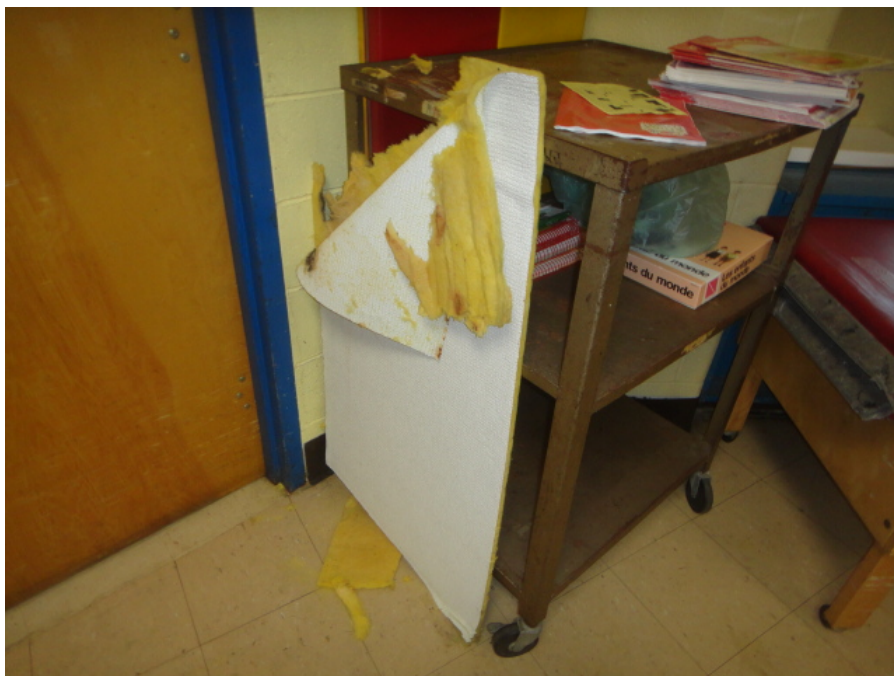
Photo 7 – Room 102

A ceiling tile was resting against the TV cart. Mold growth was observed on the fiberglass pipe insulation located above the suspended ceiling.

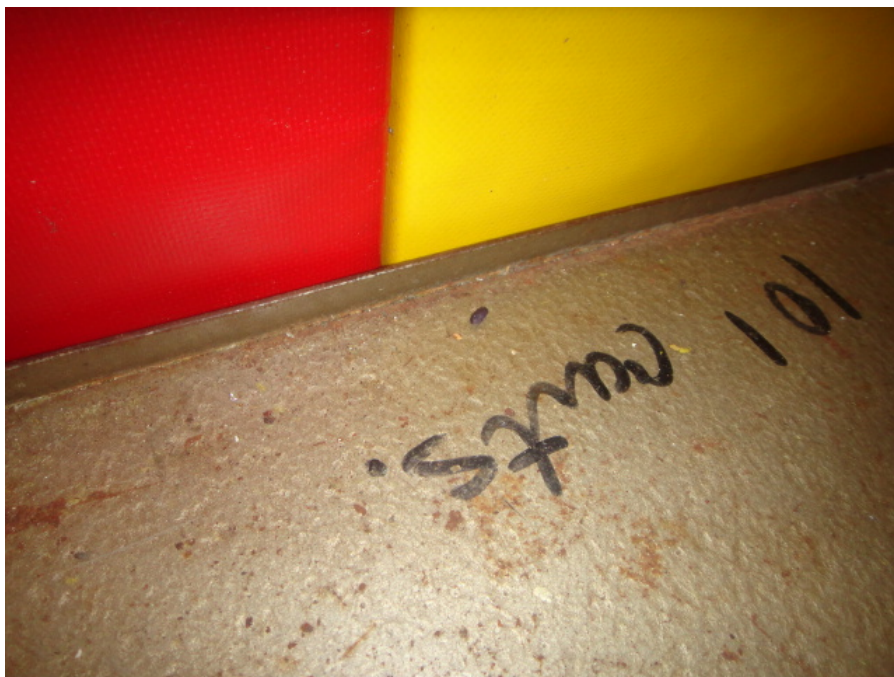
Photo 8 – Room 102

Mouse dropping were observed on the TV cart and other areas in the room including around the sink.

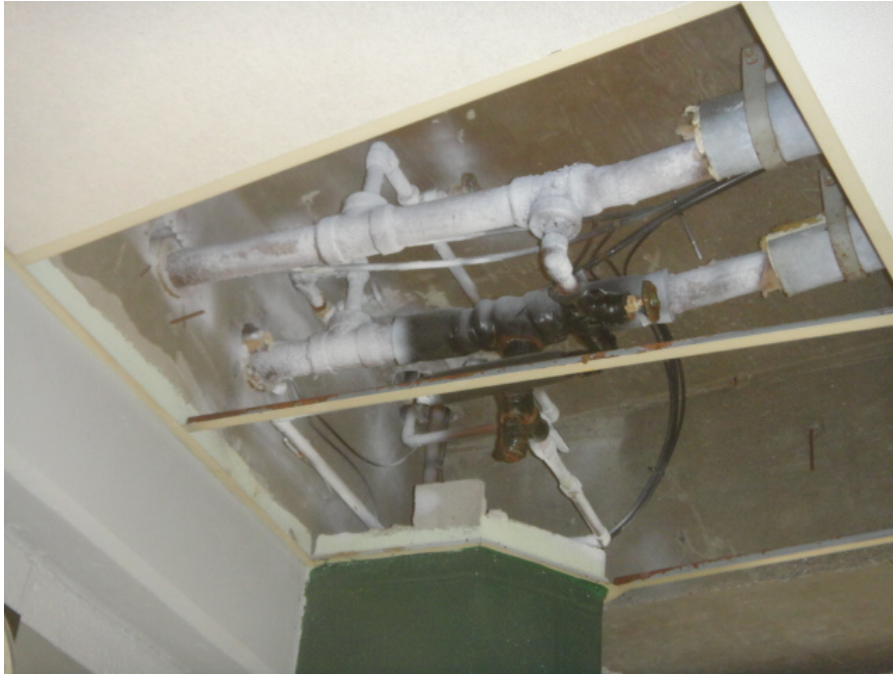
Photo 9 – Room 111

The mold growth on the insulation was remediated and pipe leak was repaired. The ceiling tiles were missing and the piping needs to be reinsulated.

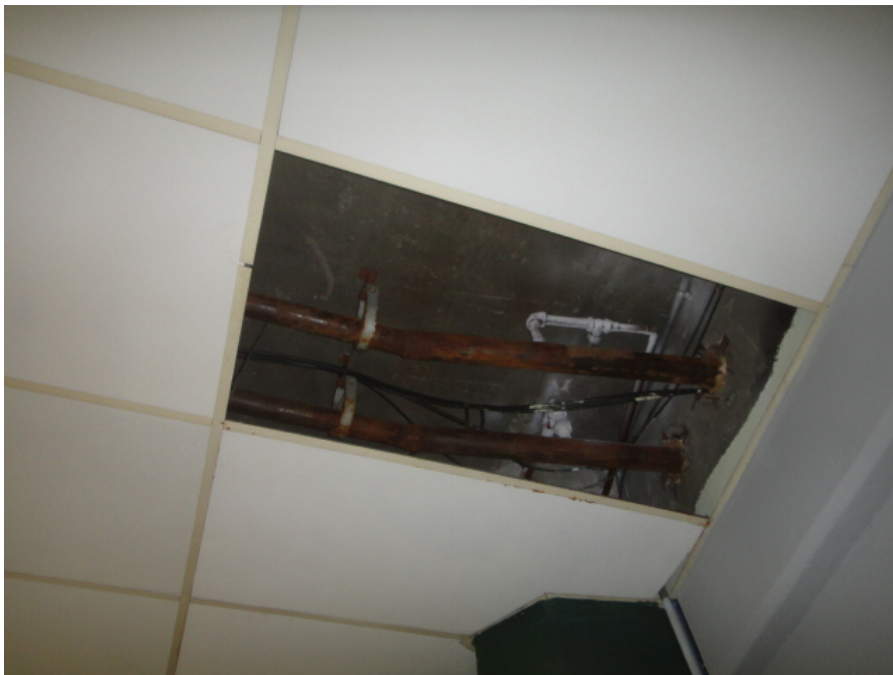
Photo 10 – Room 111

The mold growth on the insulation was remediated and pipe leak was repaired. The ceiling tiles were missing and the piping needs to be reinsulated.

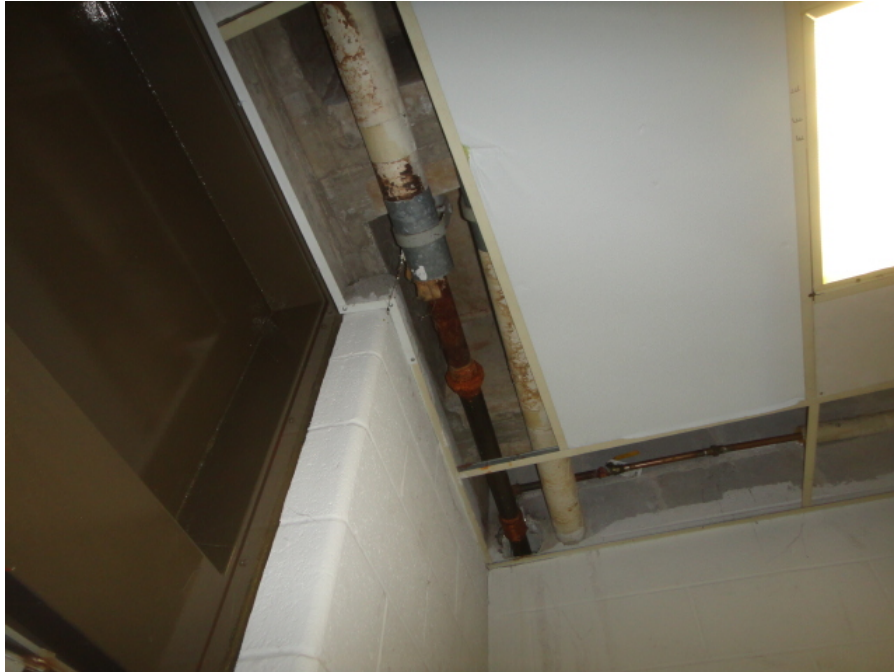
Photo 11– Kindergarten (K-3)
Pipe insulation was missing from the line located above the suspended ceiling.

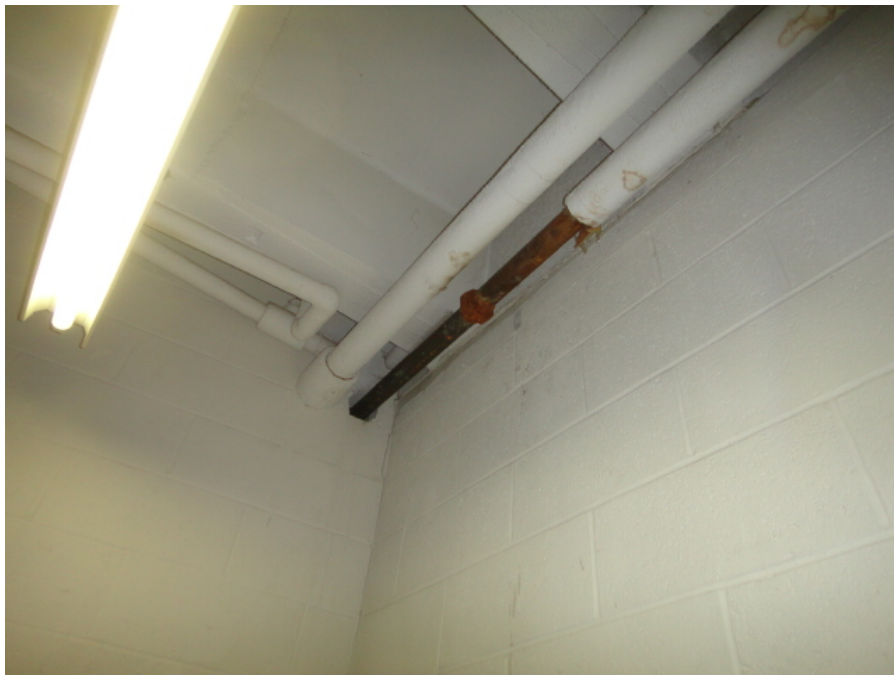
Photo 12 – Kindergarten (K-3) Closet
Pipe insulation was missing from the line located above the suspended ceiling.

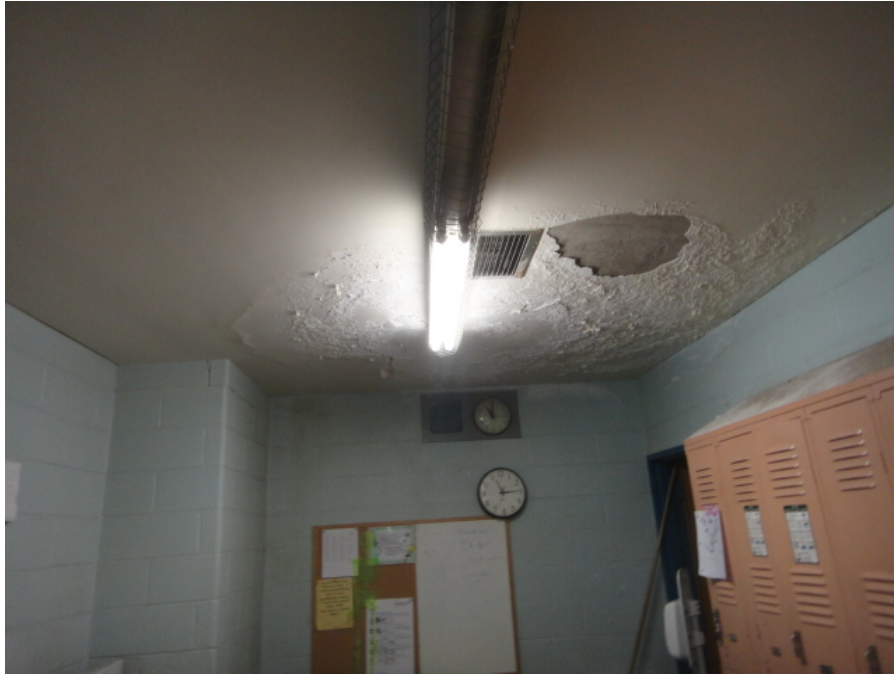
Photo 13 – Former Student Locker Room
Moisture damaged plaster ceilings were observed.

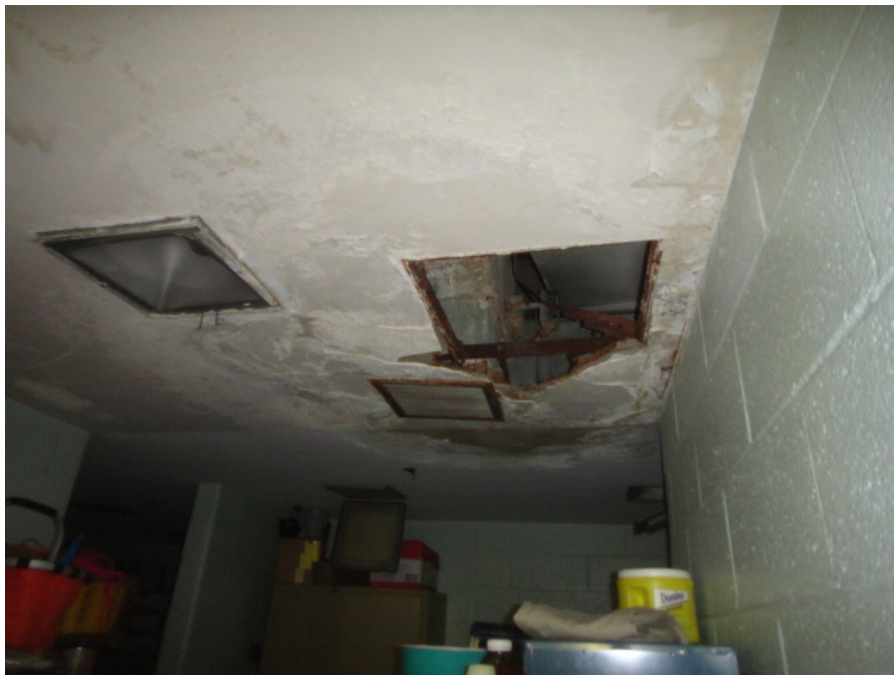
Photo 14 – Former Student Locker Room
Moisture damaged plaster ceilings were observed.
