**Philadelphia Federation
of Teachers (PFT)
Health & Welfare Fund**

Inspection Date: 12.13.2016

**Beeber Elementary School
IEQ Site Visit**

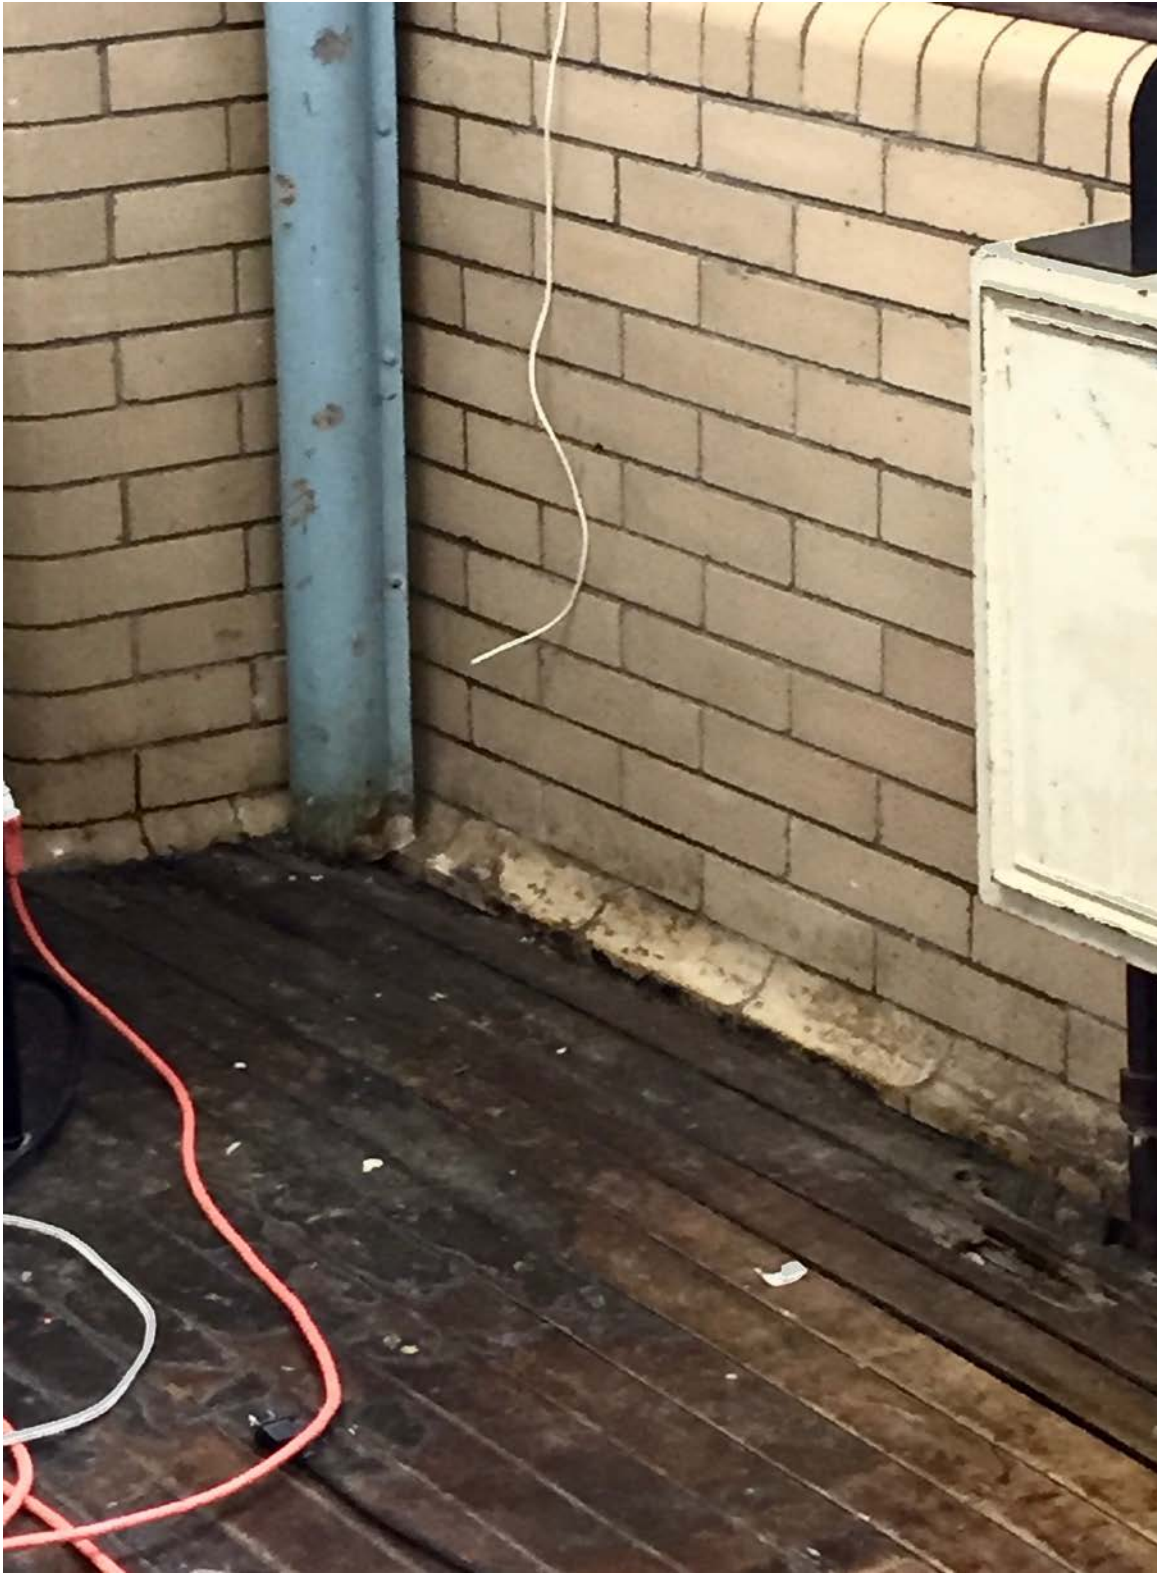
Photo 1 - Beeber MS - 12.13.2016 – Room 101 – Steam Leak at Radiator – Floor Damage

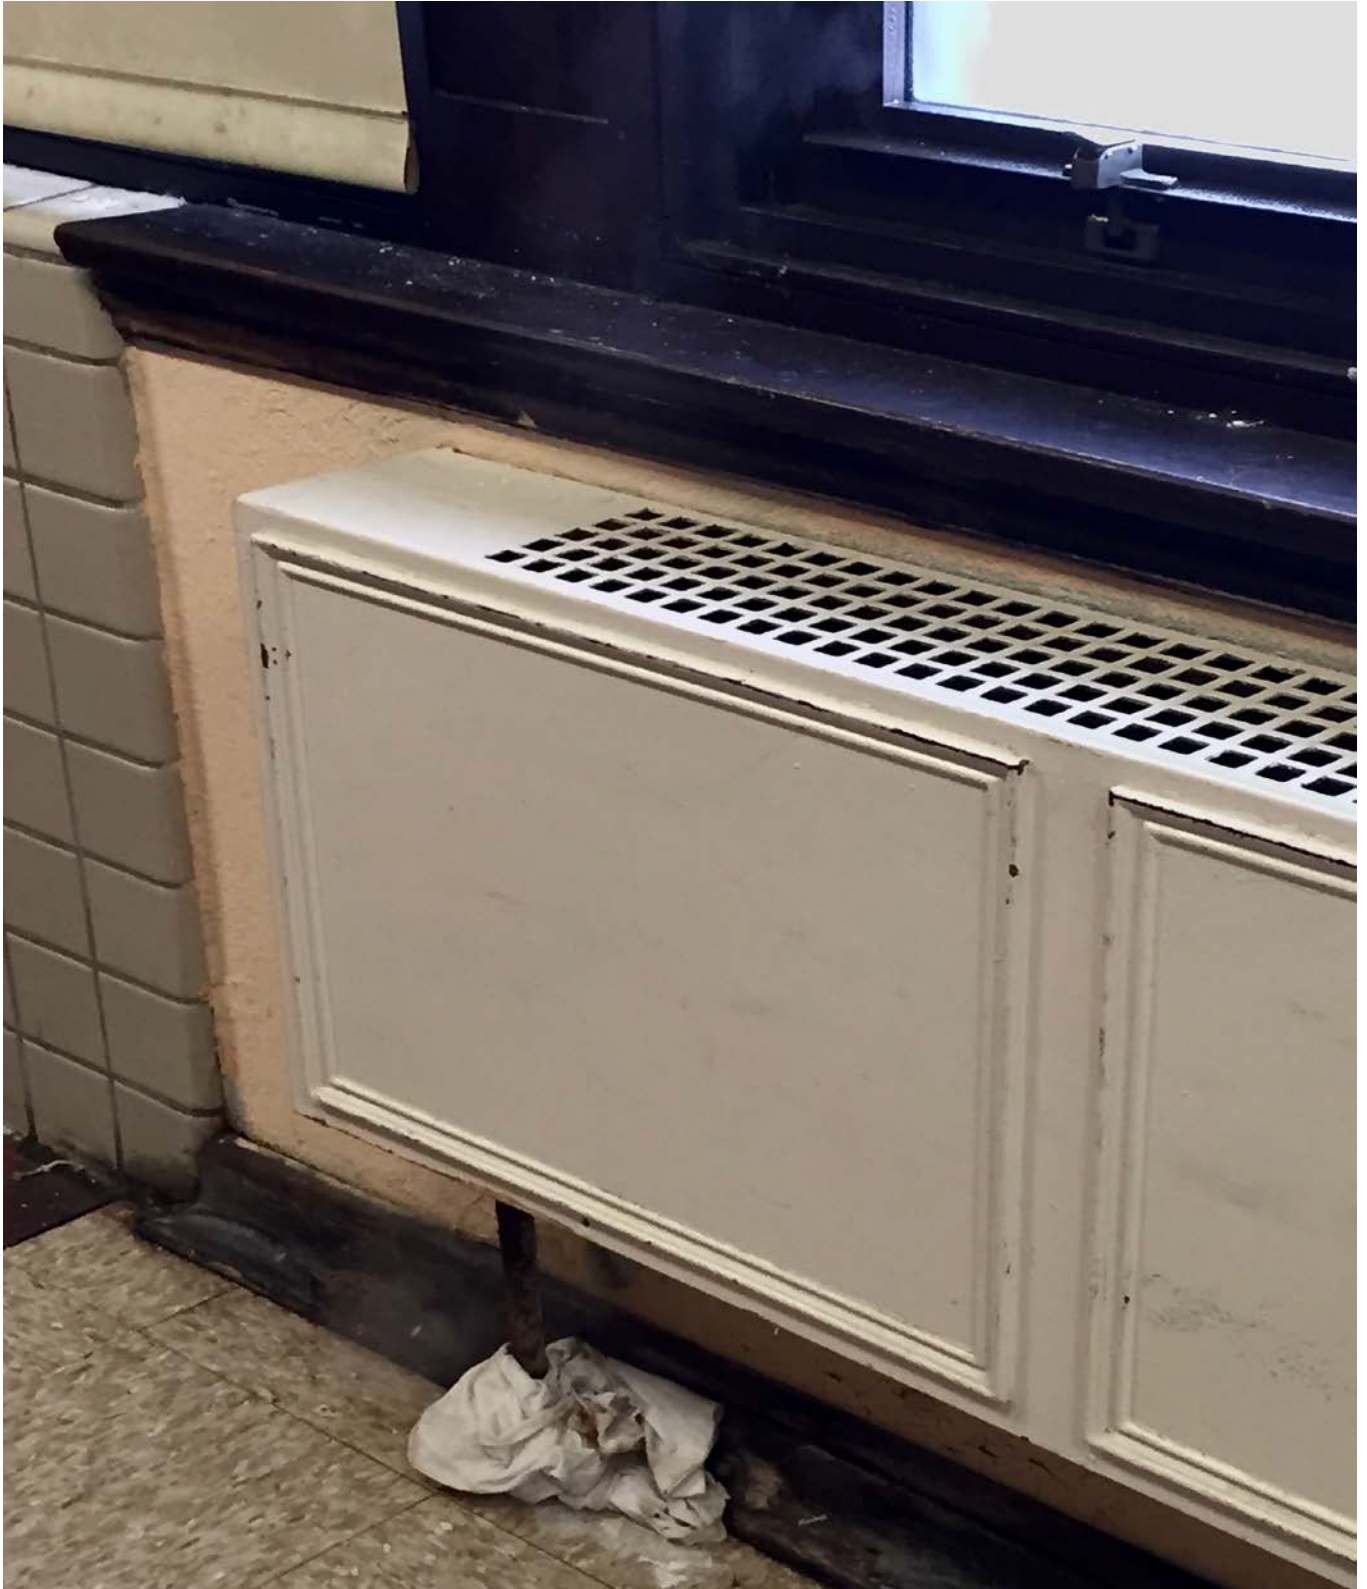
Photo 3 - Beeber MS - 12.13.2016 – Room 108 – Steam leak at radiator underneath floor – baseboard impacted

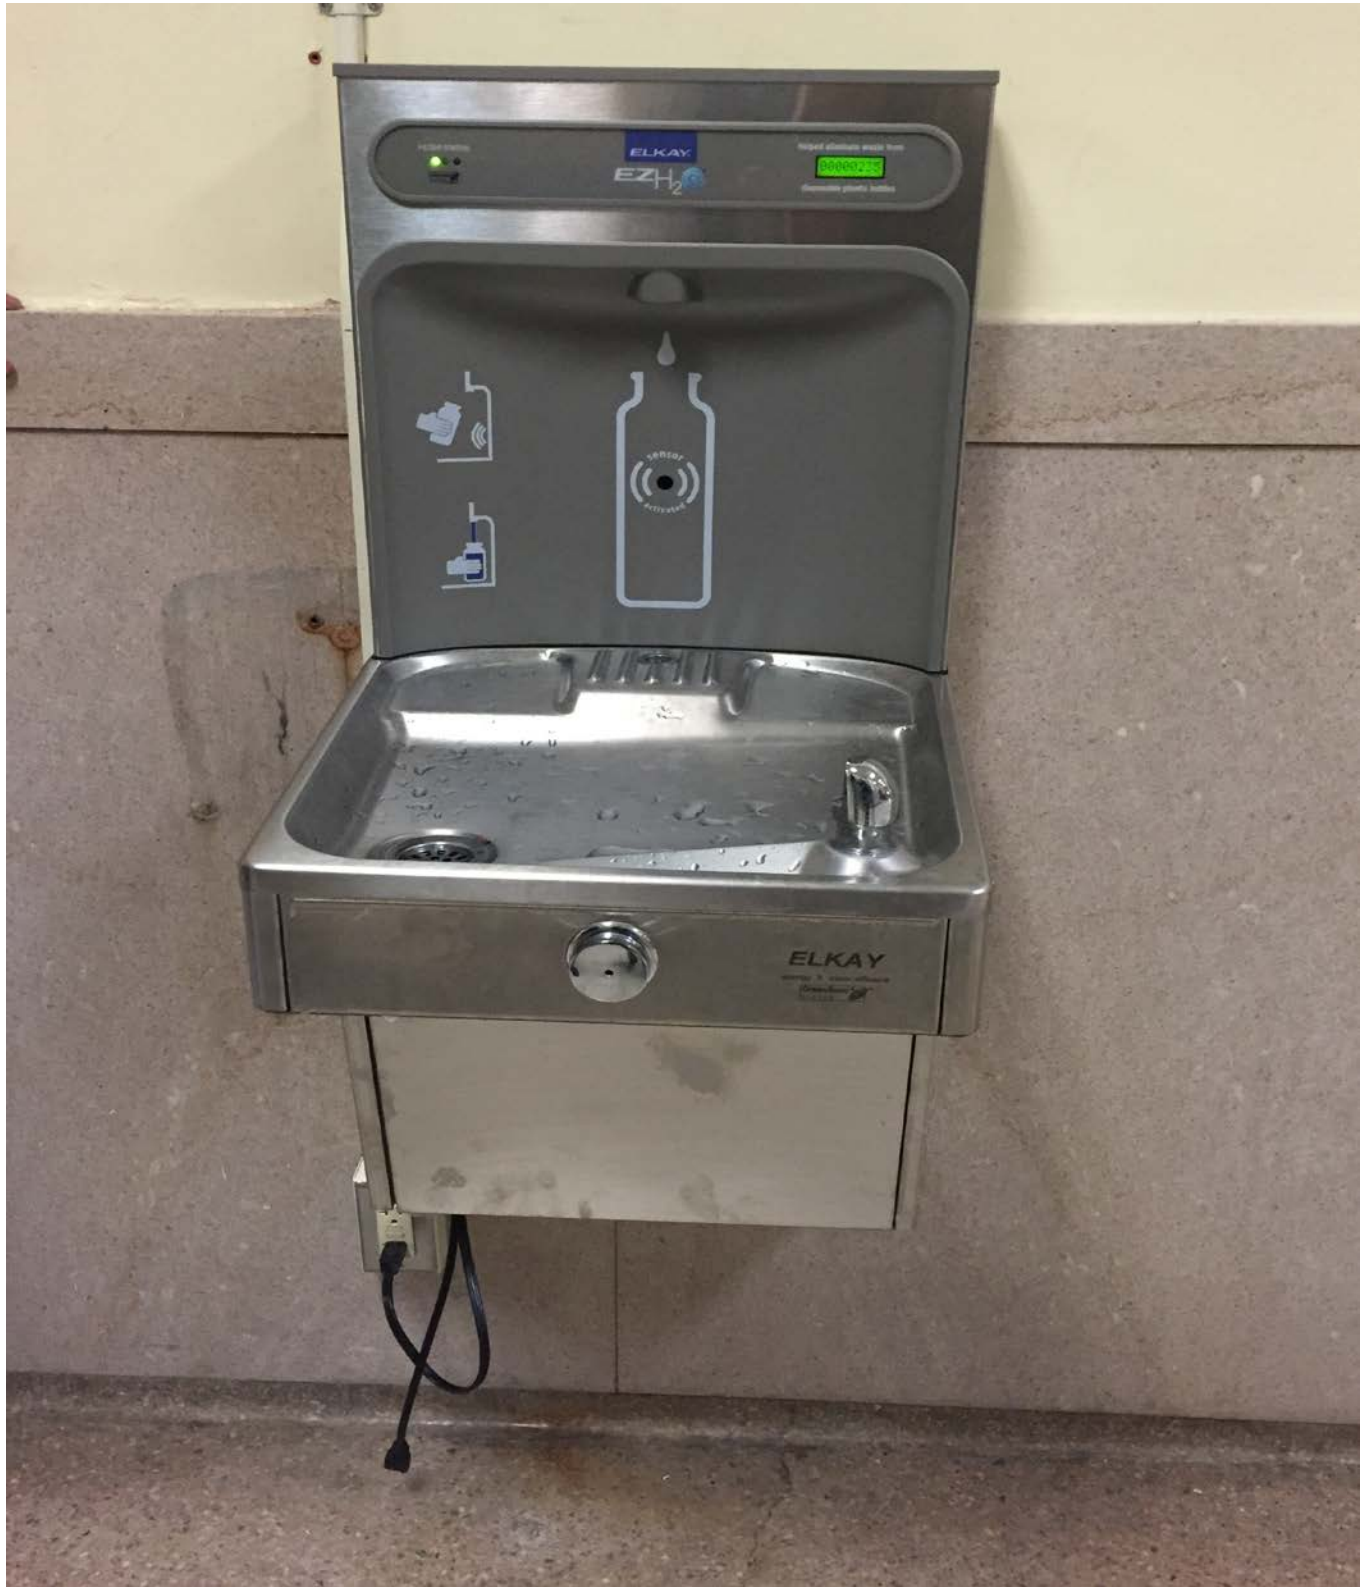
Hallway – 1st Floor	<ul style="list-style-type: none"> • Newly installed [about 3 weeks ago] Hydration Station not functioning properly – Problem was reportedly with the new compressor [one of the power cords for the hydration station was unplugged] • Lack of available information related to filter storage [on site] and availability, and/or filter handling/replacement and change 	1) Assess and repair compressor/hydration station. 2) Ensure B.E. is provided with necessary information and support to facilitate routine preventive and reactive maintenance work and filter changes for the hydration station.
Building Wide Issues	<ul style="list-style-type: none"> • Steam leak & related heating system have been documented as occurring for an extended period of time • Problems with the Automatic Temperature Control [ATC] system, steam traps and other heating system components have been documented and reported during previous inspections 	1) Immediately conduct a comprehensive evaluation of the heating & ATC systems and all components and review all outstanding work orders and make repairs as necessary to ensure occupant areas are properly heated. 2) FM&O should coordinate with and notify B.E., Principal and PFT and PFTH&WF/U-H&S representative about repair schedule details in order to facilitate communication and remediation verification.

Photo 4 - Beeber MS - 12.13.2016 – 1st Floor Hallway – Hydration Station – Bad Compressor & Unplugged
