<div>HUTCHENS INDUSTRIES, INC. SPRINGFIELD, MISSOURI</div>							
CHECKED: FR		DATE: 11/21/1973								
MFG APPL:		DATE:								
ER:		DATE:								
PROJECT OR FILE REFERENCE NO.			RADIUS ROD BOLT HOLE REPAIR FAB HANGERS W/722-00 BUSHING							
SCALE: N/A		SHEET 1 OF 1	SIZE: D	DRAWING NO.: 19068		REV. B		1 OF 1

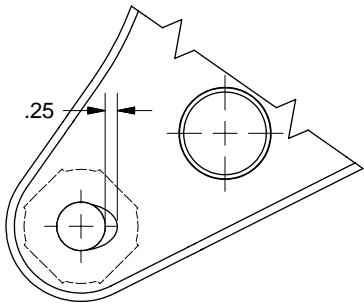
STEP 1

REMOVE TORQUE ARMS AND INSPECT ALL TORQUE ARM BOLT HOLES FOR LOOSE OR WORN WAHSER BUSHINGS

(FRONT HANGER SHOWN... TREAT CENTER HANGER SAME).
