ISP1362 Errata

Rev. 01.00 — 27 May 2004

Errata

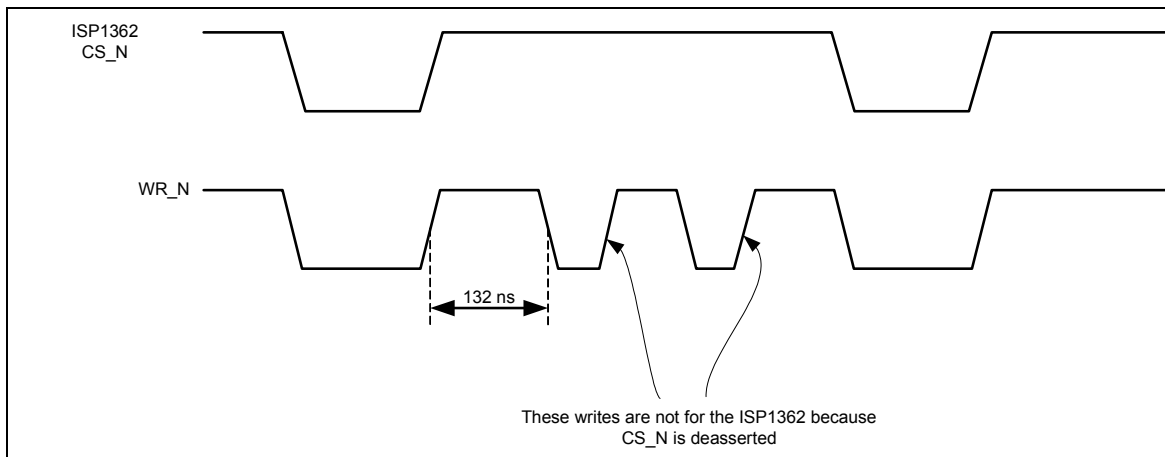
After a data write operation, the ISP1362 peripheral controller requires a 132-ns delay before a write assertion can be issued for other devices. This must be fulfilled even after CS_N is deasserted (See Figure 1 and Figure 2).

Will lead to data corruption if the timing requirements in Figure 1 and Figure 2 are not handled.

Make sure that the system can handle the write timing requirements as given in Figure 1 and Figure 2. If the system is really fast and needs immediate write accesses to other devices, then it is better to qualify WR_N with respect to CS_N and provide the resulting write signal to the ISP1362 (see Figure 3).
