# **BRAKTOOTH: Causing Havoc on Bluetooth Link Manager**

## **VULNERABILITY DISCLOSURE REPORT**

August 31, 2021

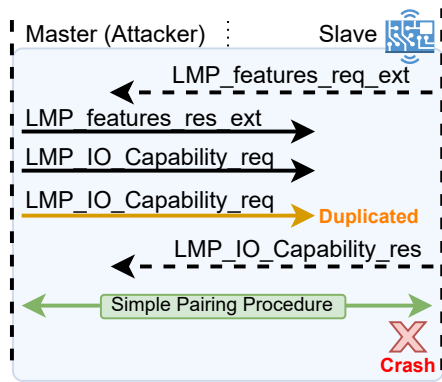
Figure 8: Duplicated IOCAP

The Bluetooth Classic implementation in Espressif ESP-IDF 4.4 and earlier [7] does not properly handle the reception of multiple *LMP\_IO\_Capability\_req* packets during the *pairing process* (see Figure 8). This allows attackers in radio range to trigger memory corruption (and consequently a crash) in ESP32 via a replayed (duplicated) LMP packet. The issue was raised due to the sudden disconnection of ESP32 while its bluedroid host stack was still in the pairing process. The patch provided by Espressif rectifies this issue by handling a sudden disconnection during the pairing procedure (c.f., Table 5).

**Impact:** The attacker can exploit this vulnerability to promptly cause firmware crashes and therefore maintain a DoS while the attack is taking place. Since ESP32 restarts its firmware by default upon receiving a fault, no user interaction is needed to restore BT communication after the attack is stopped.

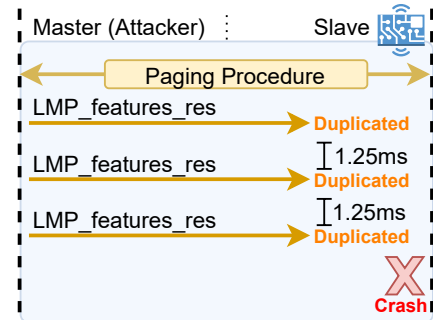
Figure 9: Feature Response Flooding

**Impact:** The attack triggers a firmware crash on ESP32 and a shutdown on **JBL TUNE500BT** and **Xiaomi MDZ-36-DB**.

In the case of a shutdown, the user needs to manually power on the device again to restore communication. Furthermore, since all targets accept multiple BT connections, the attack can also be triggered while the target is already connected to another device. For example, it is possible to immediately stop audio from playing on JBL TUNE500BT and Xiaomi MDZ-36-DB. The attacker, however, needs to know the BDAAddress of the target to launch the attack.

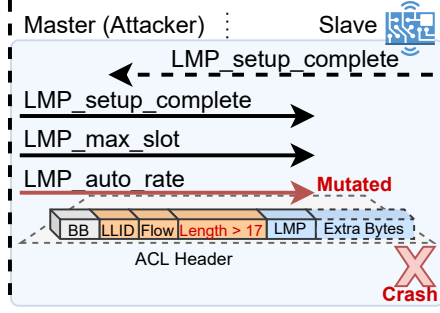
Figure 10: LMP Auto Rate Overflow

**Impact:** The attack causes a firmware crash on both **WT32i** and **AC6905X**. This can be used to cause a sporadic denial of service (DoS) attacks on such devices.

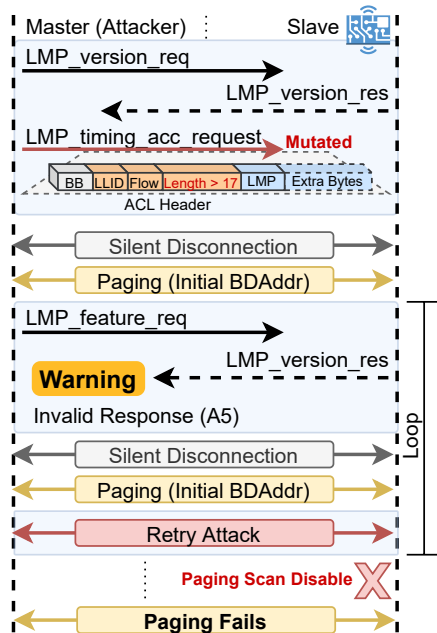
This vulnerability is depicted in Figure 21. As shown in Figure 21, sending an invalid packet during the LMP timing accuracy procedure (i.e. packet *LMP\_timing\_acc\_request*), followed by a forced re-connection with the same BDAddress

(any arbitrary BDAddress of choice of the attacker), leads **Intel AX200** to reject any externally initiated BT connections for an undetermined amount of time. This persists even after the attack stops and requires user intervention to recover **AX200** normal functionalities.

**Impact:** Once the attack is triggered and successful, the attacker can cause DoS via the following **AX200** behaviours: (I) paging scan is disabled, which prevents any external de-

vice to connect to the target even if the BDAAddress is known. This behaviour can be used to trick an user to connect to the attacker's BT hardware instead of the legitimate target since **AX200** paging scan is disabled; **(II)** Multiple active BT connections cannot be performed from the target. The user requires to manually restart the Bluetooth service to restore normal BT behaviour. On Linux and Windows, BT is recovered by disabling and enabling Bluetooth via their respective configuration menu.
