80960SA/SB SPECIFICATION UPDATE

Release Date: August, 2004

Order Number: 272850-003

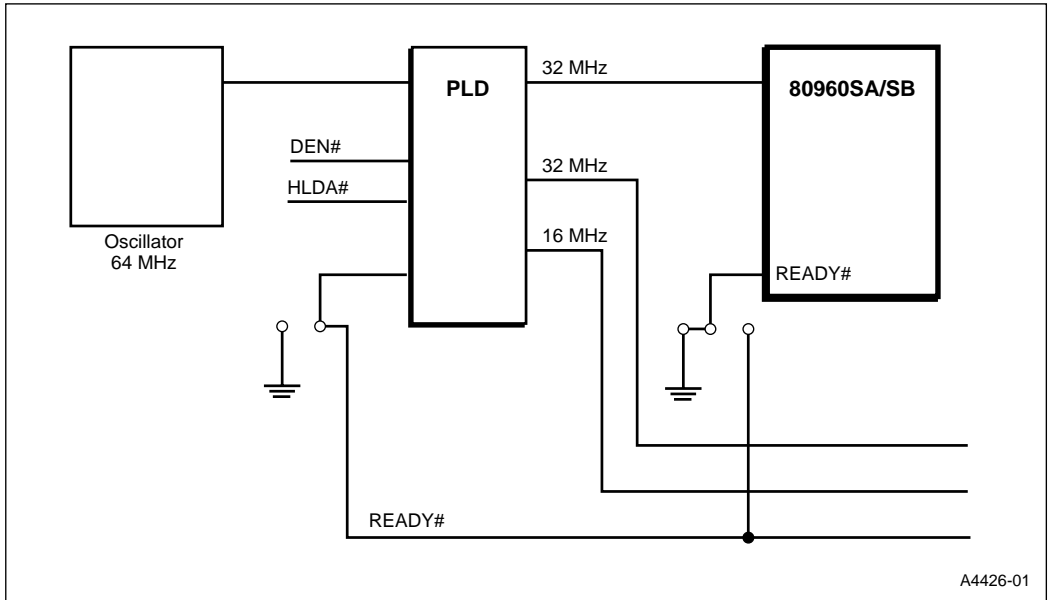
Figure 1. Block Diagram of Workaround

PROBLEM: During many accesses with wait states, the BE1:0# signals incorrectly switch after the first Tw state. The affected accesses include:

- All byte accesses with wait states.
- All quad-word, triple-word, long-word, word or short-word accesses with single-byte misalignment and wait states.

If the bus cycle is a burst access, the problem occurs on each data transfer within the burst. This problem will not occur if READY# always goes active early enough to signal zero wait states.

WORKAROUND: Do not use the READY# input; tie it to a LOW logic state. If wait states are necessary, gate the input clock using external logic.

Figure 1 illustrates example workaround logic. A programmable logic device (PLD) driven by a 4X clock oscillator provides a 2X clock for the 80960SA/SB and other system clocks. READY# is an input to the PLD which stops the 2X clock whenever it is asserted. When READY# is deasserted, the PLD resynchronizes the 2X clock to the system clocks. Figure 2 is a state diagram of the workaround.

The 80960SA/SB has dynamic registers, so do not stop its input clock for more than about one microsecond. This restriction limits the number of wait states to about nine for a 10 MHz 80960SA/SB.
