Roof Structure

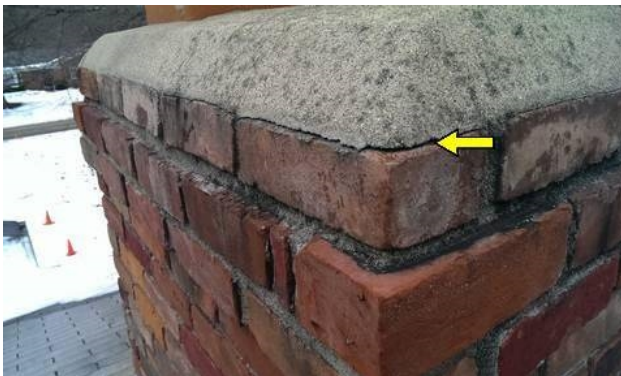
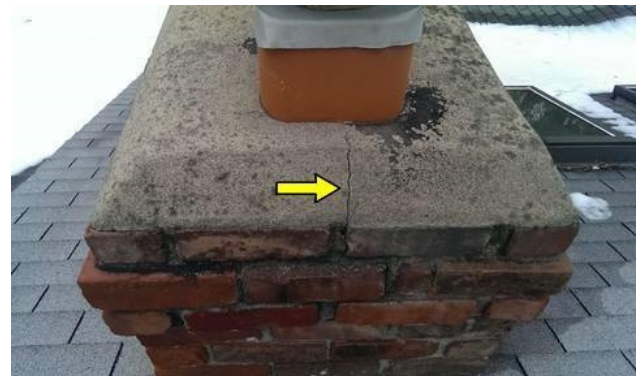
Chimney Structure/Crown/Flue

The concrete chimney cap is cracked and/or beginning to deteriorate. If deterioration of the cap is left un repaired the chimney structure could be affected. Suggest repairs to correct.
