AVIATION SAFETY NETWORK

Type: [Airbus A300B4-203](#)

Owner/operator: Air France

Registration: F-BVGK

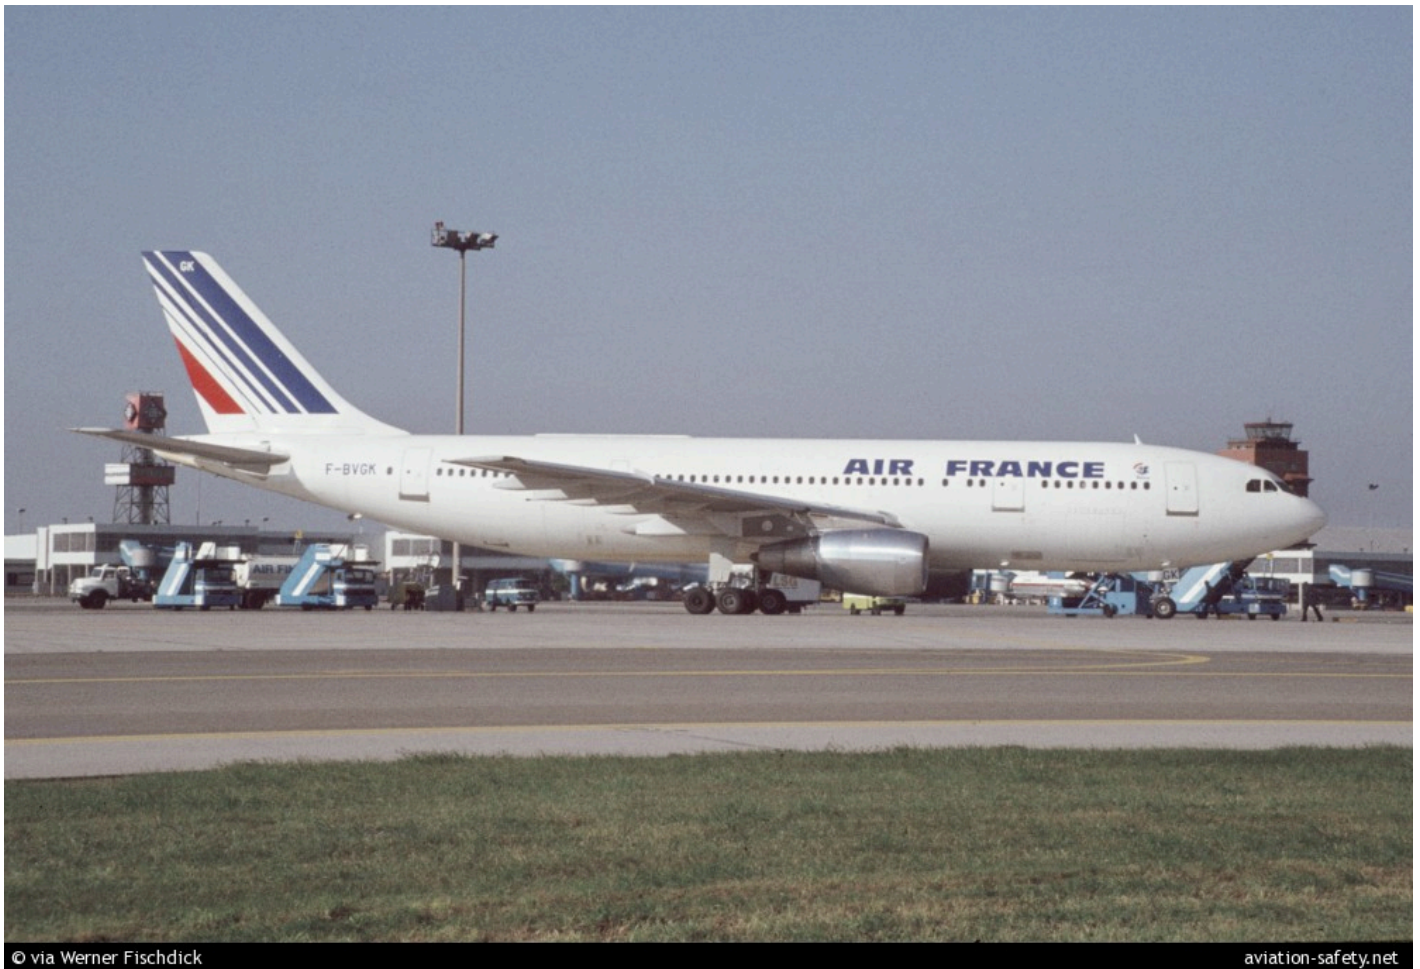
While travelling at 95 knots during takeoff from San'a International Airport, an explosion was felt, followed by shimmy and vibrations. The crew, thinking a tyre had exploded, aborted the takeoff. The explosion was in fact caused by an uncontained failure of the stage 1 HP compressor disk of the no. 2 engine. Debris punctured the fuel tank, causing a fire on the right hand side of the aircraft. The propagation of a low cycle fatigue crack on one of the embossments of the disk rim caused the disk fracture.

CAUSES: "The accident directly resulted from the uncontained explosion of a first stage high pressure turbine disk of the right hand engine. The propagation of a low cycle fatigue crack on one of the embossments of the disk rim was at the origin of the disk fracture.

This cracks, which existed before, had not been detected during the inspection conducted in the operator's workshops, according to the method defined by the manufacturer and in accordance with the requirements of the airworthiness authority. The investigations showed that it was necessary, not only to reduce the intervals between the inspections of these disks and conduct two independent sequential inspections, but also to modify the design and make sure they were
