AVIATION SAFETY NETWORK

Date: Monday 15 November 1993

Type: [Airbus A300B2-101](#)

Owner/operator: Indian Airlines

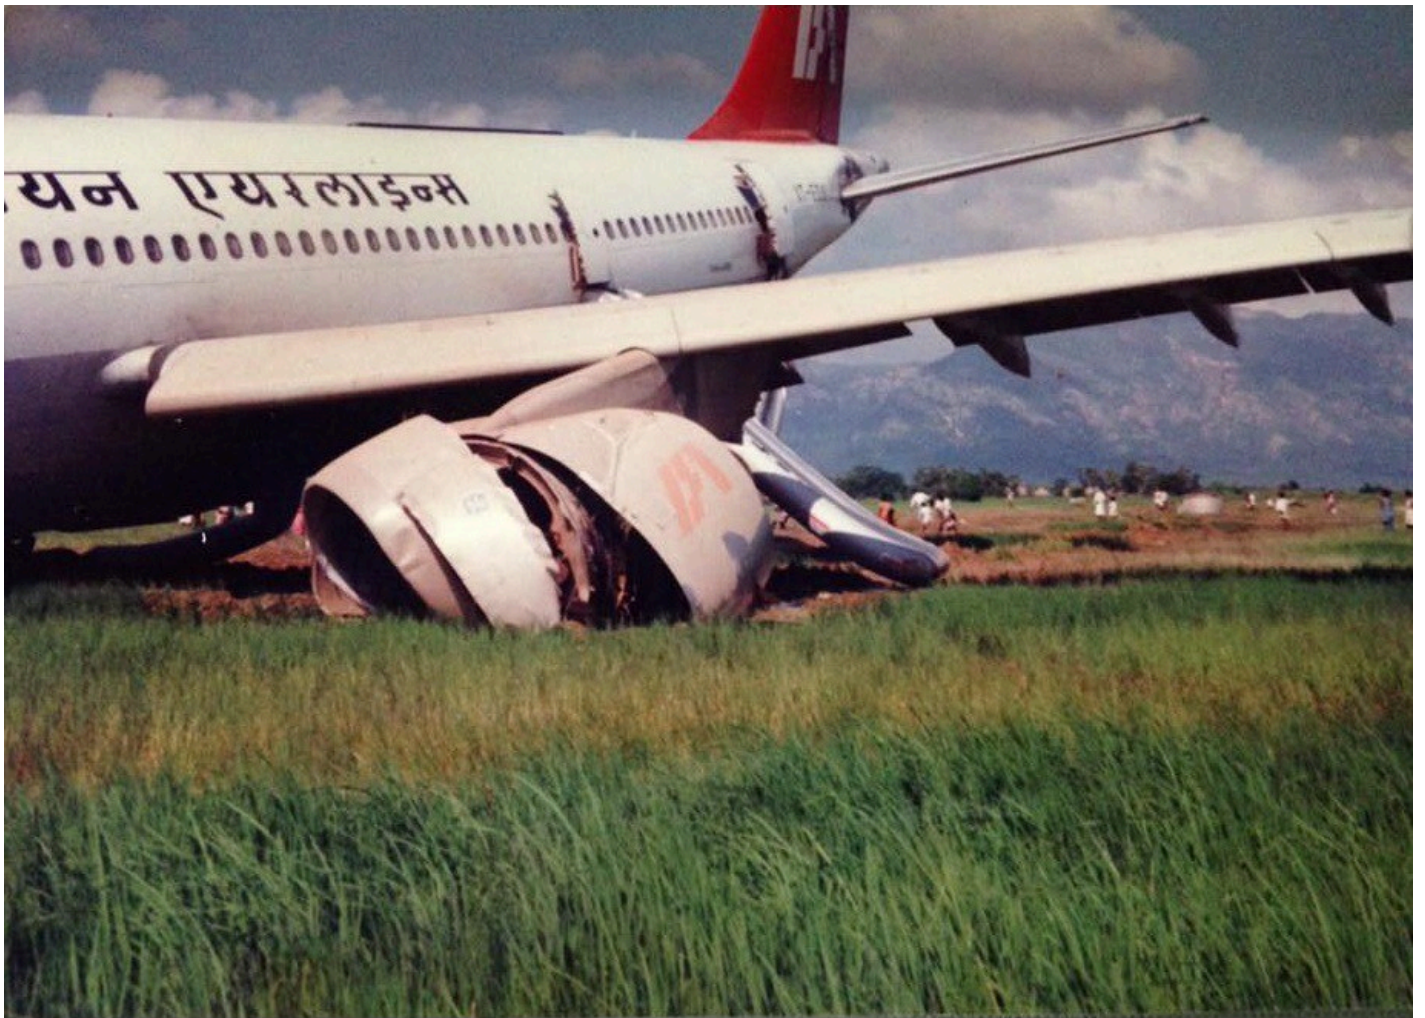
photo (c) Dave; Tirupati Airport (TIR); 15 November 1993

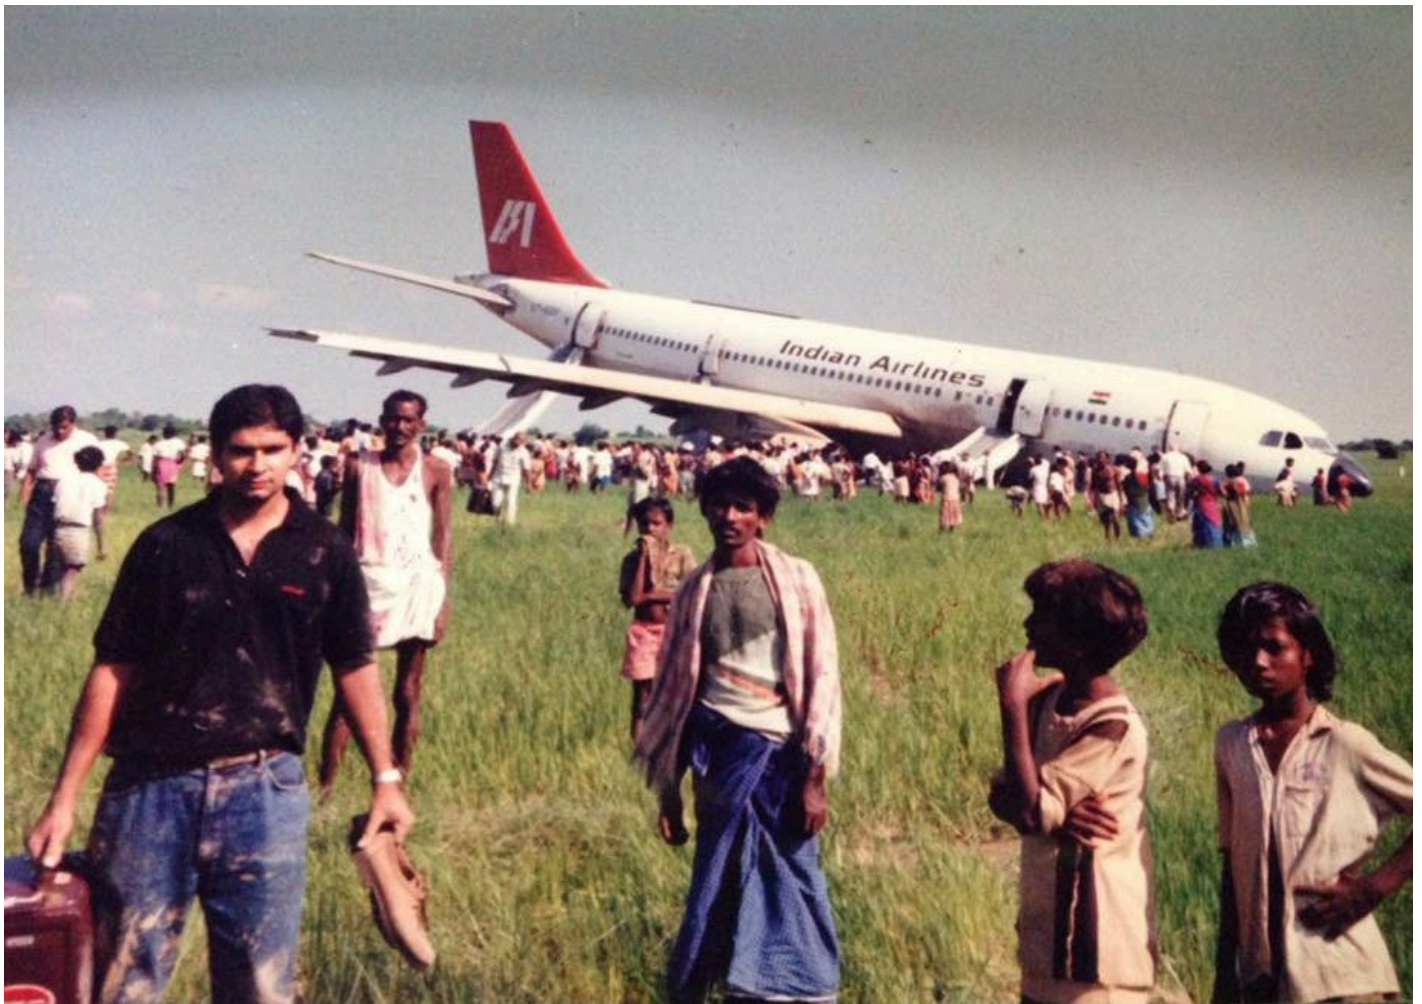
photo (c) Dave; Tirupati Airport (TIR); 15 November 1993

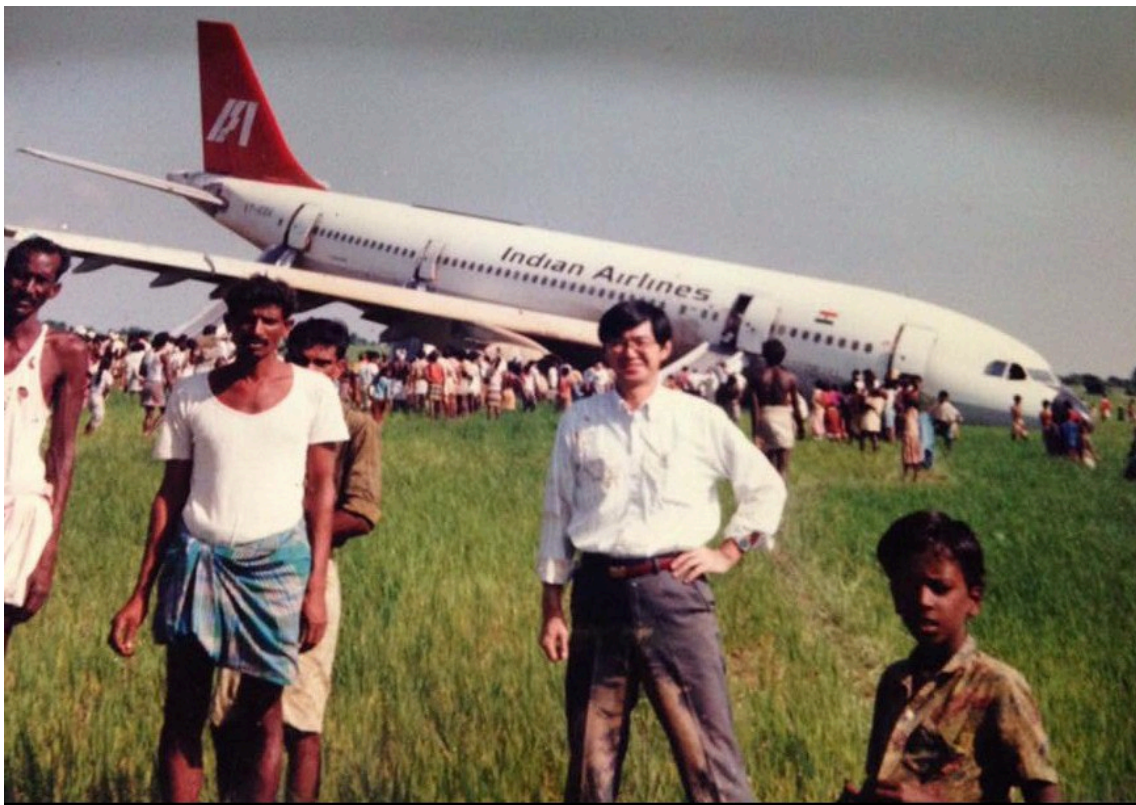
photo (c) Dave; Tirupati Airport (TIR); 15 November 1993
