Pizza Rework Project

Pizza

Slice

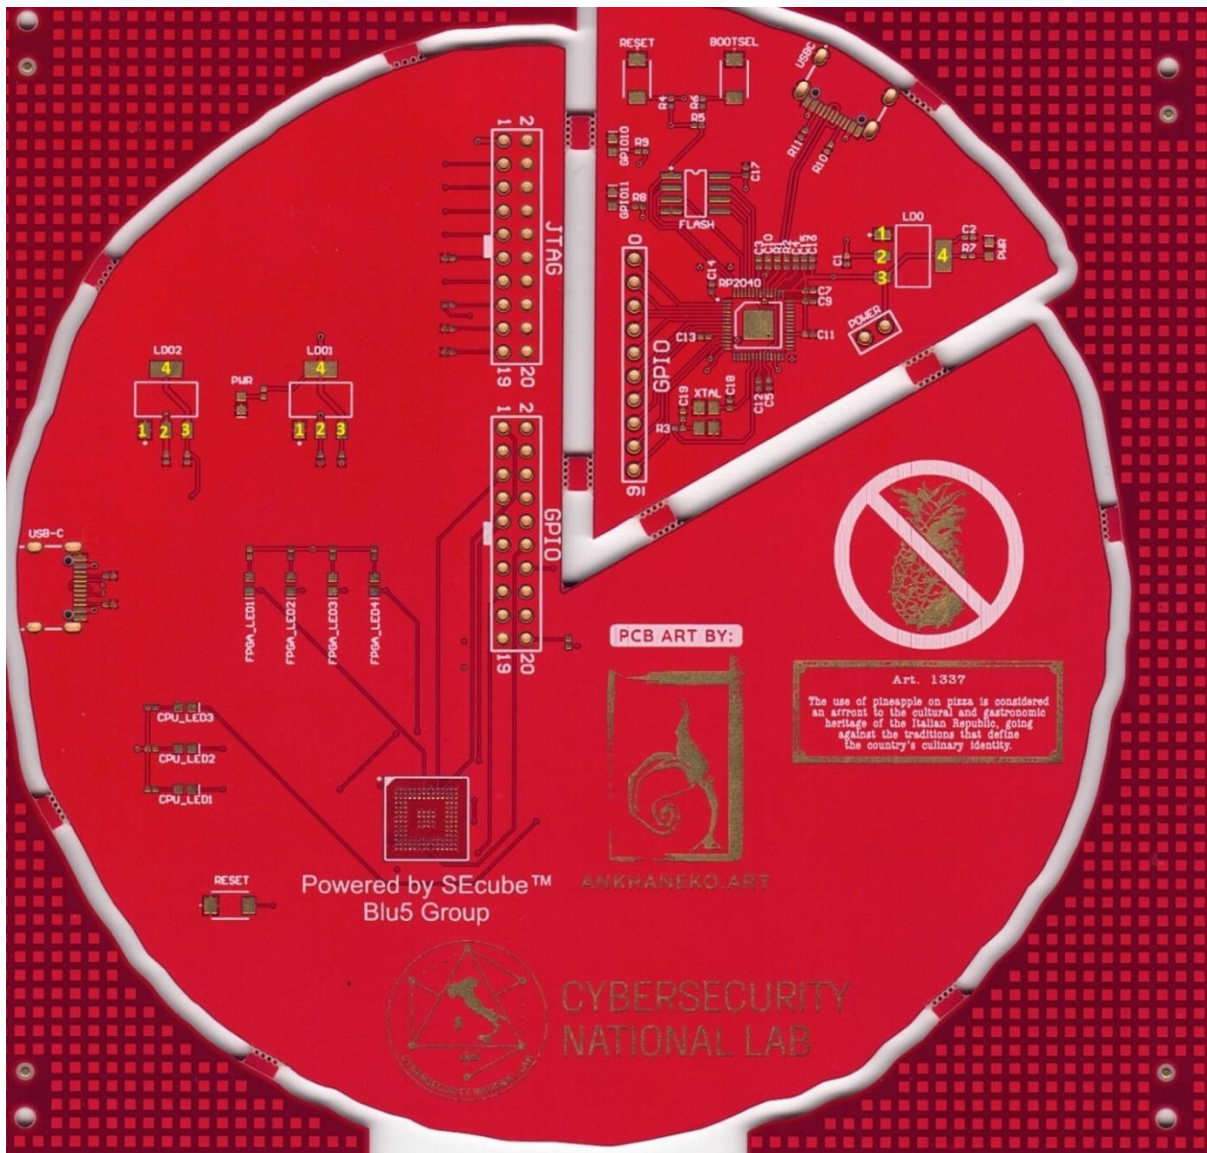
1. LDO Rewiring

Pads 2 and 3 are inverted, and as a result, pad 4 is incorrectly connected to pad 3 instead of pad 2.

Pins 2 and 4 of the component are internally connected, so it is not necessary to connect both of them.

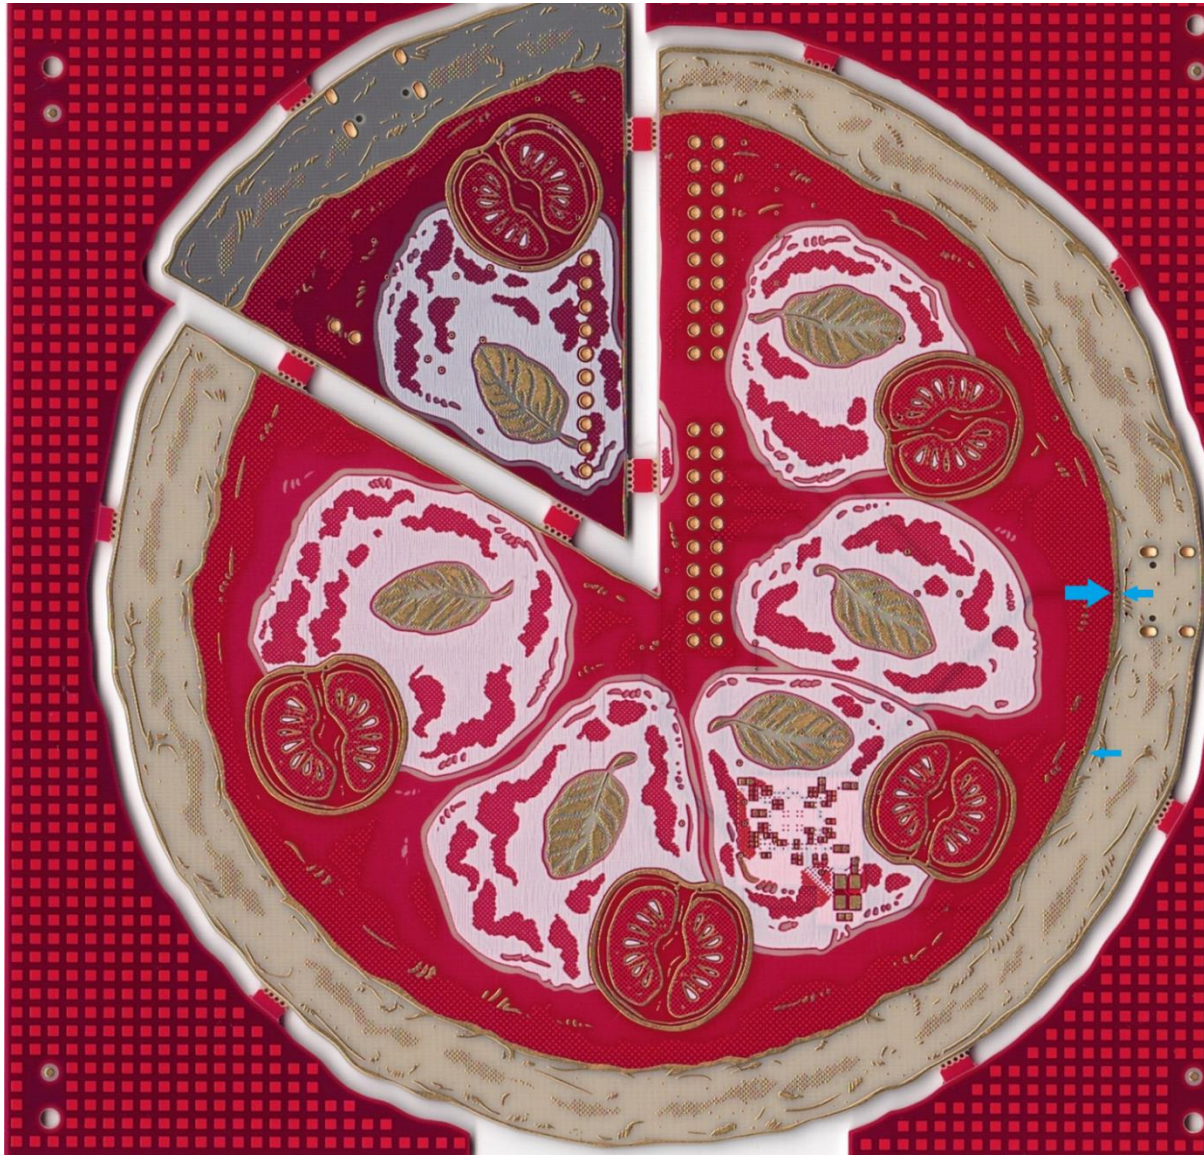
2. Removal of Short Circuits

There is a short circuit on the front of the board due to some vias ending on the graphic design. It can be easily resolved by cutting a few traces on the top layer.

The two nearby arrows indicate two vias that intersect the edge of the pad, while the arrow below points to another via that should be isolated.

Particular attention must be paid to the two adjacent vias because they have a trace on the layer immediately below.

WARNING: Pay attention in the case of the two nearby vias, because on the layer immediately below, there are traces connected to them.

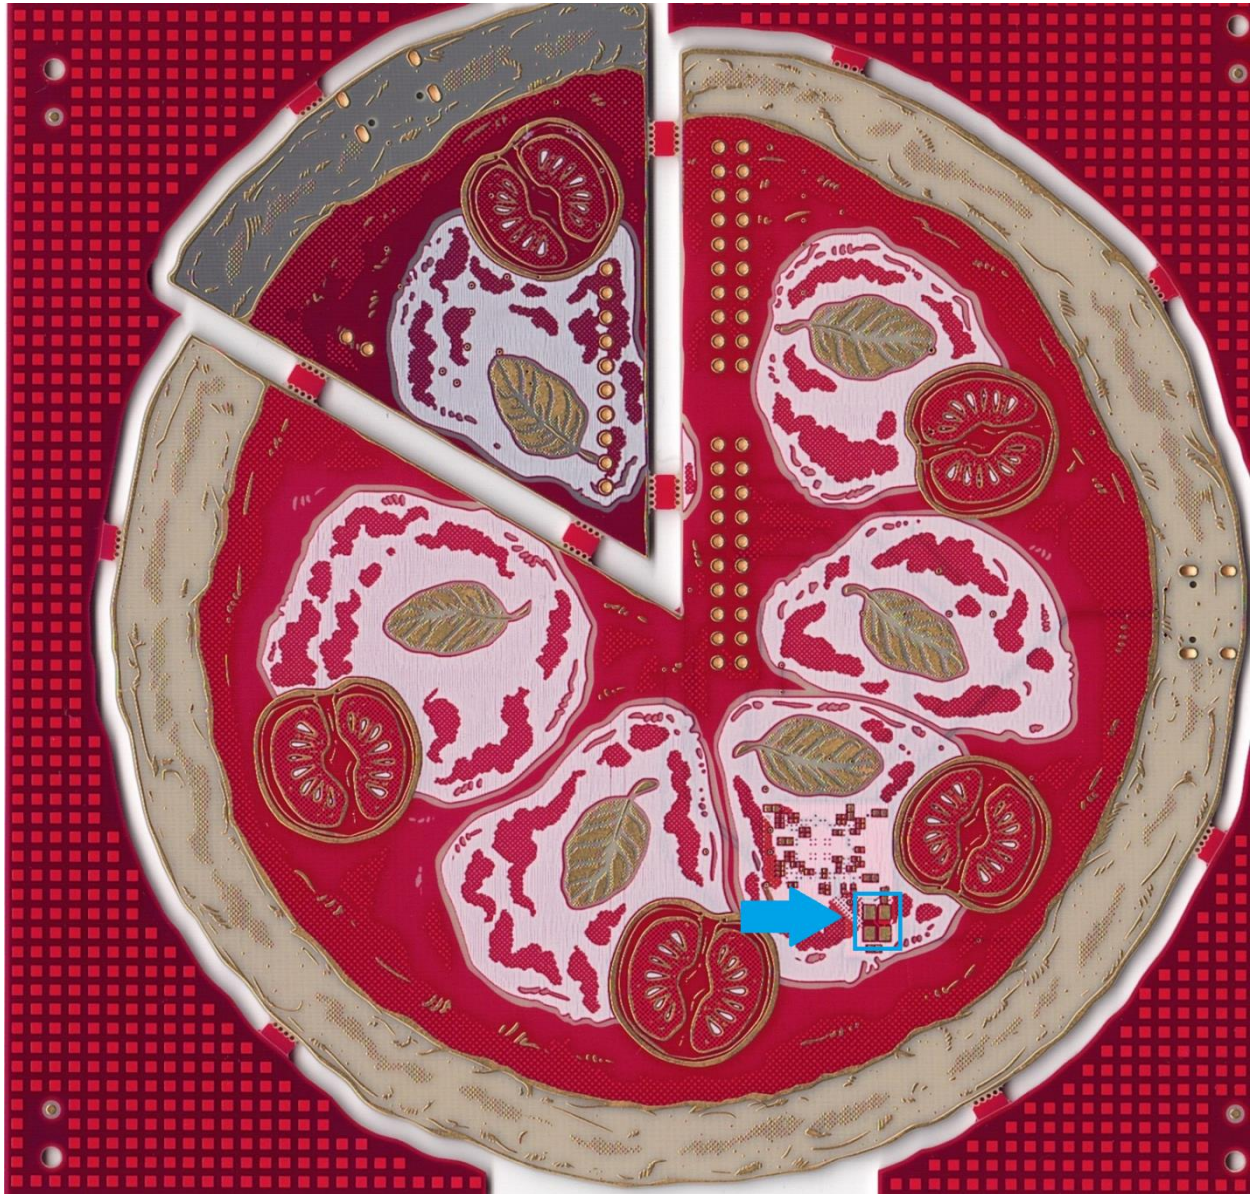
3. Quartz Oscillator Rotation

The quartz oscillator is installed in the wrong direction. To fix it, it needs to be rotated by 90 degrees. The footprint allows for good compatibility even in that orientation.

WARNING: It is highly discouraged to use a hot air station, as this area contains a large copper rectangle connected to several vias leading to the SEcube. This would transfer a lot of heat, potentially damaging it.

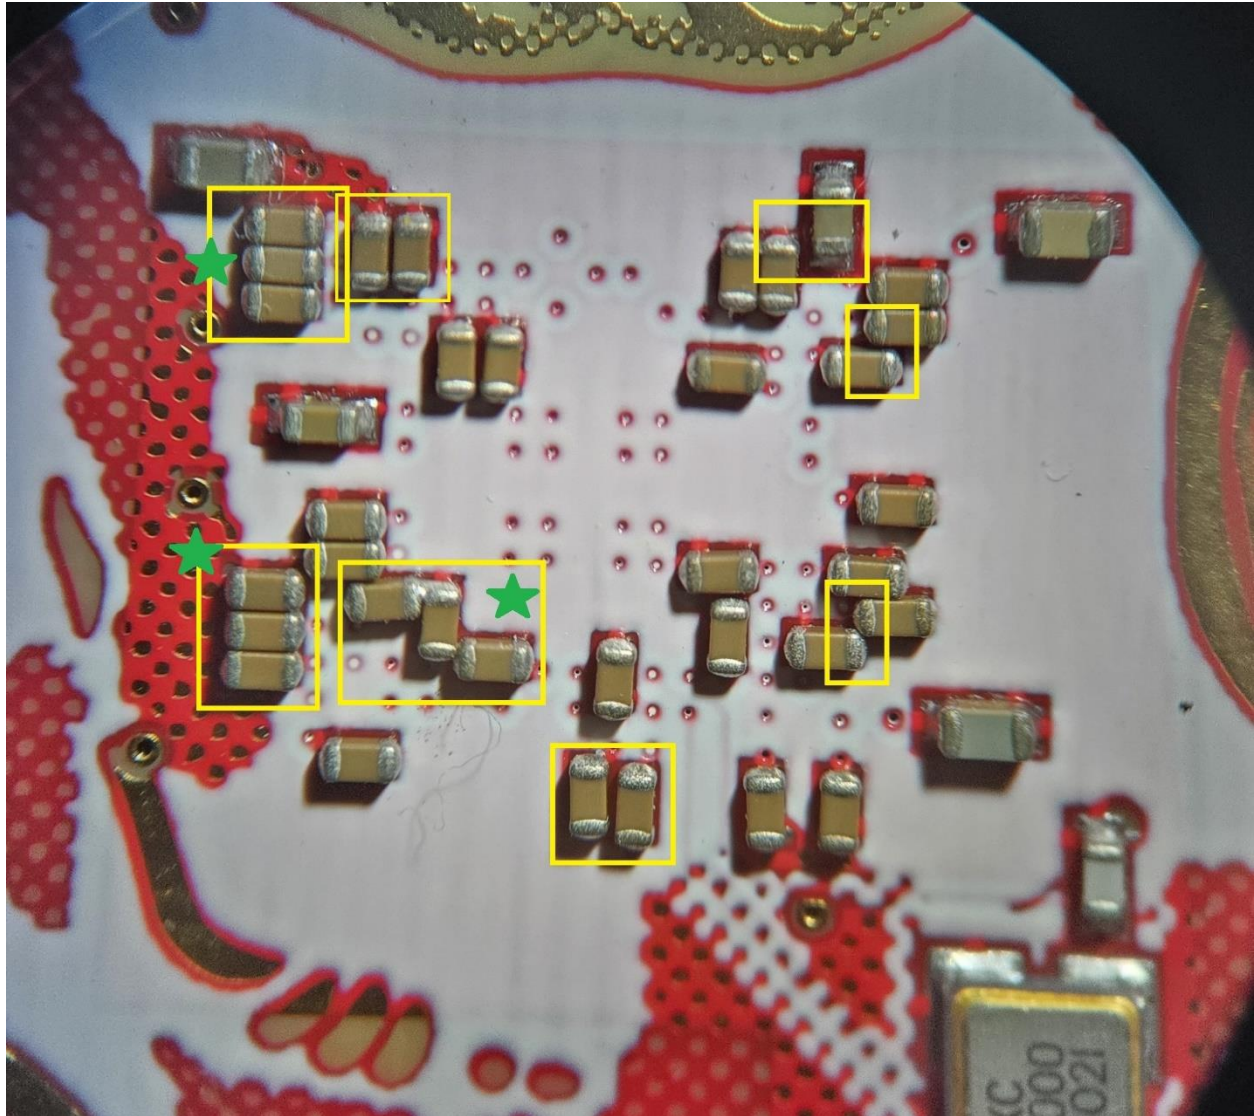
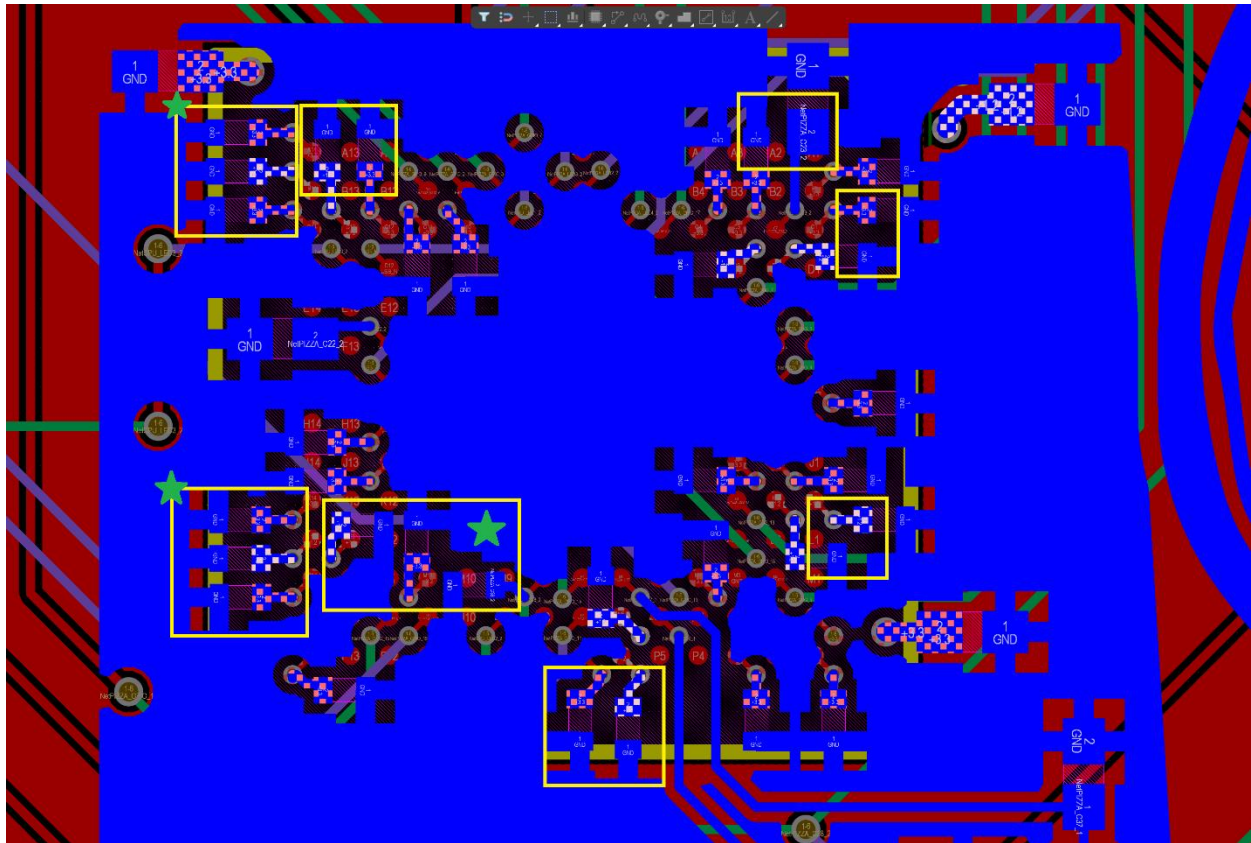
4. Capacitor Removal

The extreme proximity of the capacitors under the SEcube (BGA microchip) on the pad has caused the formation of solder bridges between some pads. The groups of capacitors in the yellow squares are problematic; those marked with a green star definitely need to be addressed, while the others depend on the situation of the individual board.

Not all capacitors are strictly necessary; the goal is to keep as many as possible.

WARNING: It is highly discouraged to use a hot air station, as this area contains a large copper rectangle connected to several vias leading to the SEcube. This would transfer a lot of heat, potentially damaging it.

In the case of triplets (all those with the star), it is suggested to remove the central capacitor. For the other groups, it is recommended to proceed only if necessary and to prioritize removal in this order, referring to the CAD view with the following colors: capacitors with a white-blue checkered pad, capacitors with a red-blue checkered pad, and others.

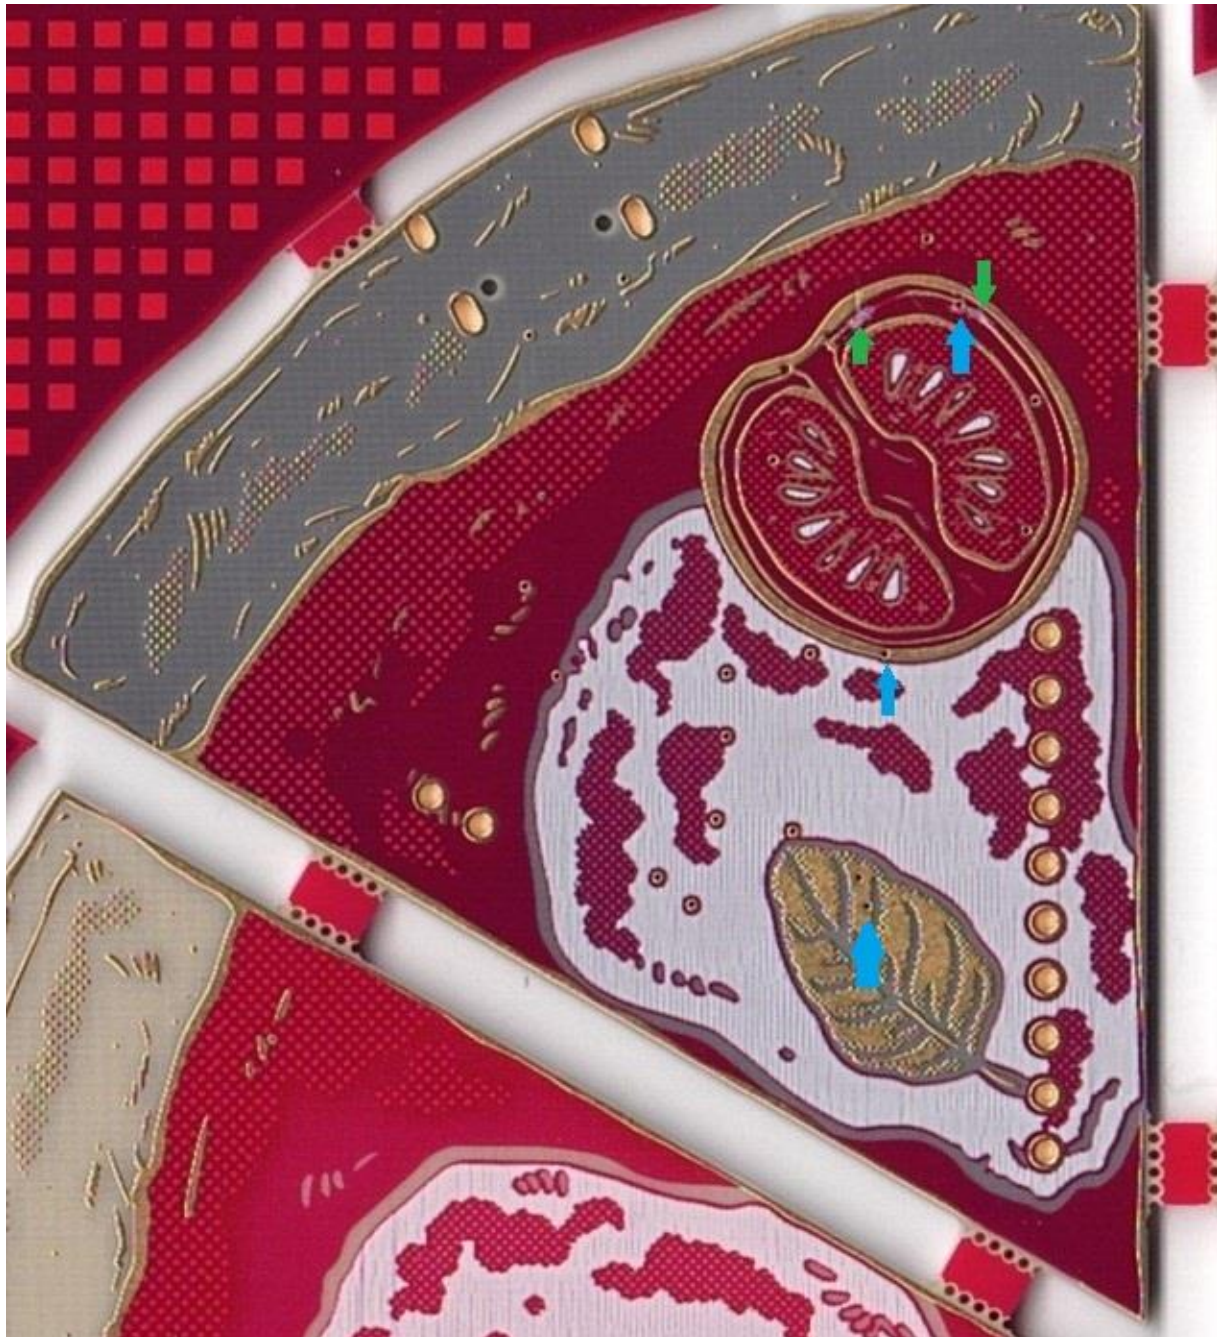
There are short circuits on the front of the board due to some vias ending on the graphic design. They can be easily resolved by cutting a few traces on the top layer.

The blue arrows indicate the problematic vias, while the green ones mark the two points that I consider best for cutting the traces, as they are very thin (in the photo, the modification to the vias on the "tomato" has already been applied).
