# ES\_LPC177x/8x

## Errata sheet LPC177x/8x

Rev. 2.2 — 17 January 2012

Errata sheet

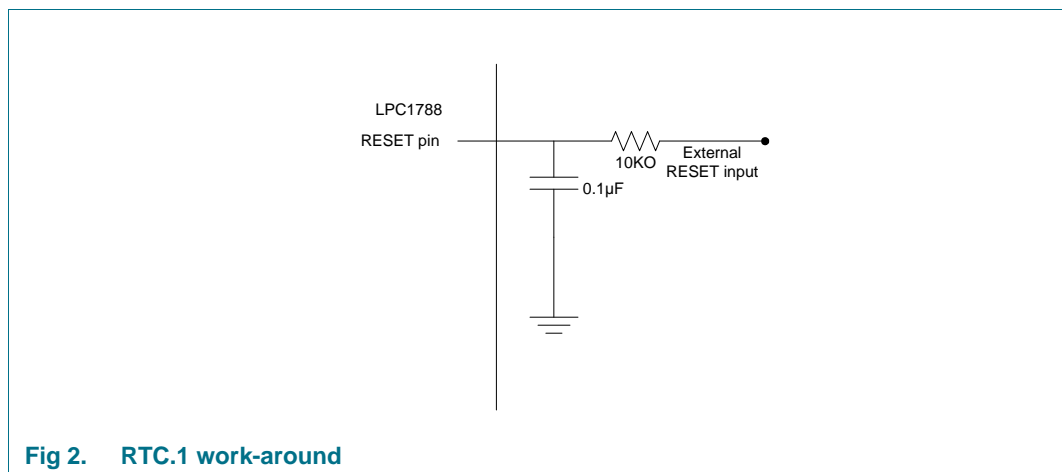
Fig 2. RTC.1 work-around

RTC temporarily pauses and loses fractions of a second during the rising and falling edges of RESET. This occurs only in the LQFP packages with certain voltage swings and ramp rates. The problem is exacerbated by low temperatures. Reducing the voltage swing and/or ramp rate of the reset pulse will eliminate this loss of time counts. When this issue occurs, the impact on RTC accuracy is expected to be one second every several thousand reset events.

Adding an RC filter between the reset pin and the external reset input to control the reset signal voltage ramp rate can prevent this problem.
