Investigation Report

Item	Investigation flange cracks and shank defects on items made from U.S. billetcast material trial	November 3, 2016
------	---	------------------

An investigation was launched following flange cracks and shank defects found on bolts made from U.S. billet-cast material.

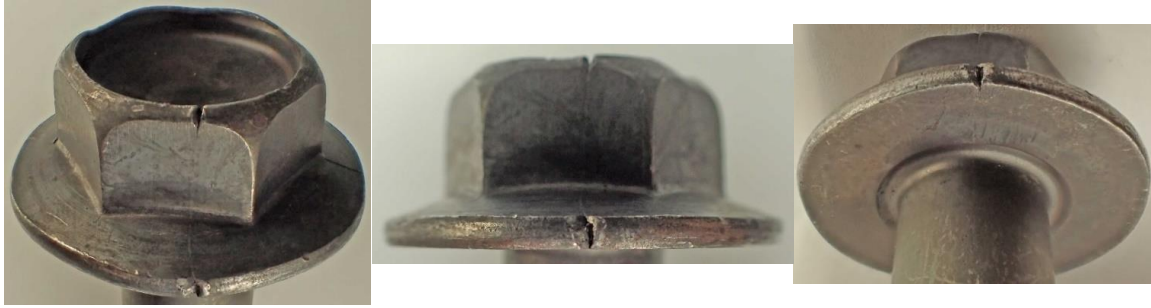
Billet SAE10B23 Flange Crack and Shank Defect Depth**SAE10B23 Flange Crack No.1**

Flange Crack View

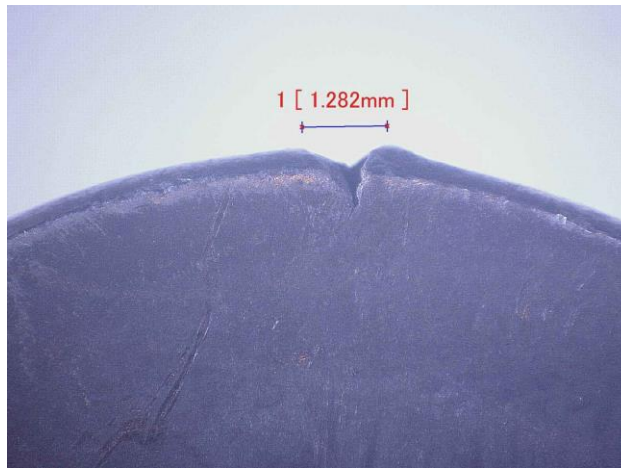
Flange Crack Magnification (Photo from surface in)
(Magnification: X40; Free of display magnification)

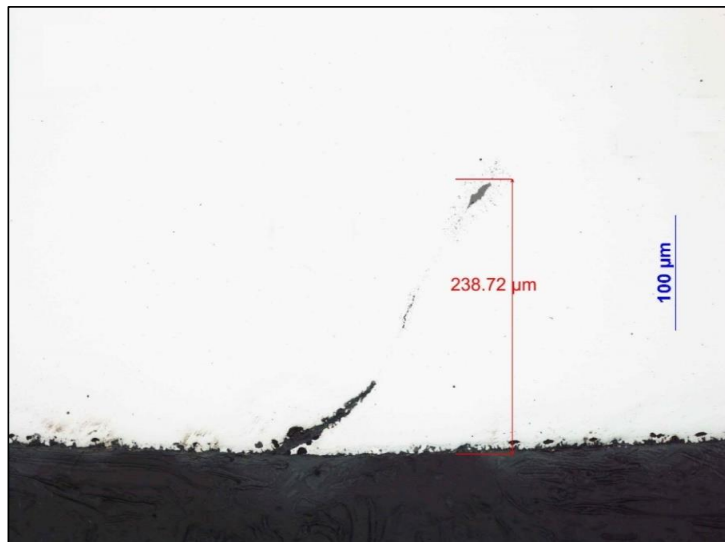
Shank Cross Section Shank length ~5mm
(Magnification: X200; Free of display magnification)

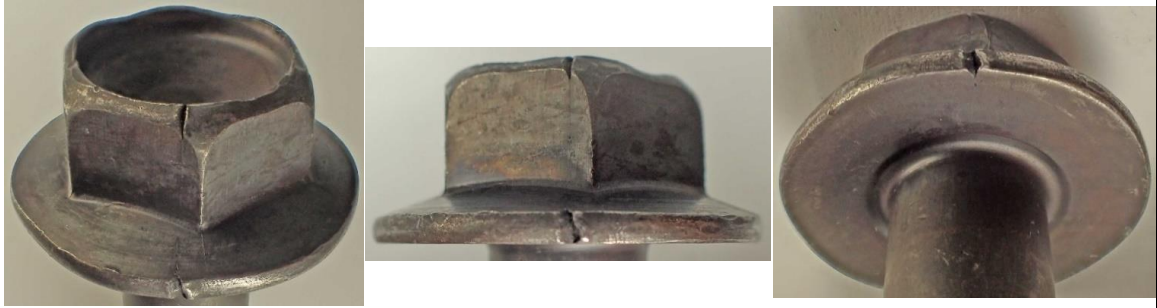
SAE10B23 Flange Crack No.2

Flange Crack View

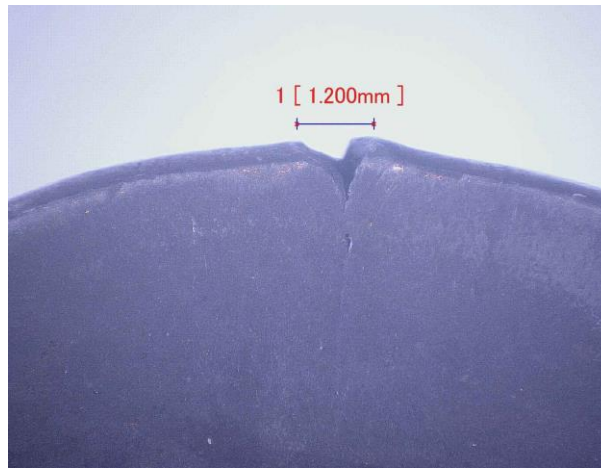
Flange Crack Magnification (Photo from surface in)
(Magnification: X40; Free of display magnification)

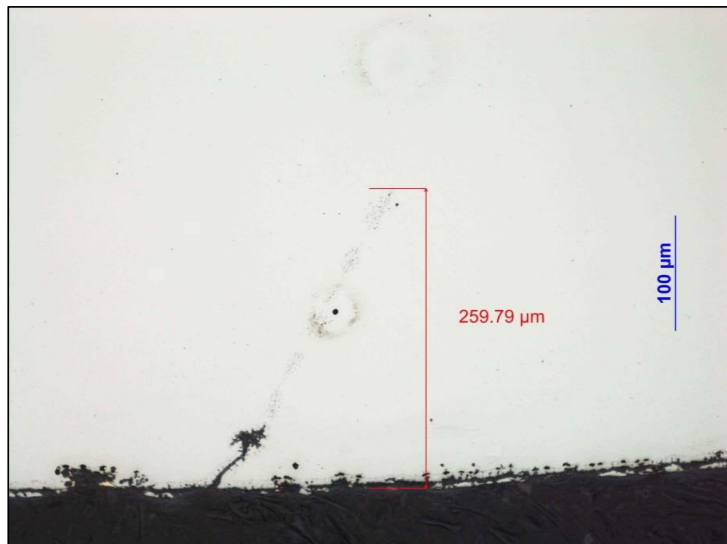
Shank Cross Section Shank length ~5mm
(Magnification: X200; Free of display magnification)

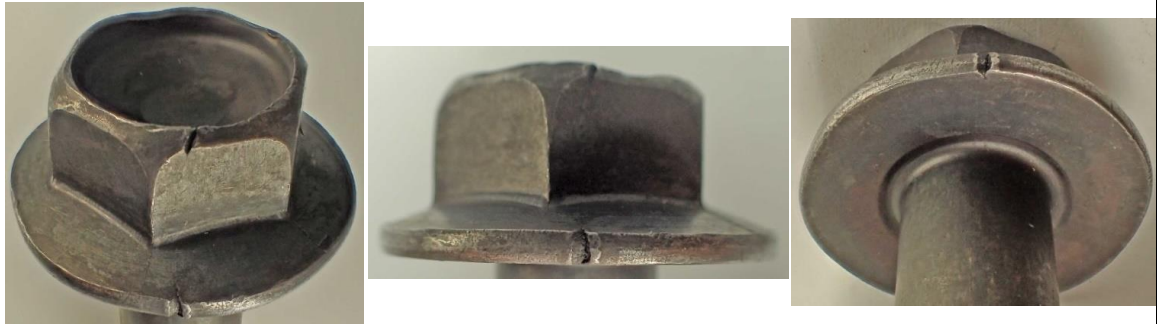
SAE10B23 Flange Crack No.3

Flange Crack View

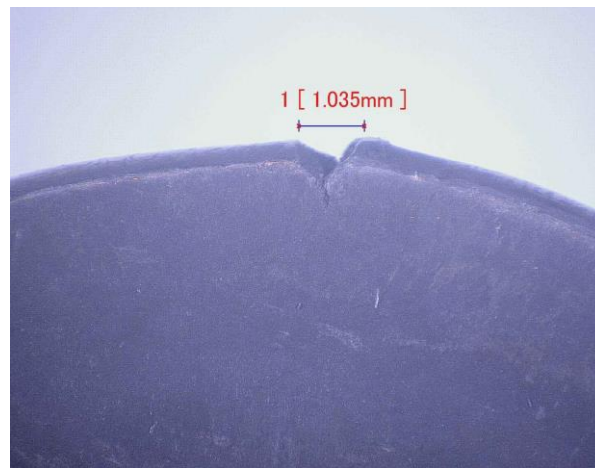
Flange Crack Magnification (Photo from surface in)
(Magnification: X40; Free of display magnification)

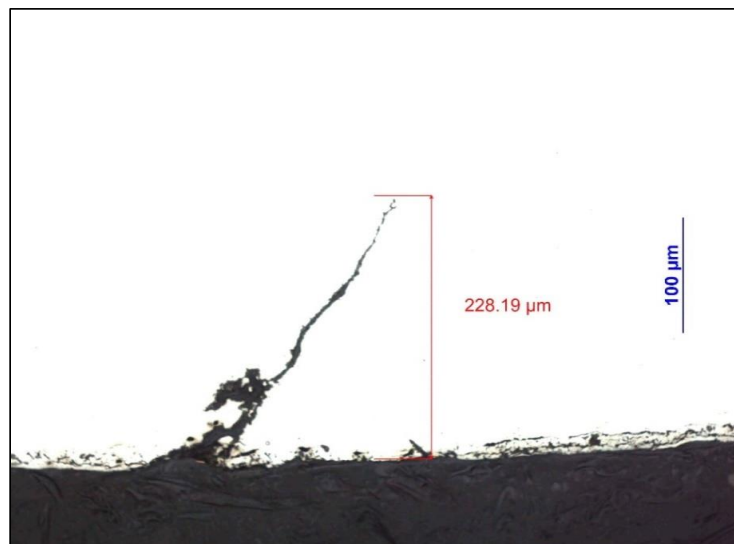
Shank Cross Section Shank length ~5mm
(Magnification: X200; Free of display magnification)

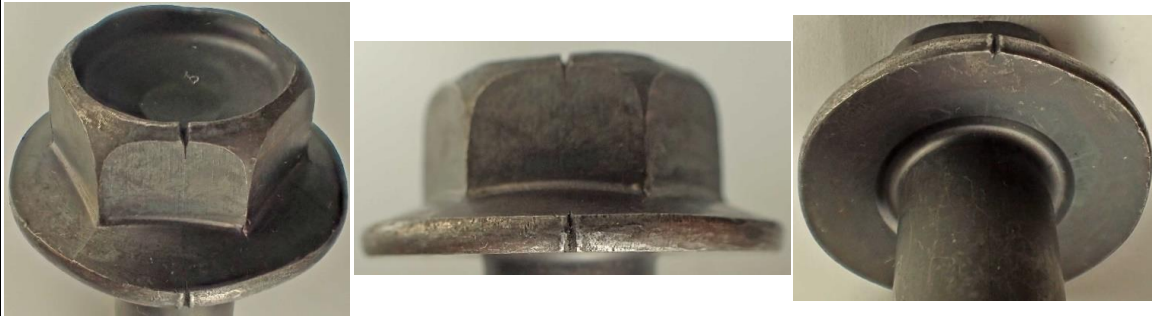
SAE10B23 Flange Crack No.4

Flange Crack View

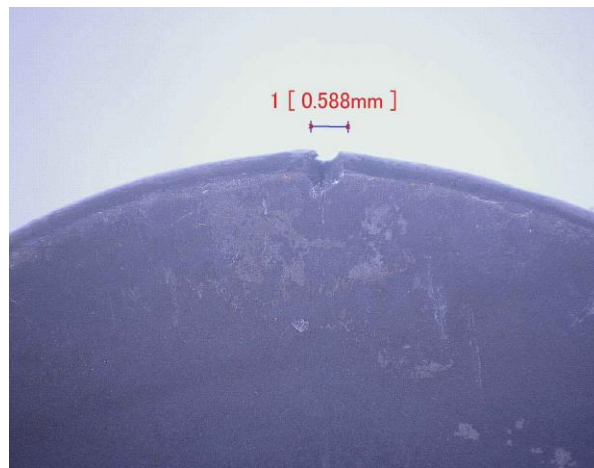
Flange Crack Magnification (Photo from surface in)
(Magnification: X40; Free of display magnification)

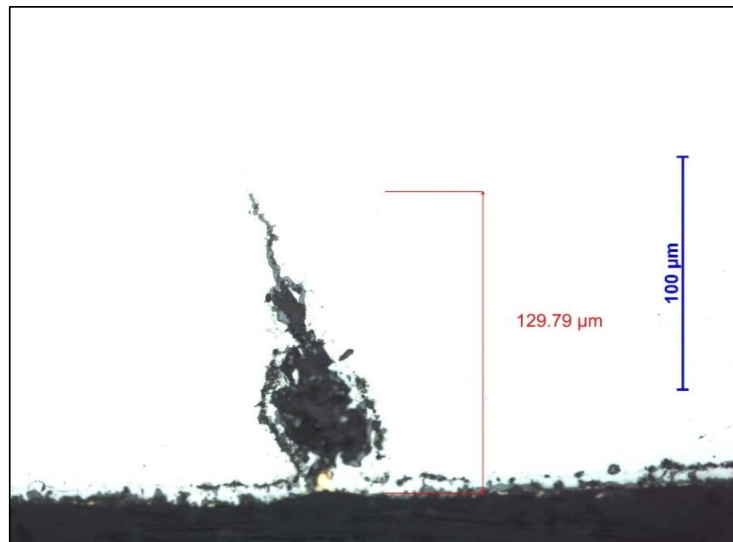
Shank Cross Section Shank length ~5mm
(Magnification: X200; Free of display magnification)

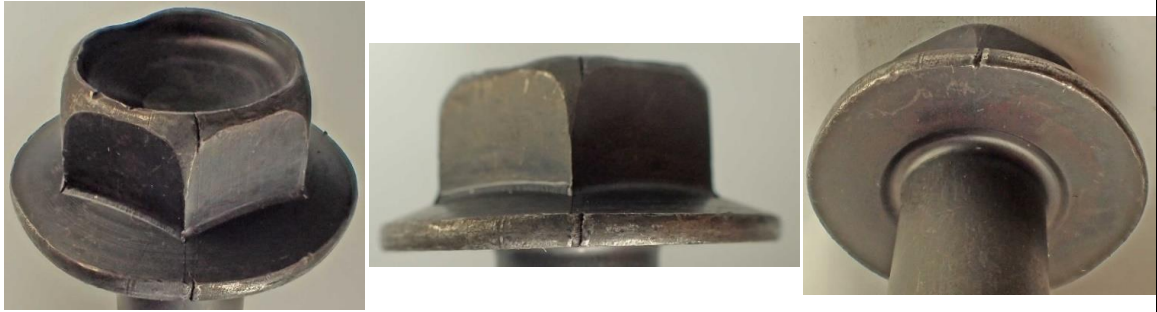
SAE10B23 Flange Crack No.5

Flange Crack View

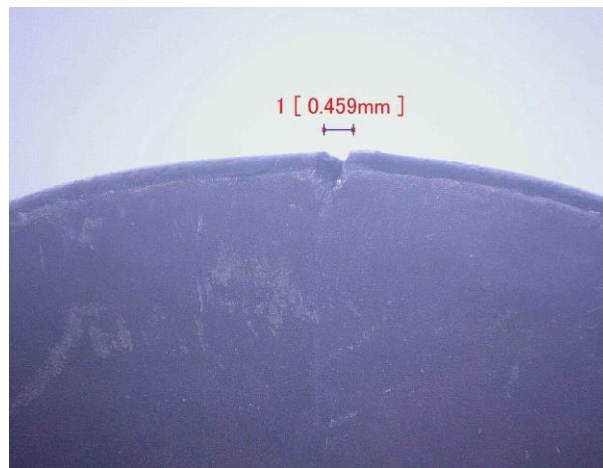
Flange Crack Magnification (Photo from surface in)
(Magnification: X40; Free of display magnification)

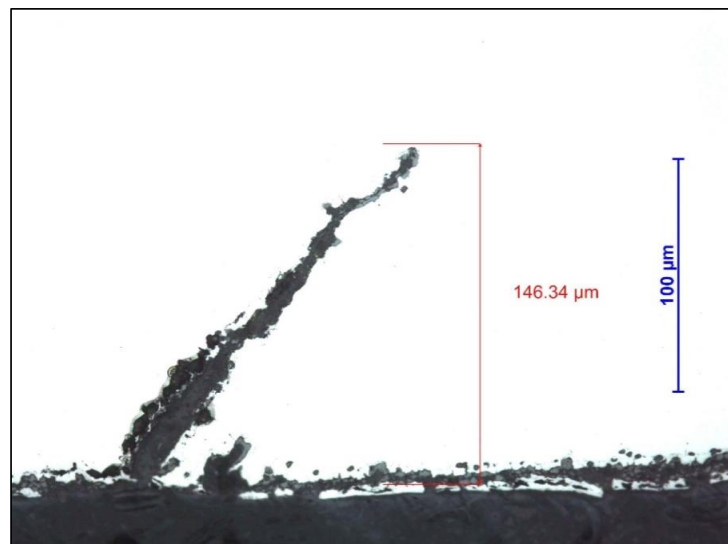
Shank Cross Section Shank length ~5mm
(Magnification: X200; Free of display magnification)

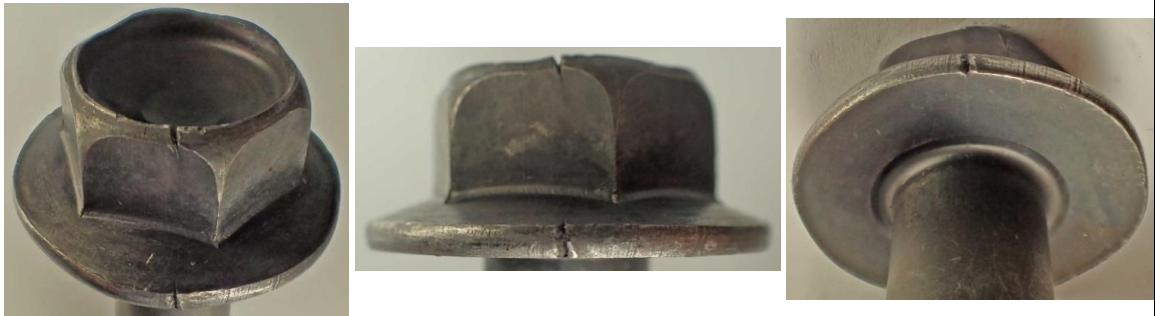
SAE10B23 Flange Crack No.6

Flange Crack View

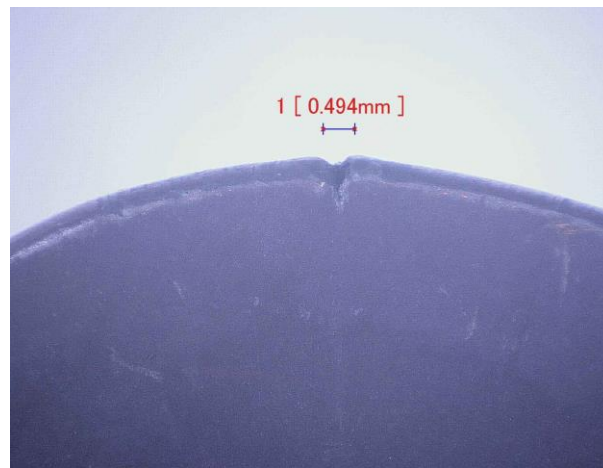
Flange Crack Magnification (Photo from surface in)
(Magnification: X40; Free of display magnification)

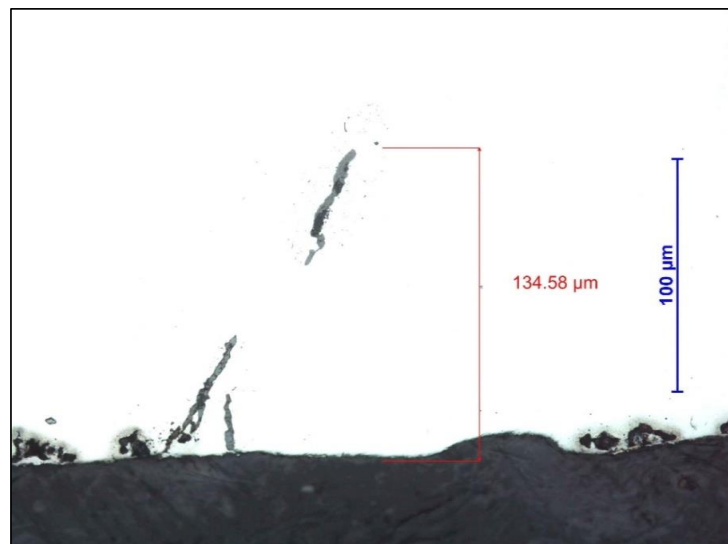
Shank Cross Section Shank length ~5mm
(Magnification: X200; Free of display magnification)
