STM32F405/407xx and STM32F415/417xx device errata

It gives a summary and a description of the device errata, with respect to the device datasheet and reference manual RM0090.

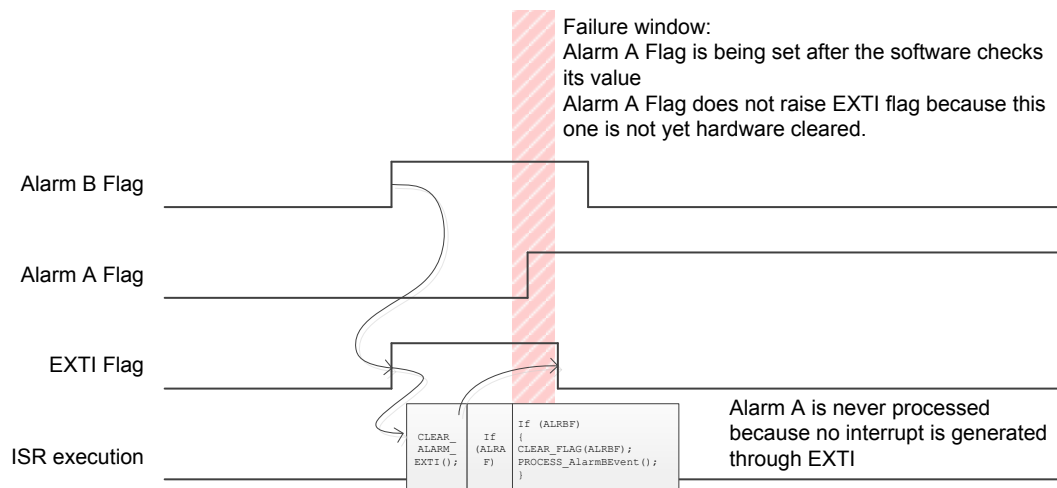
Figure 1. Masked RTC interrupt

The following code example and figure illustrate the failure mechanism: The Alarm A event is lost (fails to generate interrupt) as it occurs in the failure window, that is, after checking the Alarm A event flag but before the effective clear of the EXTI interrupt flag by hardware. The effective clear of the EXTI interrupt flag is delayed with respect to the software instruction to clear it.
