dsPIC33CH512MP508 Family Silicon Errata and Data Sheet Clarification

The dsPIC33CH512MP508 family devices that you have received conform functionally to the current Device Data Sheet (DS70005371D), except for the anomalies described in this document.

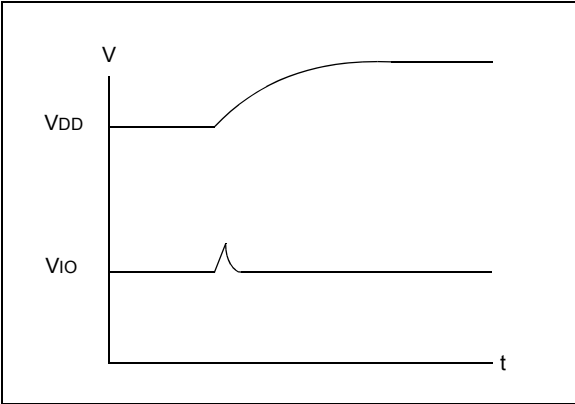
FIGURE 1-1: I/O RAMP

During a fast device power-up, when the VDD ramp is less than 4 mS, the I/O pins may drive up to 100 μ A current for a duration of up to 10 μ S (Figure 1-1).

Example applications affected may include complementary power switches, where a transient current shoot-through might occur. High-voltage applications with complementary switches should power the high-voltage 200 μ Sec later than powering the dsPIC® device to avoid the current shoot-through. This behavior is specific to each device and not affected by aging.

1. Slow down the VDD ramp time (greater than 4 mS for VDD to ramp 0V to 3.3V).
2. Ensure the circuitry that is connected to the pins can endure this pulse.
