## PIC32MZ Embedded Connectivity with Floating Point Unit (EF) Family Silicon Errata and Data Sheet Clarification

The PIC32MZ Embedded Connectivity with Floating Point Unit (EF) family of devices that you have received conform functionally to the current Device Data Sheet (DS60001320), except for the anomalies described in this document.

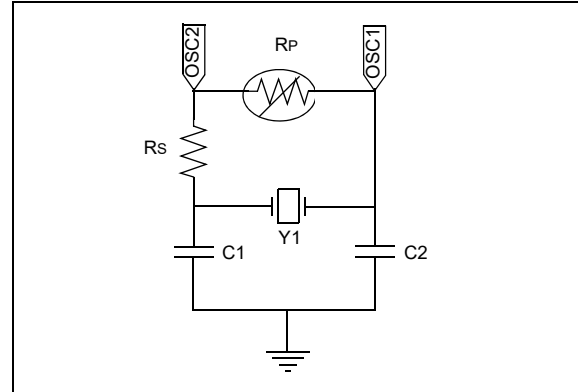
**FIGURE 1: Posc CRYSTAL CIRCUIT**

**Revision A3 and B3 Silicon:** The Posc has been tested in a normal power-up sequence and supports specific crystal operation.

The Primary Oscillator (Posc) has been characterized to operate at 8 MHz, 12 MHz, and 24 MHz when the circuit in [Figure 1](#) is implemented, and the operating conditions listed in [Table 3](#) are met.

#### Silicon Work around 2

Alternatively, use an external clock or the Internal FRC oscillator.
