PIC32MZ Embedded Connectivity with Floating Point Unit (EF) Family Silicon Errata and Data Sheet Clarification

The PIC32MZ Embedded Connectivity with Floating Point Unit (EF) family of devices that you have received conform functionally to the current Device Data Sheet (DS60001320), except for the anomalies described in this document.

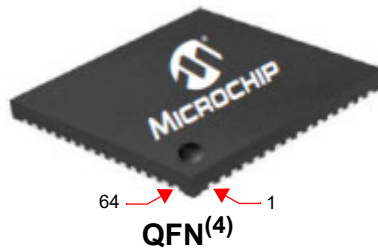
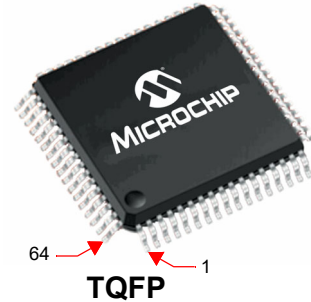
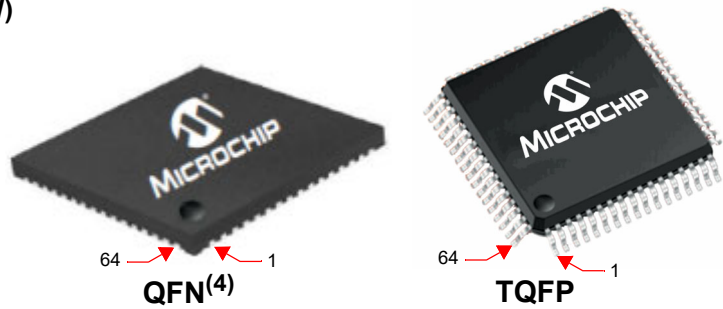
64-PIN QFN⁽⁴⁾ AND TQFP (TOP VIEW)

The following typographic corrections and clarifications are to be noted for the latest version of the device data sheet (DS60001320H):
