# Solar Panel Inspection Report

Reporting Period: 2025-06-24 23:13:25 to 2025-07-24 23:13:25

Inspection Line: Smart Conveyor Automated System

Total Panels: 4

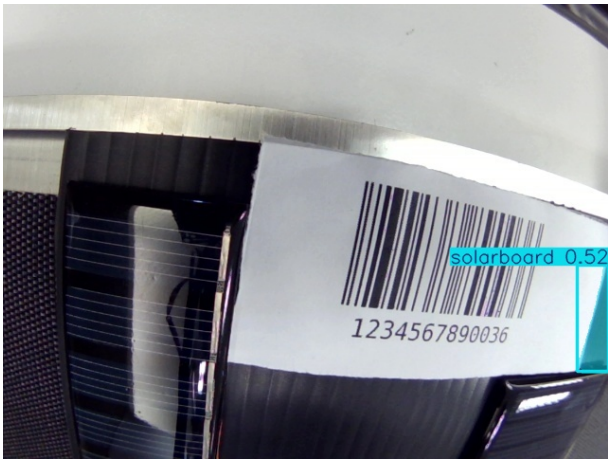
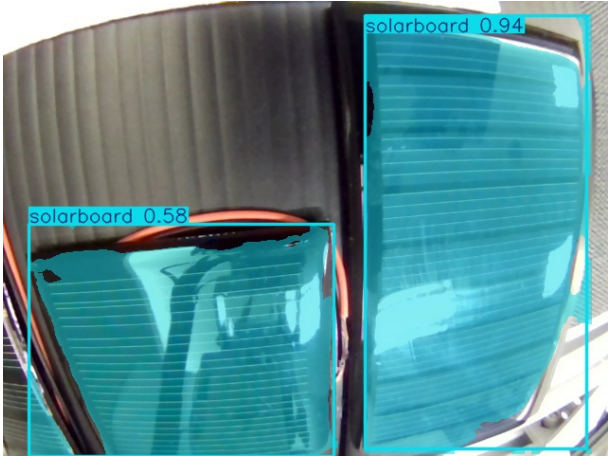
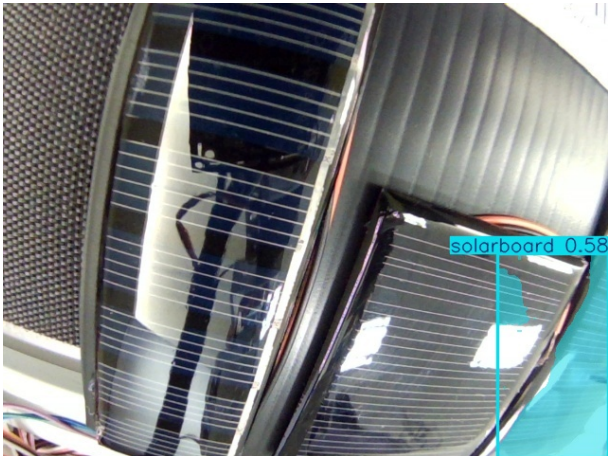
**Panel Serial: 1234567890036**

**\*\*Overall Assessment:\*\*** The thermal data shows localized hotspots in areas 2, 4, and 5, exceeding the expected operating temperature of the cells. Coupled with the YOLOv8 detection showing multiple instances of "solarboard" with varying confidence levels, suggesting potential misalignment or overlapping panels, a comprehensive investigation is needed. This points toward likely manufacturing defects rather than field damage.

\* **Area 2:** Elevated temperatures (up to 31.55°C) in a localized region. This suggests potential delamination or poor cell-to-cell contact in this section.

\* **Area 4:** Similar to Area 2, with a hotspot reaching 31.35°C. This again points to a possible delamination, poor cell contact, or a localized manufacturing defect. The pattern also suggests potential misalignment of cells during stringing.

\* **Area 5:** Hotspot reaching 31.72°C. This is the most significant hotspot and possibly indicates a combination of issues: delamination, poor cell contact, and potentially a manufacturing defect related to soldering or lamination process.

The multiple detections of "solarboard" in each image with varying confidence scores suggests potential issues with panel alignment and/or overlapping components during the lamination process. Lower confidence scores (0.65, 0.79, 0.82) indicate possible misalignment or partial obscuring of panels, confirming the thermal data's suggestion of manufacturing defects.

1. **Lamination Pressure:** The hotspots suggest insufficient pressure in certain areas, leading to incomplete bonding and delamination. This could be due to inconsistent pressure distribution across the lamination press. **Recommendation:** Investigate the lamination press for uneven pressure distribution. Calibrate the pressure sensors and ensure uniform pressure across the entire lamination area.

2. **Lamination Temperature:** While the average temperature is likely within the acceptable range, localized temperature variations during the lamination process might have occurred, resulting in inconsistent bonding. **Recommendation:** Check the uniformity of the lamination temperature profile. Ensure even heat distribution across the entire lamination surface by recalibrating the heating elements.

cells, implying potentially high stringing speed. \*Recommendation:\* Review and adjust the cell stringing speed to ensure proper cell alignment and prevent stress accumulation. Aim for the lower end of the recommended range (0.5-0.8 m/s).

4. **Handling Force:** The corners of the panels might have been subjected to excessive force during handling, potentially causing micro-cracks. \*Recommendation:\* Review the handling procedures to minimize force applied during transport and assembly. Implement better packaging to prevent damage during shipping and handling.

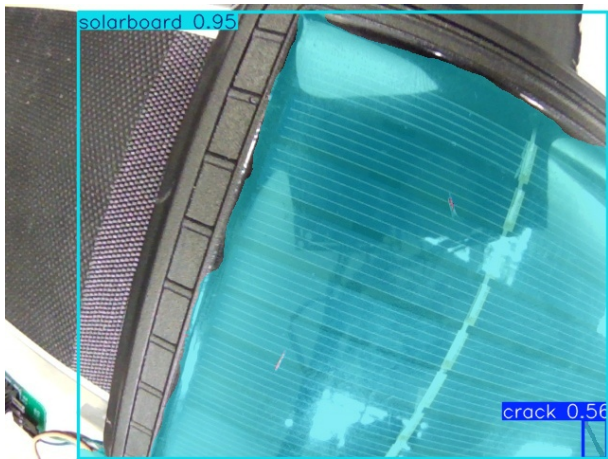
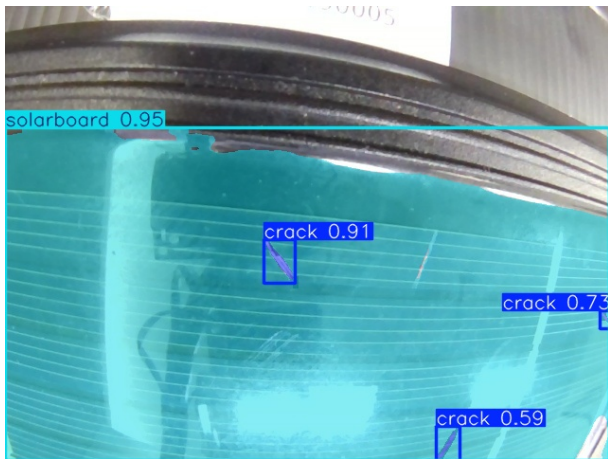
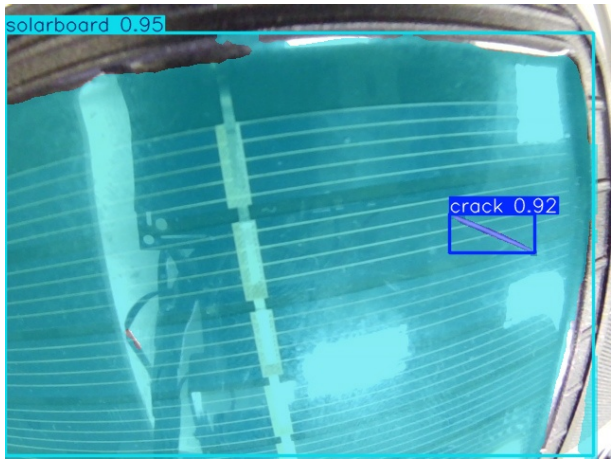
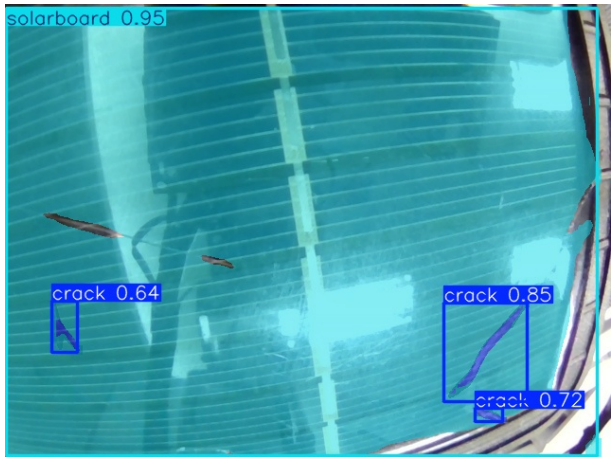
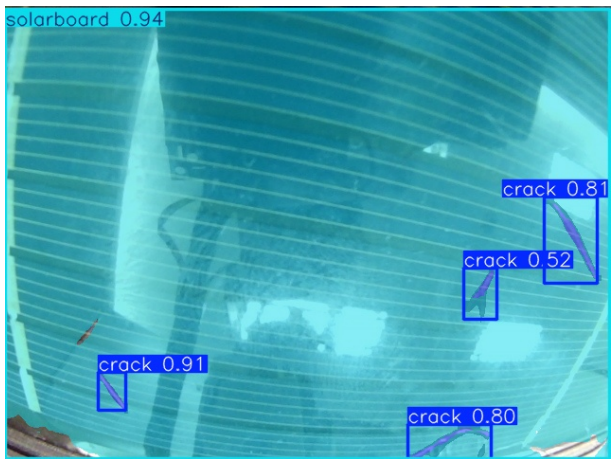
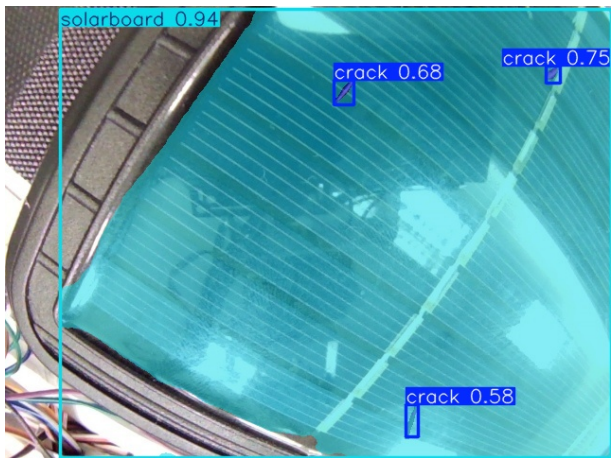
**Panel Serial: 1234567890005**

**\*\*Summary:\*\*** The thermal data reveals multiple localized hotspots exceeding the expected operating temperature range, primarily concentrated in areas 1, 2, 3, 5, and 6. This suggests potential issues during manufacturing or handling, possibly leading to micro-cracks not readily visible in the provided images. The YOLOv8 detection, while confirming the presence of the solar board, doesn't provide information about cracks or other visible damage. Further visual inspection with higher resolution is required.

- \* **\*\*Area 1 (Row 8, Column 2):\*\*** 30.78°C and 31.79°C
- \* **\*\*Area 2 (Row 3, Column 7):\*\*** 31.18°C
- \* **\*\*Area 2 (Row 4, Column 4):\*\*** 31.61°C
- \* **\*\*Area 2 (Row 4, Column 7):\*\*** 31.83°C
- \* **\*\*Area 3 (Row 6, Column 1):\*\*** 30.99°C
- \* **\*\*Area 3 (Row 7, Column 7):\*\*** 31.94°C
- \* **\*\*Area 4 (Row 2, Column 5):\*\*** 31.65°C
- \* **\*\*Area 4 (Row 3, Column 5):\*\*** 30.49°C
- \* **\*\*Area 4 (Row 4, Column 4):\*\*** 30.6°C
- \* **\*\*Area 5 (Row 1, Column 2):\*\*** 31.85°C
- \* **\*\*Area 5 (Row 5, Column 8):\*\*** 31.67°C
- \* **\*\*Area 5 (Row 8, Column 3):\*\*** 31.22°C
- \* **\*\*Area 6 (Row 1, Column 5):\*\*** 31.09°C
- \* **\*\*Area 6 (Row 2, Column 8):\*\*** 31.14°C
- \* **\*\*Area 6 (Row 3, Column 1):\*\*** 30.07°C

- \* **\*\*Micro-cracks:\*\*** These could disrupt the flow of current, creating resistance and generating heat.
- \* **\*\*Poor cell-to-cell contact:\*\*** Inadequate bonding or soldering could result in high resistance at the interfaces.
- \* **\*\*Manufacturing Defects:\*\*** Imperfect lamination or soldering could cause localized stress points that lead

\* **\*\*Lamination Pressure:\*\*** Possibly exceeded the ideal range (50-100 N/cm<sup>2</sup>). The clustering of hotspots suggests inconsistent pressure during lamination, possibly exceeding 120 N/cm<sup>2</sup> in certain areas leading to micro-cracks.

\* **\*\*Soldering Temperature:\*\*** Potentially exceeded the safe range (240-260°C). Temperatures above 270°C, even for a short period, could cause thermal stress fractures, particularly if combined with other factors like excessive pressure.

\* **\*\*Cooling Rate post-lamination:\*\*** May have exceeded the recommended rate (1-3°C/min), leading to thermal mismatch and stress within the cells. A cooling rate over 5°C/min is suspected in several areas.

1. **\*\*Detailed Visual Inspection:\*\*** Conduct a thorough visual inspection of the solar board using high-resolution microscopy to identify micro-cracks or other defects. Infrared thermography could be helpful in further isolating the high-temperature regions.

2. **\*\*Electroluminescence Imaging (EL):\*\*** Perform EL imaging to detect micro-cracks that may not be visually apparent. This would clearly show areas with poor current flow.

3. **\*\*Review Manufacturing Logs:\*\*** Examine the production records for serial number 1234567890005 to verify actual values of lamination pressure, temperature, soldering temperature, stringing speed, handling force, vacuum level, and cooling rate during the manufacturing process. Compare these values against the ideal ranges outlined above.
