# Solar Panel Inspection Report

Reporting Period: 2025-06-25 11:24:18 to 2025-07-25 11:24:18

Inspection Line: Smart Conveyor Automated System

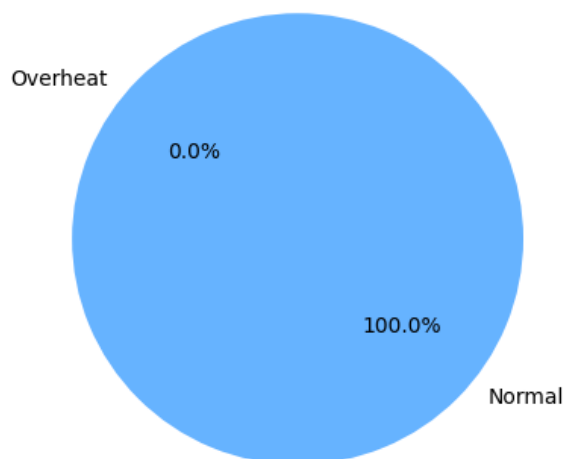
\* **Area 4:** Shows temperatures exceeding 30°C in several grid points, notably a peak of 31.54°C. This is a significant deviation from the surrounding temperatures (around 25-26°C), indicating a potential hotspot. The highest readings are clustered, hinting at a localized issue rather than a general overheating problem.

\* **Area 5:** Although less pronounced than Area 4, Area 5 also displays a localized hotspot reaching 31.77°C, suggesting a similar issue, potentially related to the same root cause. The presence of elevated temperatures in multiple grid points within this area supports this.

The localized hotspots in areas 4 and 5 strongly suggest issues related to cell bonding or soldering rather than widespread panel heating. Several production parameters could be implicated:

\* **Soldering Temperature:** The most likely culprit is a localized soldering issue. The hotspots in areas 4 and 5 may be due to uneven soldering temperature. It's possible that during the soldering process, these areas experienced a momentary spike in temperature exceeding 270°C, resulting in micro-cracks and creating localized high-resistance spots. A brief excursion above 270°C in specific areas could explain the observed thermal pattern without causing widespread damage.

1. **\*\*Visual Inspection:\*\*** Conduct a thorough visual inspection of areas 4 and 5 with a high-resolution camera and magnification, looking for micro-cracks or imperfections in the cell surface or solder joints. Infrared thermography would confirm the hotspots and their precise location.

2. **\*\*Electrical Testing:\*\*** Perform detailed electroluminescence (EL) imaging and I-V curve measurements to identify any cell defects or performance degradation associated with the hotspots. This will help quantify the impact of the localized issues.

3. **\*\*Review Production Data:\*\*** Analyze production logs for Serial Number 1234567890036 for deviations in lamination pressure, temperature profiles, and soldering parameters around the time of production. This data will help to pinpoint exact parameter values to determine if they fell outside the acceptable ranges. If possible, review data from the immediate prior and following boards to assess whether these are isolated incidents.

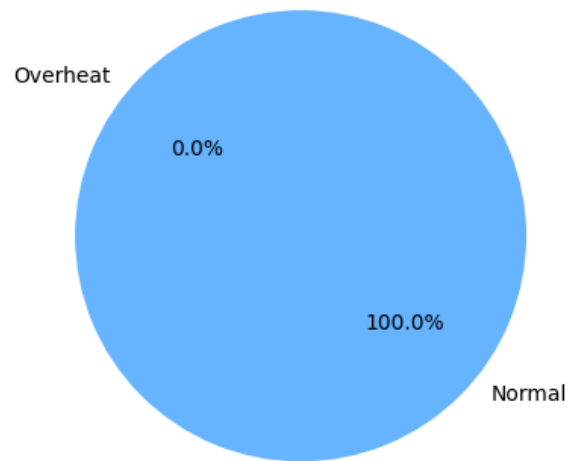
\* **\*\*Areas 1, 5, and 6:\*\*** show isolated high temperature readings (30-32°C) indicating potential localized delamination, possibly resulting from insufficient lamination pressure or vacuum. The sporadic nature suggests these aren't consistent across the entire panel.

\* **\*\*Areas 2 and 3:\*\*** show similar, although less pronounced, temperature anomalies around 30-31°C in specific cells. These could be indicative of minor cell imperfections or slight inconsistencies in the lamination process.

\* **\*\*Area 4:\*\*** shows the most concerning pattern, with a cluster of elevated temperatures reaching above 32°C. This suggests a more significant problem, possibly a more extensive crack or delamination, potentially resulting from excessive lamination pressure, high soldering temperature, or a combination of both.

\* **\*\*Lamination Pressure:\*\*** Potentially exceeded 100 N/cm<sup>2</sup> in area 4, leading to cell cracking or damage. In areas 1, 5, and 6, it might have been below the ideal 50-100 N/cm<sup>2</sup>, resulting in insufficient bonding and localized delamination.

1. **Visual Inspection:** Conduct a thorough visual inspection of the SolarBoard MAX30000, focusing on areas 1, 2, 3, 4, 5, and 6 identified in the thermal map. Look for cracks, delamination, or other physical defects. High-resolution photography or infrared imaging would be beneficial.
2. **Electroluminescence (EL) Testing:** Perform EL testing to identify any cell defects or micro-cracks that might not be visible to the naked eye. This will confirm the existence and extent of the suspected damage.
3. **Microscopic Analysis:** A microscopic inspection of the suspected damaged areas (especially area 4) is crucial to confirm the nature of the damage.

4. **\*\*Review Production Logs:\*\*** Examine the production logs for serial number 1234567890012 to verify the actual values for lamination pressure, temperature, soldering temperature, and cooling rate. Compare them to the ideal ranges.

5. **\*\*Process Optimization:\*\*** If the production parameters were outside the recommended ranges, adjust them to the ideal values to prevent similar defects in future production. Special attention should be paid to ensuring even lamination pressure across the entire panel.

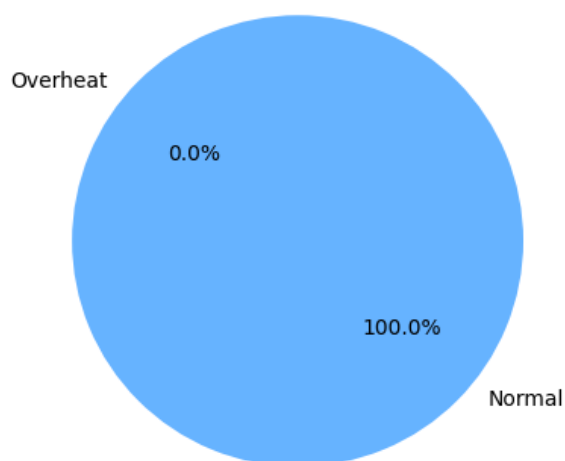
\* \*\*Area 1:\*\* Shows a localized hotspot of 31.41°C.

\* \*\*Area 2:\*\* Shows a localized hotspot of 31.72°C.

\* \*\*Area 3:\*\* Shows a localized hotspot of 31.6°C in the bottom row, and another possible one of 30.12°C near the bottom row.

\* \*\*Area 4:\*\* Shows a localized hotspot of 31.88°C.

\* \*\*Area 5:\*\* Shows a localized hotspot of 31.23°C.

\* \*\*Area 6:\*\* Shows localized hotspots of 31.58°C and 31.57°C.

These hotspots, exceeding the baseline temperature by 6-7°C, suggest potential problems during manufacturing or handling. The scattered nature of these hotspots across multiple areas argues against a single, large-scale issue and rather indicates localized problems.

Given the scattered hotspots and the lack of explicit crack detection in the YOLOv8 analysis, the most probable cause is localized stress during manufacturing, possibly in combination with minor handling damage. The hotspots are strongly suggestive of micro-cracks or delamination in the solar cells not visible in the provided images, resulting in slightly elevated temperatures in those specific areas.

1. **Visual Inspection with Magnification:** Conduct a thorough visual inspection of the SolarBoard using a microscope or magnifying glass, focusing on the areas indicated by the thermal sensors (areas 1-6). Look for micro-cracks, delamination, or any anomalies around the solder points.

2. **Electroluminescence (EL) Imaging:** Perform an EL test to visualize any micro-cracks or defects within the solar cells that are not readily visible.

3. **Review Manufacturing Log:** Examine the manufacturing log for serial number 63442000083 to verify the actual values of lamination pressure, lamination temperature, soldering temperature, cell stringing speed, and cooling rate during the production process. This will confirm or refute the suspected parameter issues.
