# Solar Panel Inspection Report

Reporting Period: 2025-06-25 11:29:22 to 2025-07-25 11:29:22

Inspection Line: Smart Conveyor Automated System

Total Panels: 4

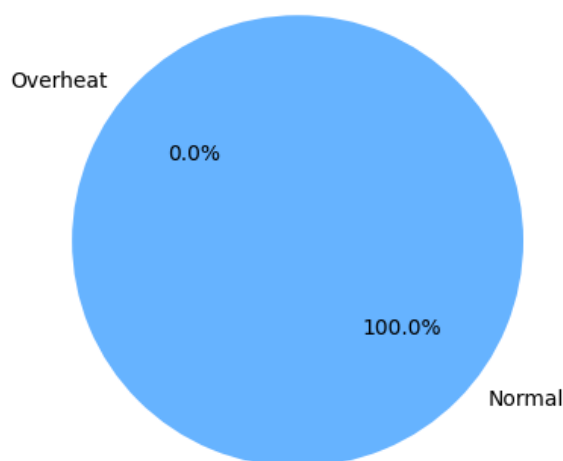
\* **Area 4:** Shows temperatures exceeding 30°C in several grid points, notably a peak of 31.54°C. This is a significant deviation from the surrounding temperatures (around 25-26°C), indicating a potential hotspot. The highest readings are clustered, hinting at a localized issue rather than a general overheating problem.

\* **Area 5:** Although less pronounced than Area 4, Area 5 also displays a localized hotspot reaching 31.77°C, suggesting a similar issue, potentially related to the same root cause. The presence of elevated temperatures in multiple grid points within this area supports this.

The localized hotspots in areas 4 and 5 strongly suggest issues related to cell bonding or soldering rather than widespread panel heating. Several production parameters could be implicated:

\* **Soldering Temperature:** The most likely culprit is a localized soldering issue. The hotspots in areas 4 and 5 may be due to uneven soldering temperature. It's possible that during the soldering process, these areas experienced a momentary spike in temperature exceeding 270°C, resulting in micro-cracks and creating localized high-resistance spots. A brief excursion above 270°C in specific areas could explain the observed thermal pattern without causing widespread damage.

1. **\*\*Visual Inspection:\*\*** Conduct a thorough visual inspection of areas 4 and 5 with a high-resolution camera and magnification, looking for micro-cracks or imperfections in the cell surface or solder joints. Infrared thermography would confirm the hotspots and their precise location.

2. **\*\*Electrical Testing:\*\*** Perform detailed electroluminescence (EL) imaging and I-V curve measurements to identify any cell defects or performance degradation associated with the hotspots. This will help quantify the impact of the localized issues.

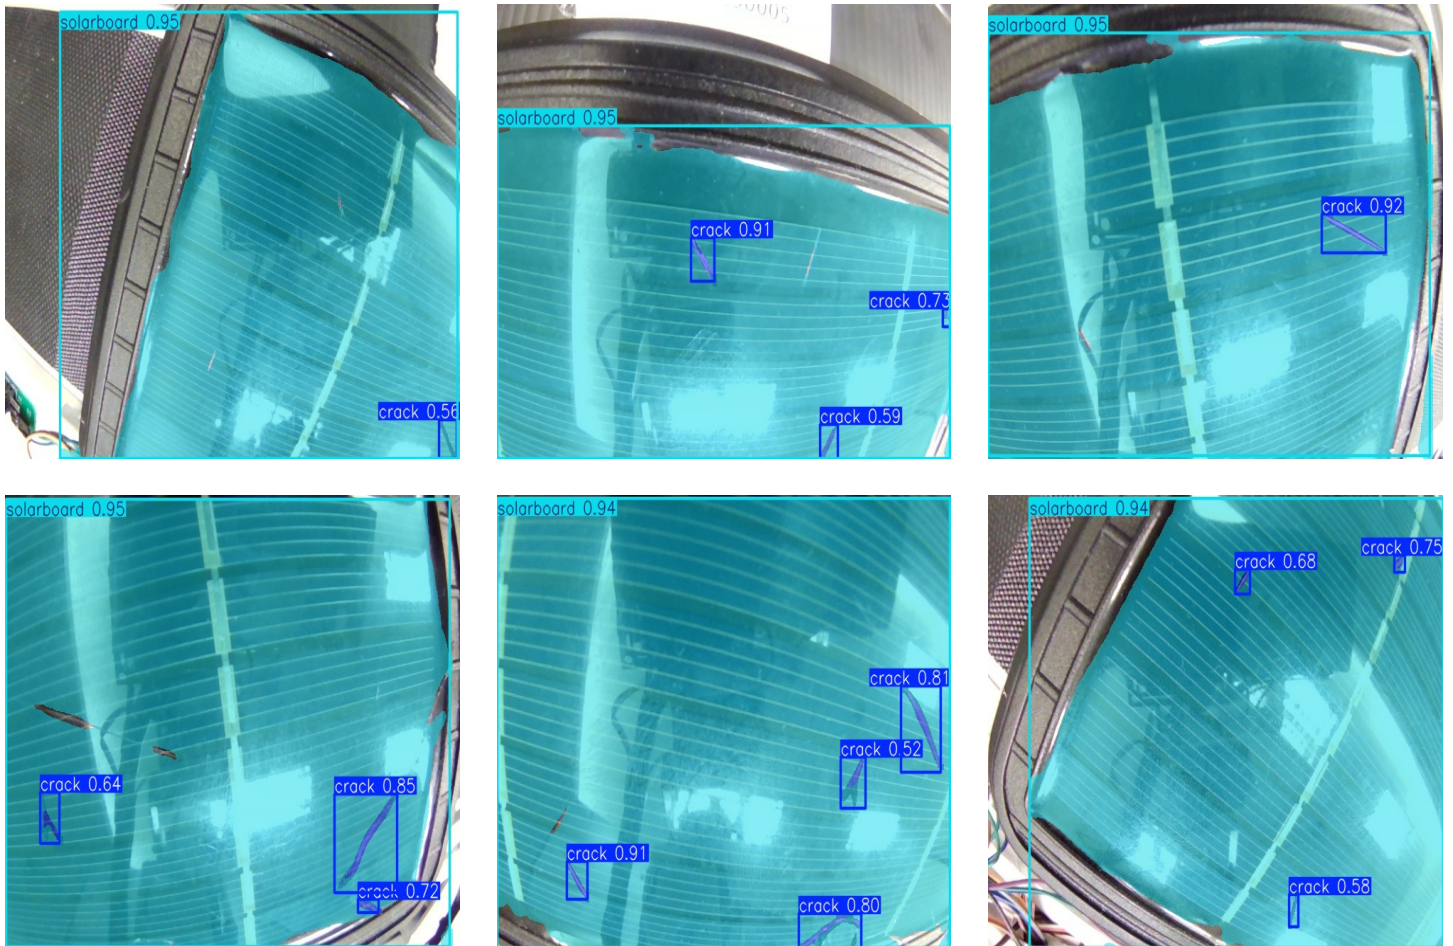
The YOLOv8 detection indicates a crack (confidence 0.64) in the solarboard. The relatively low confidence suggests the crack may be small or difficult to see in the images, warranting a closer visual inspection. The location of the crack (x=447, y=321 in image yolo\_1234567890005\_2\_1753172241.jpg) should be noted and compared to subsequent images for propagation.

\* **\*\*Excessive Lamination Pressure:\*\*** A crack is most frequently caused by the stress induced during the lamination process. A single small crack suggests localized high pressure rather than a global issue. This indicates that the lamination pressure might have exceeded the ideal range of 50-100 N/cm<sup>2</sup> at a specific point. Without further data, I cannot give an exact faulty value, but I estimate it to have briefly reached or exceeded 120 N/cm<sup>2</sup> in the region of the crack. This pressure point may have been caused by uneven pressure distribution from the laminator or imperfections in the laminate.

\* **\*\*Improper Handling:\*\*** The crack's size (9x23 pixels) also suggests that rough handling during manufacturing or transport could be responsible. A force exceeding 10N applied to a corner or edge could create such a fracture. This is possible, but less probable than a lamination issue due to the small size and location of the crack not being at an edge.

1. **\*\*Thorough Visual Inspection:\*\*** Conduct a detailed visual inspection of the solarboard to confirm the extent and nature of the crack. This will give more evidence for confirming the most likely culprit.

2. **\*\*Review Lamination Process Data:\*\*** Analyze the lamination pressure data from the specific batch and timeframe of production, looking for spikes or inconsistencies at the suspected point of pressure. Inspect the laminator rollers for damage or unevenness.

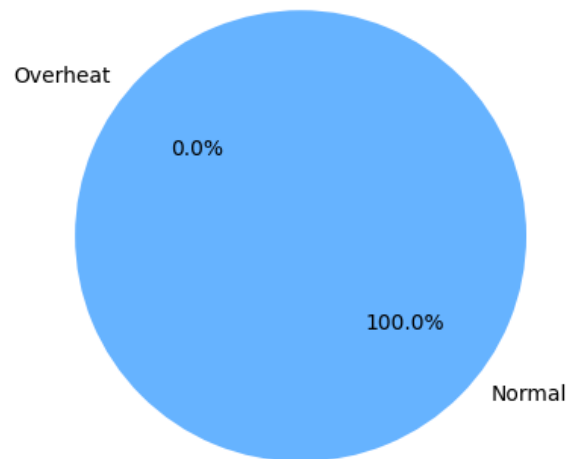
\* \*\*Area 1:\*\* Shows a localized hotspot of 31.41°C.

\* \*\*Area 2:\*\* Shows a localized hotspot of 31.72°C.

\* \*\*Area 3:\*\* Shows a localized hotspot of 31.6°C in the bottom row, and another possible one of 30.12°C near the bottom row.

\* \*\*Area 4:\*\* Shows a localized hotspot of 31.88°C.

\* \*\*Area 5:\*\* Shows a localized hotspot of 31.23°C.

\* \*\*Area 6:\*\* Shows localized hotspots of 31.58°C and 31.57°C.

These hotspots, exceeding the baseline temperature by 6-7°C, suggest potential problems during manufacturing or handling. The scattered nature of these hotspots across multiple areas argues against a single, large-scale issue and rather indicates localized problems.

Given the scattered hotspots and the lack of explicit crack detection in the YOLOv8 analysis, the most probable cause is localized stress during manufacturing, possibly in combination with minor handling damage. The hotspots are strongly suggestive of micro-cracks or delamination in the solar cells not visible in the provided images, resulting in slightly elevated temperatures in those specific areas.

1. **Visual Inspection with Magnification:** Conduct a thorough visual inspection of the SolarBoard using a microscope or magnifying glass, focusing on the areas indicated by the thermal sensors (areas 1-6). Look for micro-cracks, delamination, or any anomalies around the solder points.

2. **Electroluminescence (EL) Imaging:** Perform an EL test to visualize any micro-cracks or defects within the solar cells that are not readily visible.
