Solar Panel Inspection Report

Generated on: 2025-07-23 17:24:58

Inspection Line: Smart Conveyor Automated System

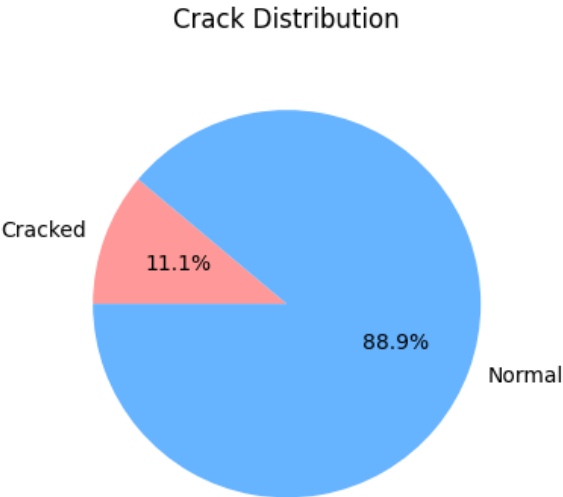
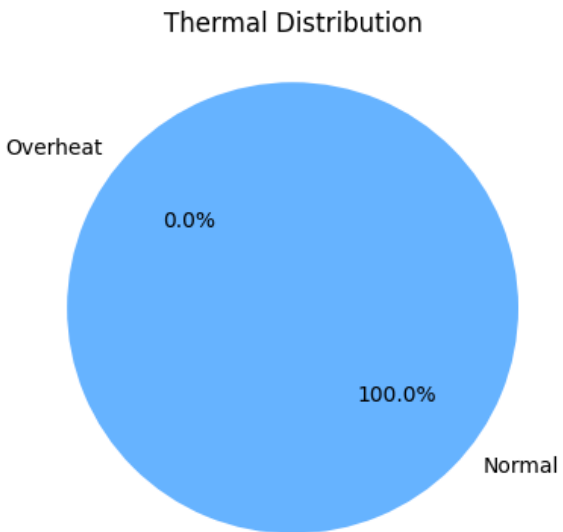
Overall Summary

Average Crack Rate: 11.11%

Average Overheat Rate: 0.00%

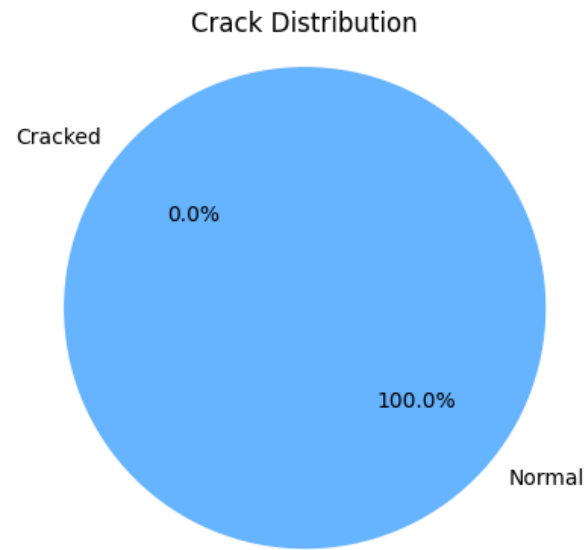
Panel Serial: 1234567890036

****Overall Assessment:**** The thermal data shows localized hotspots in areas 2, 4, and 5, exceeding the expected operating temperature of the cells. Coupled with the YOLOv8 detection showing multiple instances of "solarboard" with varying confidence levels, suggesting potential misalignment or overlapping panels, a comprehensive investigation is needed. This points toward likely manufacturing defects rather than field damage.

* ****Area 2:**** Elevated temperatures (up to 31.55°C) in a localized region. This suggests potential delamination or poor cell-to-cell contact in this section.

* ****Area 4:**** Similar to Area 2, with a hotspot reaching 31.35°C. This again points to a possible delamination, poor cell contact, or a localized manufacturing defect. The pattern also suggests potential misalignment of cells during stringing.

* ****Area 5:**** Hotspot reaching 31.72°C. This is the most significant hotspot and possibly indicates a combination of issues: delamination, poor cell contact, and potentially a manufacturing defect related to soldering or lamination process.

Scan Duration: 2025-07-22T16-47-00 to 2025-07-23T17-23-14
Total Scans: 3
Cracked Count: 0
Crack Rate: 0.00%

Scan Duration: 2025-07-22T16-47-00 to 2025-07-23T17-23-14
Total Data Points: 576
Overheated Points (>38°C): 0
Overheat Rate: 0.00%

lamination press. *Recommendation:* Investigate the lamination press for uneven pressure distribution. Calibrate the pressure sensors and ensure uniform pressure across the entire lamination area.

2. **Lamination Temperature:** While the average temperature is likely within the acceptable range, localized temperature variations during the lamination process might have occurred, resulting in inconsistent bonding. *Recommendation:* Check the uniformity of the lamination temperature profile. Ensure even heat distribution across the entire lamination surface by recalibrating the heating elements.

3. **Cell Stringing Speed:** The inconsistencies in YOLOv8 detections suggest potential misalignment of cells, implying potentially high stringing speed. *Recommendation:* Review and adjust the cell stringing speed to ensure proper cell alignment and prevent stress accumulation. Aim for the lower end of the recommended range (0.5-0.8 m/s).

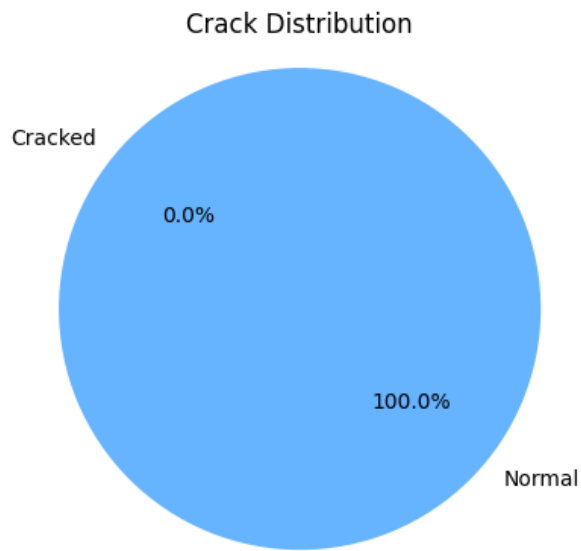
Panel Serial: 1234567890012

Scan Duration: 2025-07-22T15-22-43 to 2025-07-23T16-37-16
Total Scans: 2
Cracked Count: 0
Crack Rate: 0.00%

Scan Duration: 2025-07-22T15-22-43 to 2025-07-23T16-37-16
Total Data Points: 640
Overheated Points (>38°C): 0
Overheat Rate: 0.00%

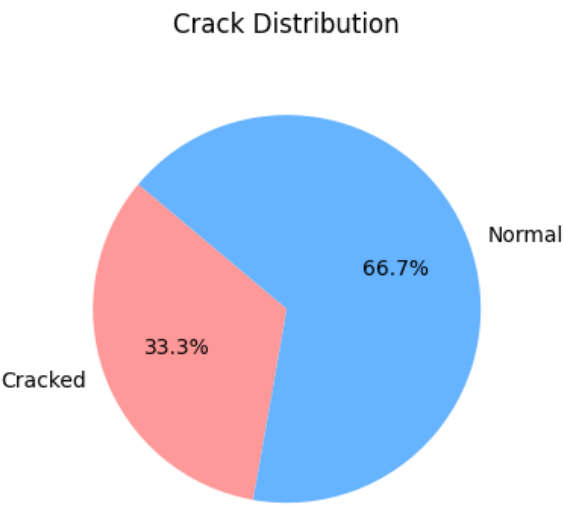
Panel Serial: 1234567890005

Scan Duration: 2025-07-22T16-17-03 to 2025-07-23T17-12-37
Total Scans: 3
Cracked Count: 1
Crack Rate: 33.33%

Scan Duration: 2025-07-22T16-17-03 to 2025-07-23T17-12-37
Total Data Points: 1152
Overheated Points (>38°C): 0
Overheat Rate: 0.00%

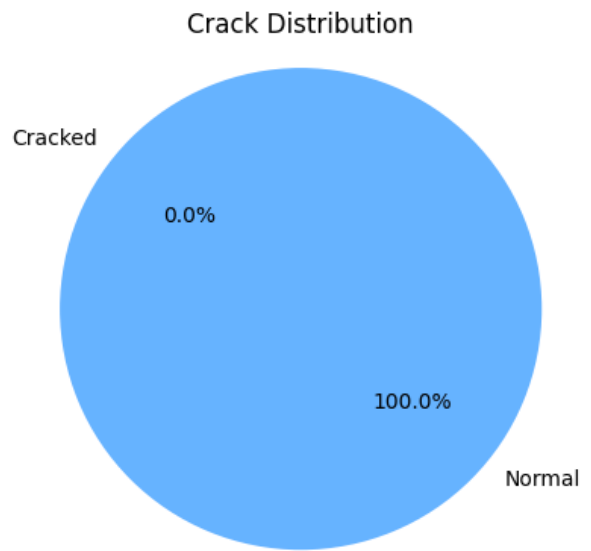
Panel Serial: 63442000083

Scan Duration: 2025-07-23T16-37-16 to 2025-07-23T16-37-16
Total Scans: 1
Cracked Count: 0
Crack Rate: 0.00%

Scan Duration: 2025-07-23T16-37-16 to 2025-07-23T16-37-16
Total Data Points: 384
Overheated Points (>38°C): 0
Overheat Rate: 0.00%
