Solar Panel Inspection Report

Reporting Period: 2025-06-25 11:41:46 to 2025-07-25 11:41:46

Inspection Line: Smart Conveyor Automated System

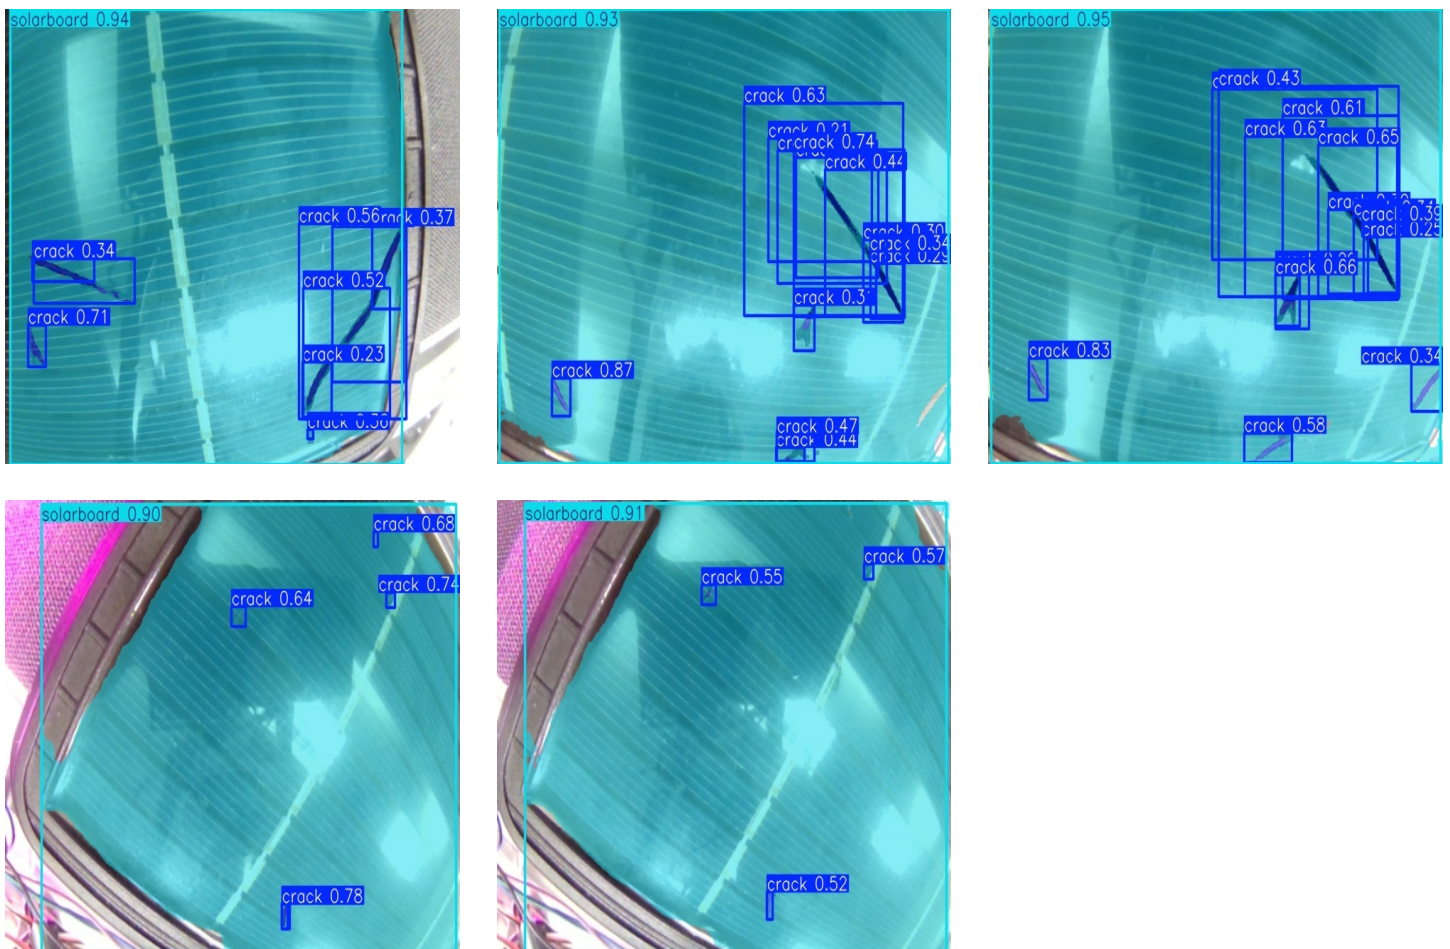
Panel Serial: 1234567890012

Summary: The thermal data reveals localized hotspots in areas 1, 2, 3, 4, 5, and 6, indicating potential

micro-cracks or delamination within the solar cells. The YOLOv8 detection shows the solar board itself is present in the images analyzed, ruling out complete board damage but not ruling out localized issues. These hotspots suggest issues during production, likely related to lamination or soldering processes.

* ****Areas 1, 5, and 6:**** show isolated high temperature readings (30-32°C) indicating potential localized delamination, possibly resulting from insufficient lamination pressure or vacuum. The sporadic nature suggests these aren't consistent across the entire panel.

* ****Areas 2 and 3:**** show similar, although less pronounced, temperature anomalies around 30-31°C in specific cells. These could be indicative of minor cell imperfections or slight inconsistencies in the lamination process.

* ****Area 4:**** shows the most concerning pattern, with a cluster of elevated temperatures reaching above 32°C. This suggests a more significant problem, possibly a more extensive crack or delamination, potentially resulting from excessive lamination pressure, high soldering temperature, or a combination of both.

* ****Lamination Pressure:**** Potentially exceeded 100 N/cm² in area 4, leading to cell cracking or damage. In areas 1, 5, and 6, it might have been below the ideal 50-100 N/cm², resulting in insufficient bonding and localized delamination.

* ****Soldering Temperature:**** While the thermal data doesn't directly indicate soldering issues, the hotspots in Area 4, showing the highest anomalies, **could** also be partly related to soldering temperature exceeding 270°C in localized areas, causing thermal stress fractures within cells.

1. **Visual Inspection:** Conduct a thorough visual inspection of the SolarBoard MAX30000, focusing on areas 1, 2, 3, 4, 5, and 6 identified in the thermal map. Look for cracks, delamination, or other physical defects. High-resolution photography or infrared imaging would be beneficial.
2. **Electroluminescence (EL) Testing:** Perform EL testing to identify any cell defects or micro-cracks that might not be visible to the naked eye. This will confirm the existence and extent of the suspected damage.
3. **Microscopic Analysis:** A microscopic inspection of the suspected damaged areas (especially area 4) is crucial to confirm the nature of the damage.

4. ****Review Production Logs:**** Examine the production logs for serial number 1234567890012 to verify the actual values for lamination pressure, temperature, soldering temperature, and cooling rate. Compare them to the ideal ranges.

5. ****Process Optimization:**** If the production parameters were outside the recommended ranges, adjust them to the ideal values to prevent similar defects in future production. Special attention should be paid to ensuring even lamination pressure across the entire panel.

6. ****Root Cause Analysis:**** Once the nature and extent of damage are confirmed, a more detailed root cause analysis needs to be performed to pinpoint the exact causes and to prevent recurrence. This might involve analyzing the thermal distribution in more detail and potentially involving experts in material science.

7. ****Repair or Replacement:**** Depending on the severity of the damage and the cost of repair vs. replacement, a decision needs to be made on whether to repair the board or replace it.
