Solar Panel Inspection Report

Generated on: 2025-07-23 16:33:03

Inspection Line: Smart Conveyor Automated System

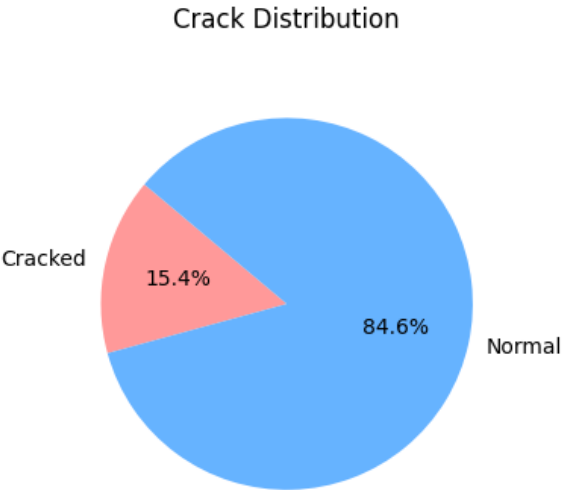
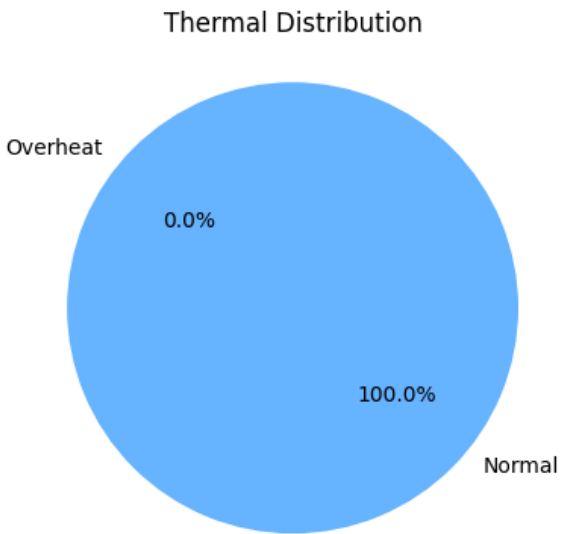
Average Crack Rate: 15.38%

Average Overheat Rate: 0.00%

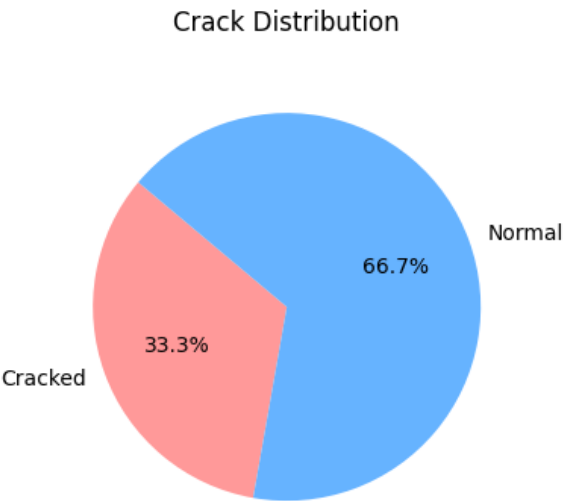
Scan Duration: 2025-06-29T15-20-46 to 2025-07-22T16-47-00
Total Scans: 3
Cracked Count: 1
Crack Rate: 33.33%
