Solar Panel Inspection Report

Generated on: 2025-07-23 16:08:41

Inspection Line: Smart Conveyor Automated System

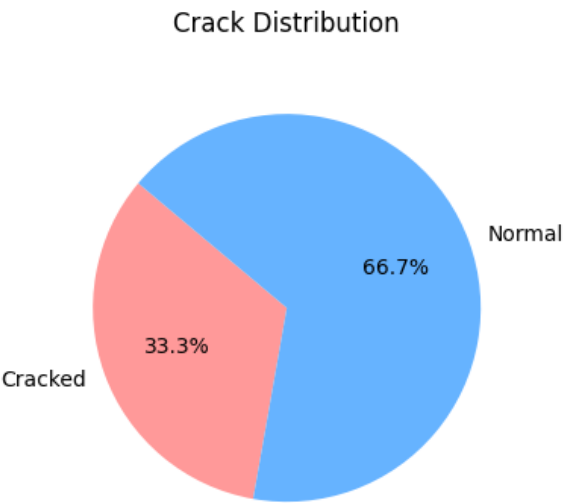
Panel Serial: 1234567890036

Scan Duration: 2025-07-22T15-14-21 to 2025-07-22T18-28-55
Total Scans: 9
Cracked Count: 3
Crack Rate: 33.33%

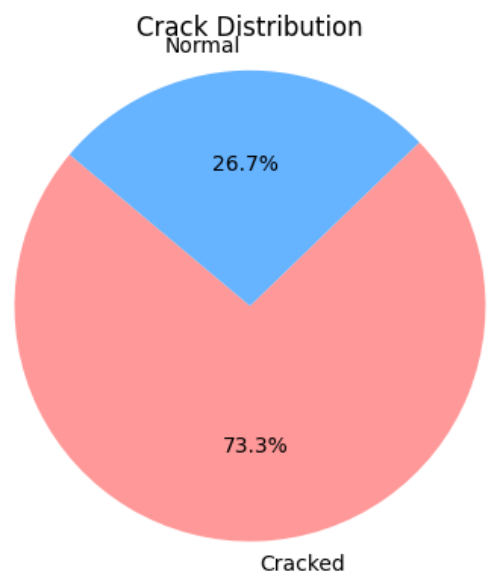
Panel Serial: 1234567890012

The YOLOv8 detection reveals a crack (22x14 pixels) detected with a confidence of 0.54 in one of the images. The relatively low confidence suggests the crack might be small or obscured, requiring visual inspection of the original images for confirmation and precise location. The size alone is insufficient to definitively determine the cause. However, we can analyze potential causes based on the available data and production parameters.

1. ****Excessive Lamination Pressure:**** A crack in a relatively small area points towards localized stress. If the lamination pressure exceeded the recommended 100 N/cm² (possibly reaching >120 N/cm²), it could have caused localized stress leading to a crack at a weak point in the cell or the laminate. This is a strong possibility considering the small size of the crack.

2. ****High Handling Force:**** A drop or impact during handling, exceeding the 10N threshold, could result in corner cracking. The location of the crack (reported at x=92, y=445) needs to be correlated to the solar panel's physical layout. If it's near a corner, this becomes a more likely scenario. The image analysis is crucial here.

Scan Duration: 2025-07-17T16-25-21 to 2025-07-22T18-28-55
Total Scans: 15
Cracked Count: 11
Crack Rate: 73.33%

1. ****Visual Inspection:**** Manually inspect the original images at high resolution to precisely locate and characterize the crack. Note its location relative to cell boundaries, corners, and other features.

2. ****Review Manufacturing Logs:**** Obtain and thoroughly review production logs for serial number 1234567890012, paying particular attention to the lamination pressure, temperature, cooling rate, and handling procedures. Focus on data from the relevant timestamp (2025-07-22T18-28-55).

3. ****Verify Cell Quality:**** Inspect the quality of the solar cells used in this panel *before* lamination, focusing on potential micro-cracks and other defects.

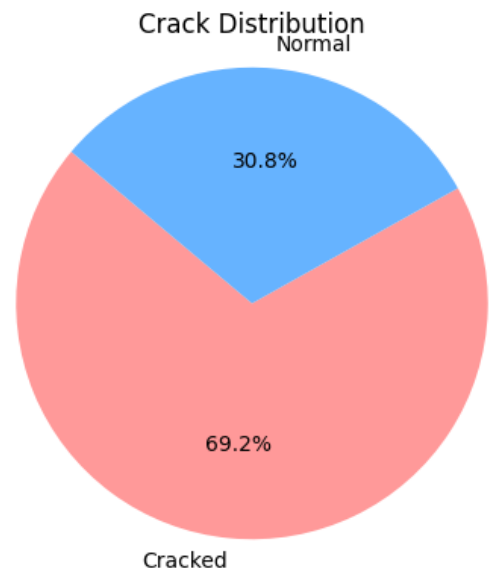
Panel Serial: 1234567890005

Scan Duration: 2025-07-21T14-41-33 to 2025-07-22T16-17-03
Total Scans: 13
Cracked Count: 9
Crack Rate: 69.23%
