# Solar Panel Inspection Report

Generated on: 2025-07-23 17:25:08

Inspection Line: Smart Conveyor Automated System

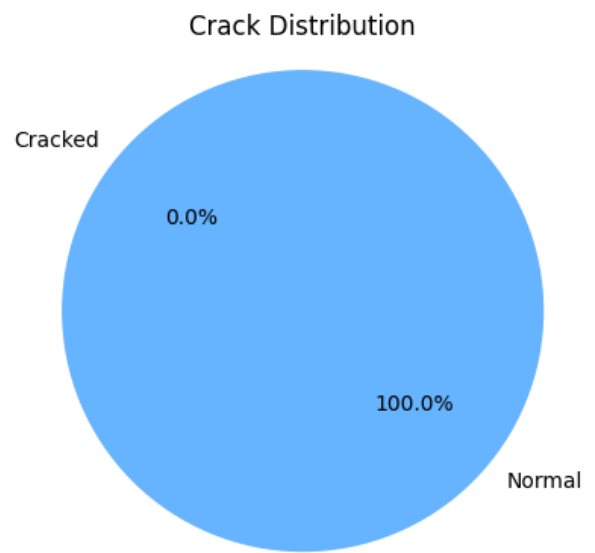
**Panel Serial: 1234567890036**

Scan Duration: 2025-07-23T16-37-16 to 2025-07-23T17-23-14  
Total Scans: 2  
Cracked Count: 0  
Crack Rate: 0.00%
