Solar Panel Inspection Report

Generated on: 2025-07-23 15:51:59

Inspection Line: Line 1

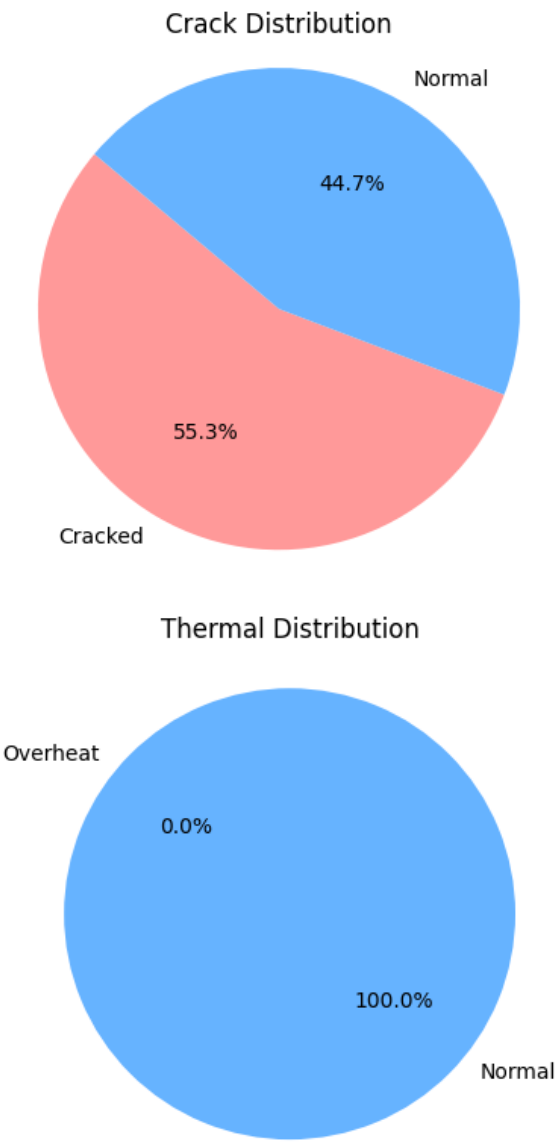
Serial Number: 1234567890012

The YOLOv8 detection reveals a crack (22x14 pixels) detected with a confidence of 0.54 in one of the images. The relatively low confidence suggests the crack might be small or obscured, requiring visual inspection of the original images for confirmation and precise location. The size alone is insufficient to definitively determine the cause. However, we can analyze potential causes based on the available data and production parameters.

1. ****Excessive Lamination Pressure:**** A crack in a relatively small area points towards localized stress. If the lamination pressure exceeded the recommended 100 N/cm² (possibly reaching >120 N/cm²), it could have caused localized stress leading to a crack at a weak point in the cell or the laminate. This is a strong possibility considering the small size of the crack.

2. ****High Handling Force:**** A drop or impact during handling, exceeding the 10N threshold, could result in corner cracking. The location of the crack (reported at x=92, y=445) needs to be correlated to the solar panel's physical layout. If it's near a corner, this becomes a more likely scenario. The image analysis is crucial here.

3. ****Thermal Stress during Lamination or Cooling:**** While a single small crack is less suggestive of widespread thermal damage, excessive lamination temperature (>160°C) or too rapid cooling (>5°C/min) could have contributed. This is less likely than excessive pressure or mishandling, but cannot be entirely ruled out without additional data.

4. ****Defective Cell:**** A pre-existing micro-crack in the solar cell itself could have been aggravated during the lamination process, regardless of the production parameter settings. This possibility highlights the need for rigorous quality control checks on individual cells **before** lamination.

1. ****Visual Inspection:**** Manually inspect the original images at high resolution to precisely locate and characterize the crack. Note its location relative to cell boundaries, corners, and other features.

2. ****Review Manufacturing Logs:**** Obtain and thoroughly review production logs for serial number 1234567890012, paying particular attention to the lamination pressure, temperature, cooling rate, and handling procedures. Focus on data from the relevant timestamp (2025-07-22T18-28-55).

3. ****Verify Cell Quality:**** Inspect the quality of the solar cells used in this panel *before* lamination, focusing on potential micro-cracks and other defects.

4. ****Adjust Production Parameters (if needed):**** If the review of logs reveals parameter values outside the recommended ranges, adjust them accordingly to prevent future occurrences. This requires a thorough analysis of the full dataset covering the production batch to which this panel belongs.

5. ****Improve Handling Procedures:**** Re-evaluate and improve handling procedures to minimize risks of damage during transportation and assembly.
6. ****Further Analysis:**** If the crack remains unexplained after reviewing the data, consider more advanced analyses like thermal imaging of the solar panel to detect stress points and material defects.
