Solar Panel Inspection Report

Generated on: 2025-07-23 16:35:51

Inspection Line: Smart Conveyor Automated System

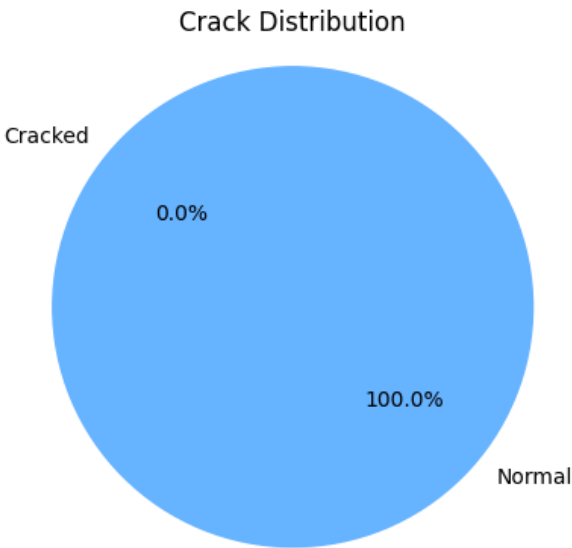
Panel Serial: 1234567890036

Scan Duration: 2025-07-22T16-47-00 to 2025-07-22T16-47-00
Total Scans: 1
Cracked Count: 0
Crack Rate: 0.00%

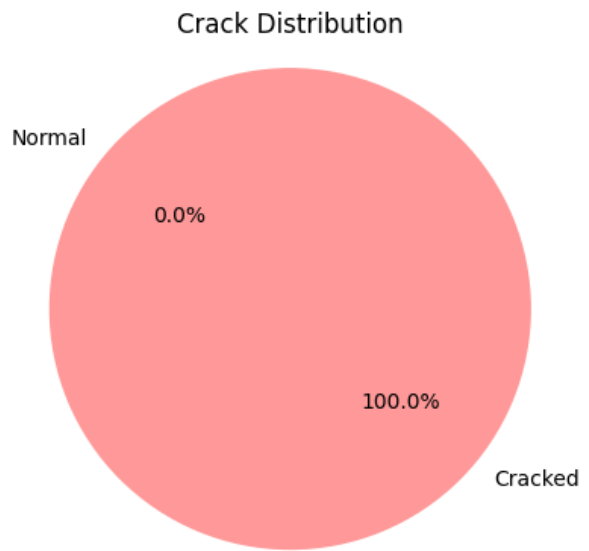
Panel Serial: 1234567890005

The YOLOv8 detection indicates a crack (confidence 0.64) in the solarboard. The relatively low confidence suggests the crack may be small or difficult to see in the images, warranting a closer visual inspection. The location of the crack (x=447, y=321 in image yolo_1234567890005_2_1753172241.jpg) should be noted and compared to subsequent images for propagation.

* ****Excessive Lamination Pressure:**** A crack is most frequently caused by the stress induced during the lamination process. A single small crack suggests localized high pressure rather than a global issue. This indicates that the lamination pressure might have exceeded the ideal range of 50-100 N/cm² at a specific point. Without further data, I cannot give an exact faulty value, but I estimate it to have briefly reached or exceeded 120 N/cm² in the region of the crack. This pressure point may have been caused by uneven pressure distribution from the laminator or imperfections in the laminate.

* ****High Soldering Temperature:**** Although less likely to cause a single small crack, it is possible that a localized high soldering temperature (above 270°C) near the crack location might have caused thermal stress leading to a fracture in the cell. This would need to be investigated with further analysis, comparing localized temperatures during soldering against the location of the crack.

* ****Improper Handling:**** The crack's size (9x23 pixels) also suggests that rough handling during manufacturing or transport could be responsible. A force exceeding 10N applied to a corner or edge could create such a fracture. This is possible, but less probable than a lamination issue due to the small size and location of the crack not being at an edge.

* ****Cell Thinness:**** If the cell thickness was closer to or below 150 µm, the fragility of the cell could increase and make it susceptible to cracking from lower forces than otherwise expected. This should be verified by

Scan Duration: 2025-07-22T16-17-03 to 2025-07-22T16-17-03
Total Scans: 1
Cracked Count: 1
Crack Rate: 100.00%

1. **Thorough Visual Inspection:** Conduct a detailed visual inspection of the solarboard to confirm the extent and nature of the crack. This will give more evidence for confirming the most likely culprit.

2. **Review Lamination Process Data:** Analyze the lamination pressure data from the specific batch and timeframe of production, looking for spikes or inconsistencies at the suspected point of pressure. Inspect the laminator rollers for damage or unevenness.

3. **Check Soldering Profile:** Examine the soldering temperature profile for the affected cell string. Look for any outliers or deviations from the ideal range.

4. **Material Analysis:** Consider micro-examination of the cracked area to check for any material defects or micro-fractures present prior to lamination.

5. **Review Handling Procedures:** Evaluate the handling procedures throughout the manufacturing and shipping processes to identify areas where improvement can prevent damage. Ensure that all handling guidelines are being followed.

6. **Cell Thickness Verification:** Verify the cell thickness used in this specific board against the design and

7. **Preventative Measures:** Implement stricter quality control measures and monitoring of the identified potential risk factors, particularly lamination pressure. Calibration and maintenance of the lamination equipment should be performed at regular intervals.
