Solar Panel Inspection Report

Generated on: 2025-07-23 17:25:03

Inspection Line: Smart Conveyor Automated System

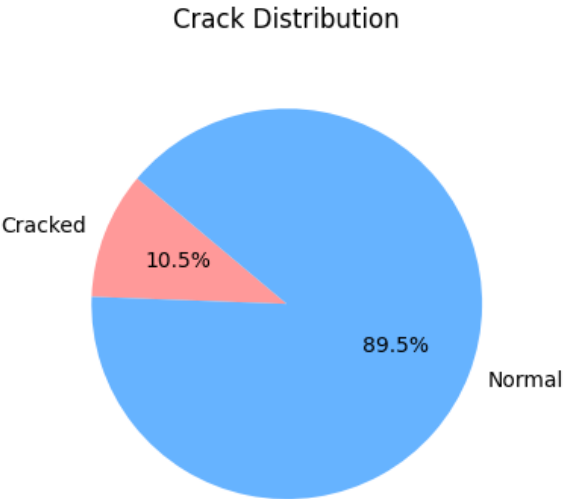
Overall Summary

Average Crack Rate: 10.53%

Average Overheat Rate: 0.00%

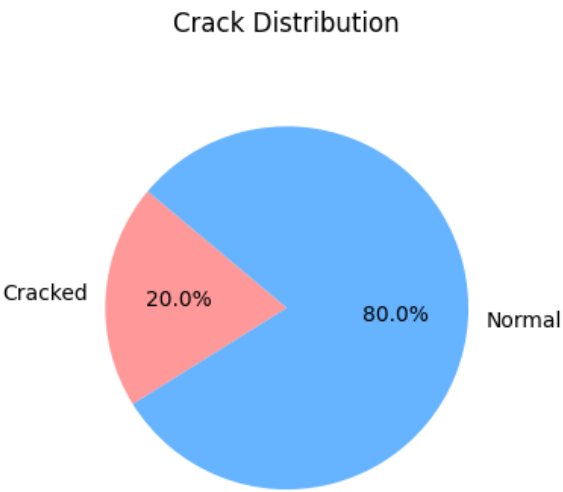
Panel Serial: 1234567890036

Scan Duration: 2025-06-29T15-20-46 to 2025-07-23T17-23-14
Total Scans: 5
Cracked Count: 1
Crack Rate: 20.00%

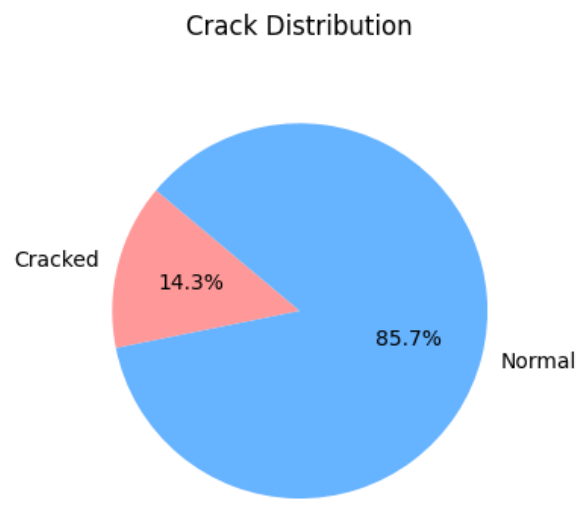
Panel Serial: 1234567890005

Scan Duration: 2025-06-29T17-17-07 to 2025-07-23T17-12-37
Total Scans: 7
Cracked Count: 1
Crack Rate: 14.29%
