# Solar Panel Inspection Report

Reporting Period: 2025-06-24 23:31:00 to 2025-07-24 23:31:00

Inspection Line: Smart Conveyor Automated System

## Panel Serial: 1234567890036

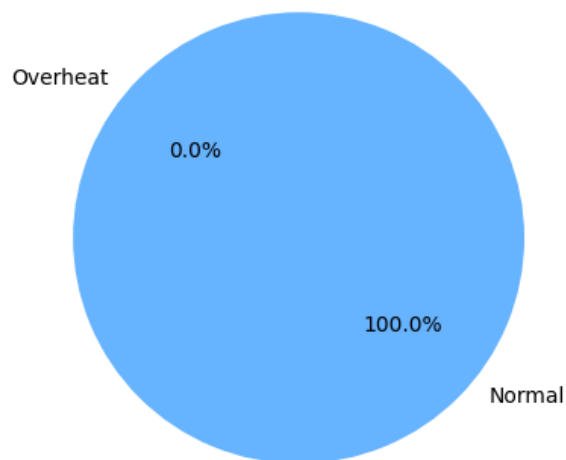
Thermal Distribution

Overheated Points (>38°C): 0

Overheat Rate: 0.00%

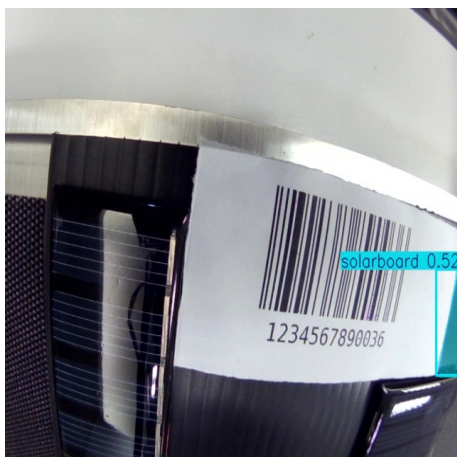
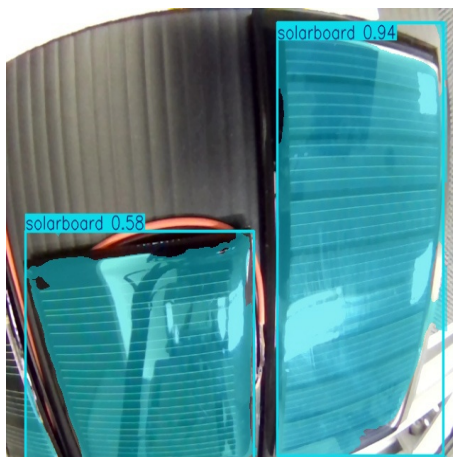
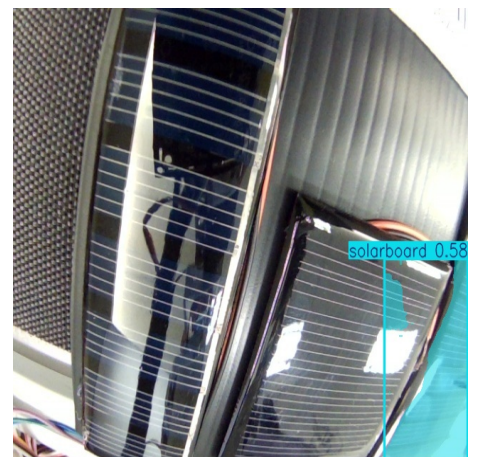
### Panel Images:

**\*\*Overall Assessment:\*\*** The thermal data shows localized hotspots in areas 2, 4, and 5, exceeding the expected operating temperature of the cells. Coupled with the YOLOv8 detection showing multiple instances of "solarboard" with varying confidence levels, suggesting potential misalignment or overlapping panels, a comprehensive investigation is needed. This points toward likely manufacturing defects rather than field damage.

\* **\*\*Area 2:\*\*** Elevated temperatures (up to 31.55°C) in a localized region. This suggests potential delamination or poor cell-to-cell contact in this section.

\* **\*\*Area 4:\*\*** Similar to Area 2, with a hotspot reaching 31.35°C. This again points to a possible delamination, poor cell contact, or a localized manufacturing defect. The pattern also suggests potential misalignment of cells during stringing.

\* **\*\*Area 5:\*\*** Hotspot reaching 31.72°C. This is the most significant hotspot and possibly indicates a combination of issues: delamination, poor cell contact, and potentially a manufacturing defect related to soldering or lamination process.

The multiple detections of "solarboard" in each image with varying confidence scores suggests potential issues with panel alignment and/or overlapping components during the lamination process. Lower confidence scores (0.65, 0.79, 0.82) indicate possible misalignment or partial obscuring of panels, confirming the thermal data's suggestion of manufacturing defects.

1. **Lamination Pressure:** The hotspots suggest insufficient pressure in certain areas, leading to incomplete bonding and delamination. This could be due to inconsistent pressure distribution across the lamination press. **Recommendation:** Investigate the lamination press for uneven pressure distribution. Calibrate the pressure sensors and ensure uniform pressure across the entire lamination area.

2. **Lamination Temperature:** While the average temperature is likely within the acceptable range, localized temperature variations during the lamination process might have occurred, resulting in inconsistent bonding. **Recommendation:** Check the uniformity of the lamination temperature profile. Ensure even heat distribution across the entire lamination surface by recalibrating the heating elements.

3. **Cell Stringing Speed:** The inconsistencies in YOLOv8 detections suggest potential misalignment of cells, implying potentially high stringing speed. **Recommendation:** Review and adjust the cell stringing speed to ensure proper cell alignment and prevent stress accumulation. Aim for the lower end of the recommended range (0.5-0.8 m/s).

4. **Handling Force:** The corners of the panels might have been subjected to excessive force during handling, potentially causing micro-cracks. **Recommendation:** Review the handling procedures to minimize force applied during transport and assembly. Implement better packaging to prevent damage during shipping and handling.

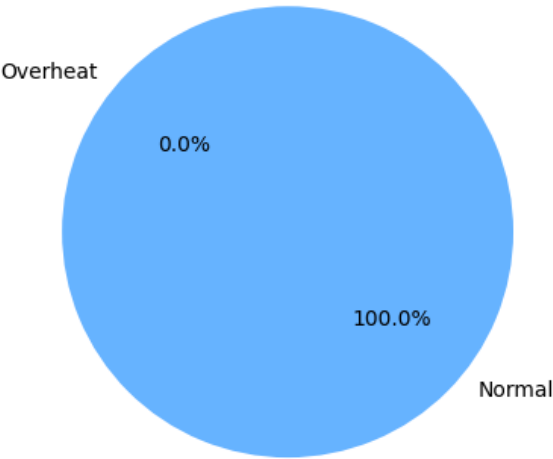
Thermal Distribution

The thermal grids show several areas with temperatures significantly above the baseline (approximately 25°C). Noteworthy hotspots are:

\* **Area 1 (Row 8, Column 2):** 30.78°C and 31.79°C

\* **Area 2 (Row 3, Column 7):** 31.18°C

\* **Area 2 (Row 4, Column 4):** 31.61°C

\* **Area 2 (Row 4, Column 7):** 31.83°C

\* **Area 3 (Row 6, Column 1):** 30.99°C

\* **Area 3 (Row 7, Column 7):** 31.94°C

\* **Area 4 (Row 2, Column 5):** 31.65°C

\* **Area 4 (Row 3, Column 5):** 30.49°C

\* **Area 4 (Row 4, Column 4):** 30.6°C

\* **Area 5 (Row 1, Column 2):** 31.85°C

\* **Area 5 (Row 5, Column 8):** 31.67°C

\* **Area 5 (Row 8, Column 3):** 31.22°C

\* **Area 6 (Row 1, Column 5):** 31.09°C

\* **Area 6 (Row 2, Column 8):** 31.14°C

\* **Area 6 (Row 3, Column 1):** 30.07°C

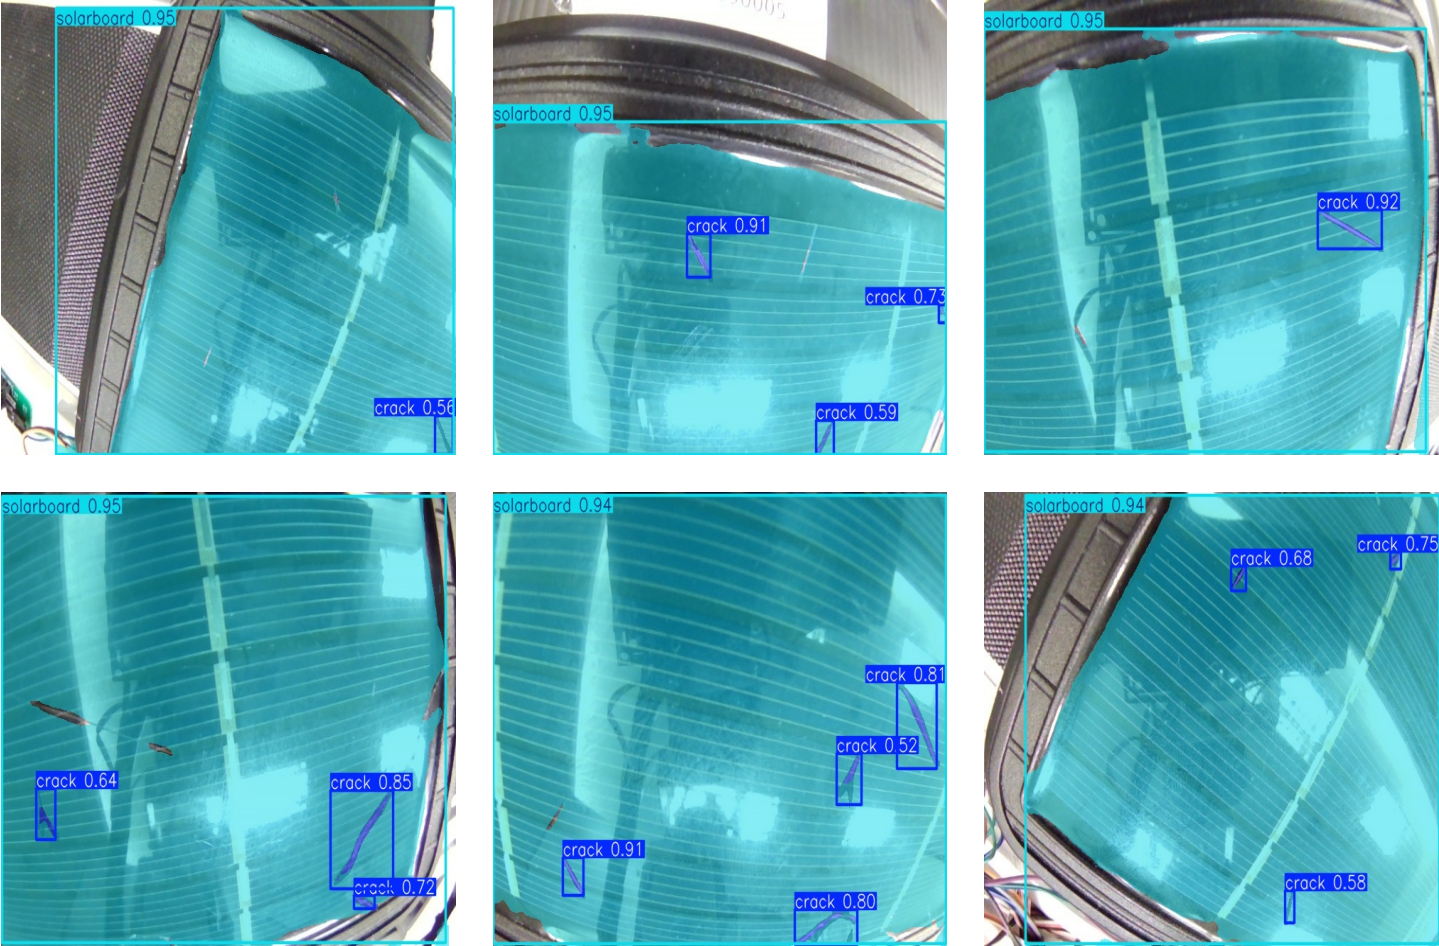
Panel Images:

temperature range, primarily concentrated in areas 1, 2, 3, 5, and 6. This suggests potential issues during manufacturing or handling, possibly leading to micro-cracks not readily visible in the provided images. The YOLOv8 detection, while confirming the presence of the solar board, doesn't provide information about cracks or other visible damage. Further visual inspection with higher resolution is required.

\* **Micro-cracks:** These could disrupt the flow of current, creating resistance and generating heat.

\* **Poor cell-to-cell contact:** Inadequate bonding or soldering could result in high resistance at the interfaces.

\* **Manufacturing Defects:** Imperfect lamination or soldering could cause localized stress points that lead to heating.

1. **\*\*Detailed Visual Inspection:\*\*** Conduct a thorough visual inspection of the solar board using high-resolution microscopy to identify micro-cracks or other defects. Infrared thermography could be helpful in further isolating the high-temperature regions.

2. **\*\*Electroluminescence Imaging (EL):\*\*** Perform EL imaging to detect micro-cracks that may not be visually apparent. This would clearly show areas with poor current flow.
