Solar Panel Inspection Report

Reporting Period: 2025-06-25 01:42:43 to 2025-07-25 01:42:43

Generated on: 2025-07-25 01:42:49

Inspection Line: Smart Conveyor Automated System

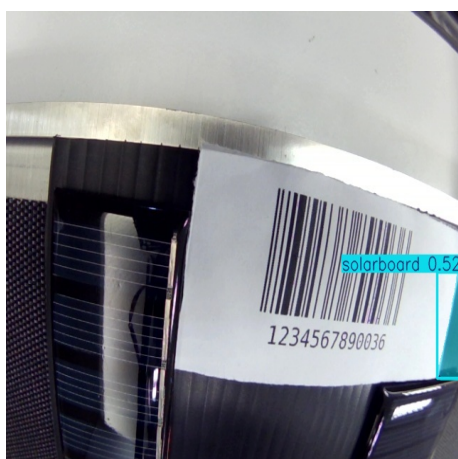
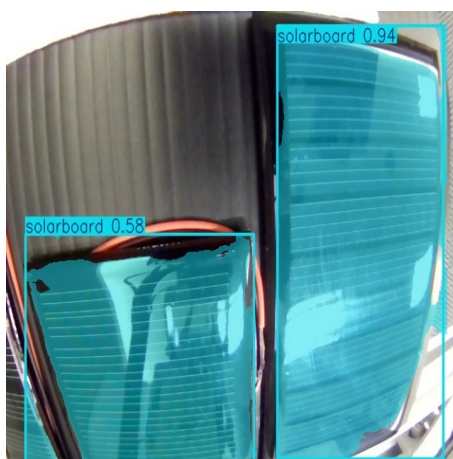
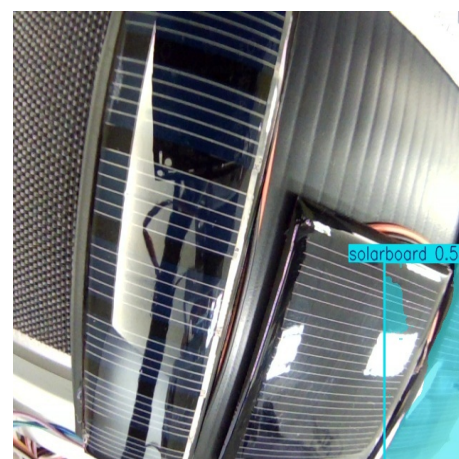
Panel Images:

****Overall Assessment:**** The thermal data shows localized hotspots in areas 2, 4, and 5, exceeding the expected operating temperature of the cells. Coupled with the YOLOv8 detection showing multiple instances of "solarboard" with varying confidence levels, suggesting potential misalignment or overlapping panels, a comprehensive investigation is needed. This points toward likely manufacturing defects rather than field damage.

* ****Area 2:**** Elevated temperatures (up to 31.55°C) in a localized region. This suggests potential

delamination or poor cell-to-cell contact in this section.

* **Area 4:** Similar to Area 2, with a hotspot reaching 31.35°C. This again points to a possible delamination, poor cell contact, or a localized manufacturing defect. The pattern also suggests potential misalignment of cells during stringing.

* **Area 5:** Hotspot reaching 31.72°C. This is the most significant hotspot and possibly indicates a combination of issues: delamination, poor cell contact, and potentially a manufacturing defect related to soldering or lamination process.

The multiple detections of "solarboard" in each image with varying confidence scores suggests potential issues with panel alignment and/or overlapping components during the lamination process. Lower confidence scores (0.65, 0.79, 0.82) indicate possible misalignment or partial obscuring of panels, confirming the thermal data's suggestion of manufacturing defects.

1. **Lamination Pressure:** The hotspots suggest insufficient pressure in certain areas, leading to incomplete bonding and delamination. This could be due to inconsistent pressure distribution across the lamination press. **Recommendation:** Investigate the lamination press for uneven pressure distribution. Calibrate the pressure sensors and ensure uniform pressure across the entire lamination area.

2. **Lamination Temperature:** While the average temperature is likely within the acceptable range, localized temperature variations during the lamination process might have occurred, resulting in inconsistent bonding. **Recommendation:** Check the uniformity of the lamination temperature profile. Ensure even heat distribution across the entire lamination surface by recalibrating the heating elements.

3. **Cell Stringing Speed:** The inconsistencies in YOLOv8 detections suggest potential misalignment of cells, implying potentially high stringing speed. **Recommendation:** Review and adjust the cell stringing

speed to ensure proper cell alignment and prevent stress accumulation. Aim for the lower end of the recommended range (0.5-0.8 m/s).

4. **Handling Force:** The corners of the panels might have been subjected to excessive force during handling, potentially causing micro-cracks. **Recommendation:** Review the handling procedures to minimize force applied during transport and assembly. Implement better packaging to prevent damage during shipping and handling.

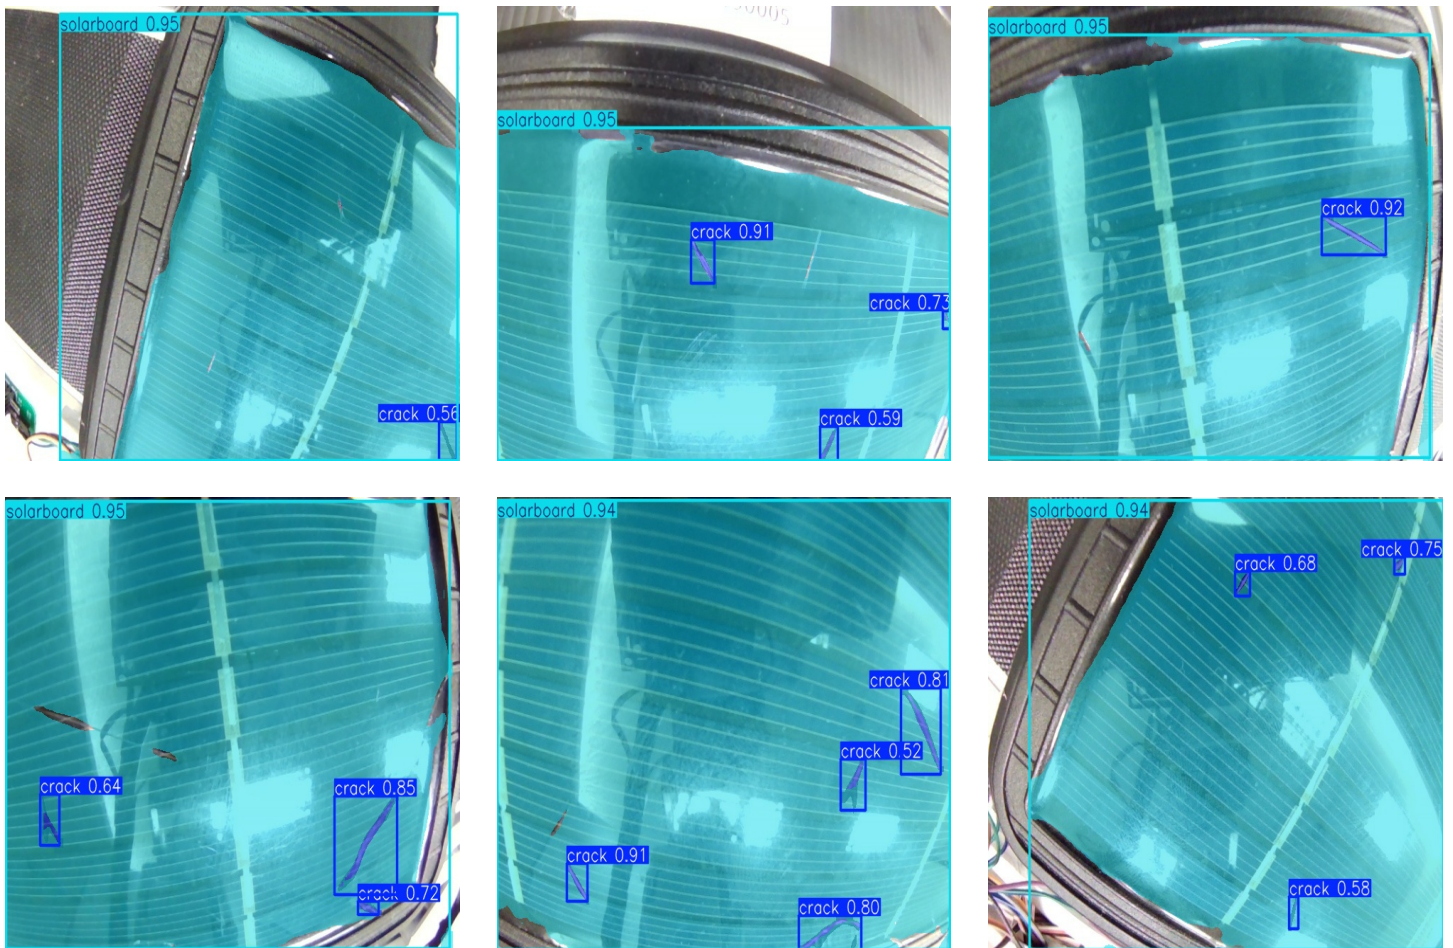
Panel Images:

Summary: The thermal data reveals multiple localized hotspots exceeding the expected operating

temperature range, primarily concentrated in areas 1, 2, 3, 5, and 6. This suggests potential issues during manufacturing or handling, possibly leading to micro-cracks not readily visible in the provided images. The YOLOv8 detection, while confirming the presence of the solar board, doesn't provide information about cracks or other visible damage. Further visual inspection with higher resolution is required.

- * ****Area 1 (Row 8, Column 2):**** 30.78°C and 31.79°C
- * ****Area 2 (Row 3, Column 7):**** 31.18°C
- * ****Area 2 (Row 4, Column 4):**** 31.61°C
- * ****Area 2 (Row 4, Column 7):**** 31.83°C
- * ****Area 3 (Row 6, Column 1):**** 30.99°C
- * ****Area 3 (Row 7, Column 7):**** 31.94°C
- * ****Area 4 (Row 2, Column 5):**** 31.65°C
- * ****Area 4 (Row 3, Column 5):**** 30.49°C
- * ****Area 4 (Row 4, Column 4):**** 30.6°C
- * ****Area 5 (Row 1, Column 2):**** 31.85°C
- * ****Area 5 (Row 5, Column 8):**** 31.67°C
- * ****Area 5 (Row 8, Column 3):**** 31.22°C
- * ****Area 6 (Row 1, Column 5):**** 31.09°C
- * ****Area 6 (Row 2, Column 8):**** 31.14°C
- * ****Area 6 (Row 3, Column 1):**** 30.07°C

These elevated temperatures point to localized heating, possibly due to:

- * ****Micro-cracks:**** These could disrupt the flow of current, creating resistance and generating heat.
- * ****Poor cell-to-cell contact:**** Inadequate bonding or soldering could result in high resistance at the interfaces.
- * ****Manufacturing Defects:**** Imperfect lamination or soldering could cause localized stress points that lead to heating.

* ****Lamination Pressure:**** Possibly exceeded the ideal range (50-100 N/cm²). The clustering of hotspots suggests inconsistent pressure during lamination, possibly exceeding 120 N/cm² in certain areas leading to micro-cracks.

* ****Soldering Temperature:**** Potentially exceeded the safe range (240-260°C). Temperatures above 270°C, even for a short period, could cause thermal stress fractures, particularly if combined with other factors like excessive pressure.

* ****Cooling Rate post-lamination:**** May have exceeded the recommended rate (1-3°C/min), leading to thermal mismatch and stress within the cells. A cooling rate over 5°C/min is suspected in several areas.

1. ****Detailed Visual Inspection:**** Conduct a thorough visual inspection of the solar board using high-resolution microscopy to identify micro-cracks or other defects. Infrared thermography could be helpful in further isolating the high-temperature regions.

2. ****Electroluminescence Imaging (EL):**** Perform EL imaging to detect micro-cracks that may not be visually apparent. This would clearly show areas with poor current flow.

3. ****Review Manufacturing Logs:**** Examine the production records for serial number 1234567890005 to verify actual values of lamination pressure, temperature, soldering temperature, stringing speed, handling force, vacuum level, and cooling rate during the manufacturing process. Compare these values against the ideal ranges outlined above.

4. ****Root Cause Analysis:**** Based on the visual inspection and manufacturing logs, conduct a root cause analysis to identify the exact reasons for the anomalies.

5. ****Process Improvement:**** If the root cause involves deviations from ideal manufacturing parameters, implement corrective actions to ensure future production runs meet the required specifications. This might include adjustments to equipment calibration, operator training, or process optimization.
