Solar Panel Inspection Report

Reporting Period: 2025-06-25 11:22:03 to 2025-07-25 11:22:03

Inspection Line: Smart Conveyor Automated System

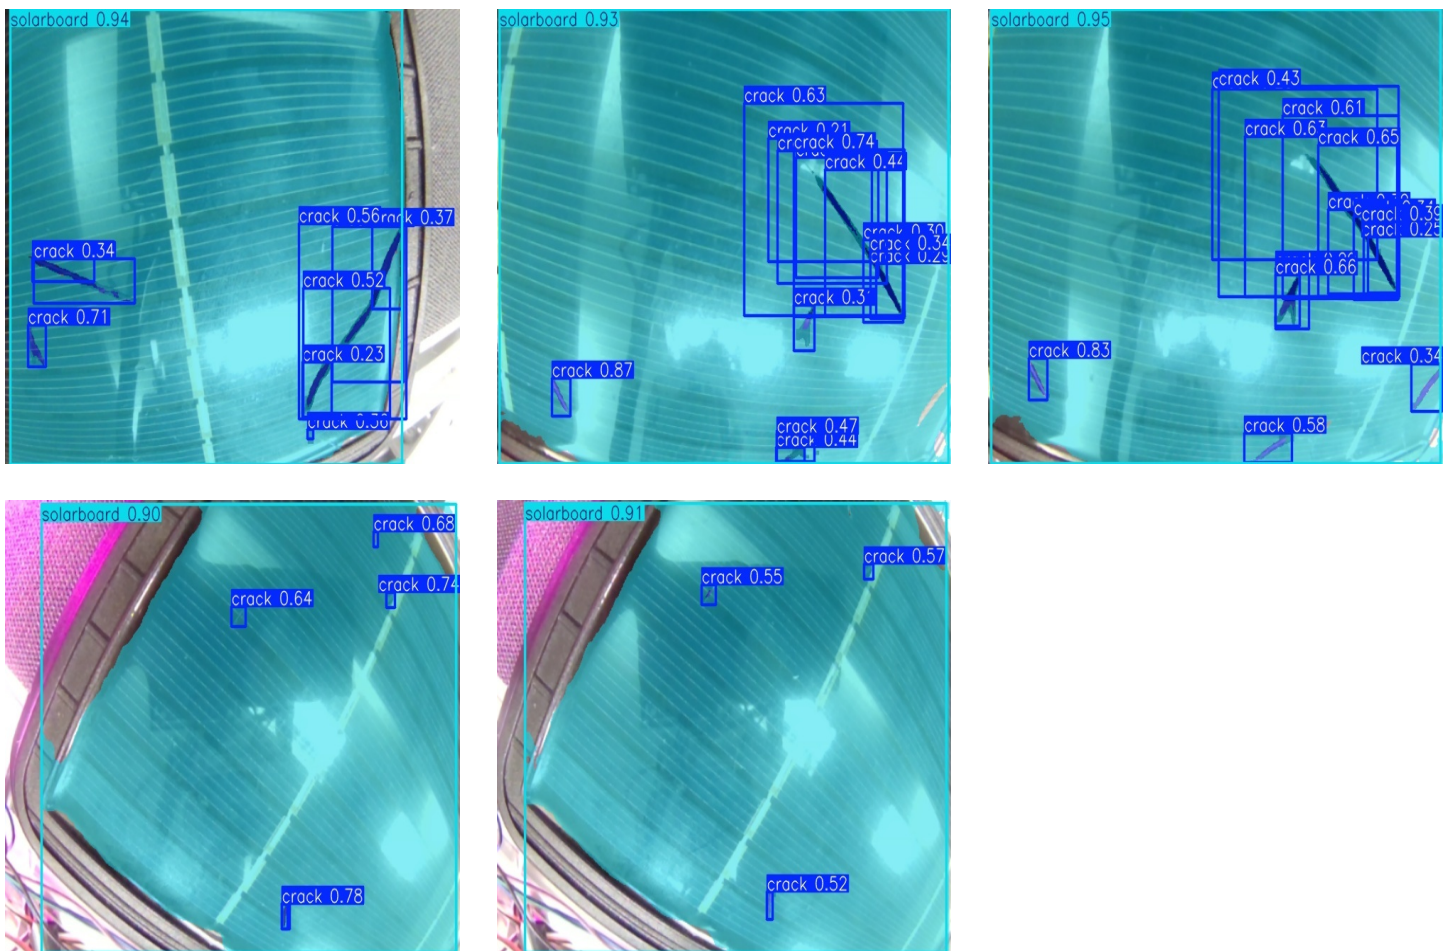
Panel Serial: 1234567890012

****Summary:**** The thermal data reveals localized hotspots in areas 1, 2, 3, 4, 5, and 6, indicating potential

micro-cracks or delamination within the solar cells. The YOLOv8 detection shows the solar board itself is present in the images analyzed, ruling out complete board damage but not ruling out localized issues. These hotspots suggest issues during production, likely related to lamination or soldering processes.

* ****Areas 1, 5, and 6:**** show isolated high temperature readings (30-32°C) indicating potential localized delamination, possibly resulting from insufficient lamination pressure or vacuum. The sporadic nature suggests these aren't consistent across the entire panel.

* ****Areas 2 and 3:**** show similar, although less pronounced, temperature anomalies around 30-31°C in specific cells. These could be indicative of minor cell imperfections or slight inconsistencies in the lamination process.

* ****Area 4:**** shows the most concerning pattern, with a cluster of elevated temperatures reaching above 32°C. This suggests a more significant problem, possibly a more extensive crack or delamination, potentially resulting from excessive lamination pressure, high soldering temperature, or a combination of both.

* ****Lamination Pressure:**** Potentially exceeded 100 N/cm² in area 4, leading to cell cracking or damage. In areas 1, 5, and 6, it might have been below the ideal 50-100 N/cm², resulting in insufficient bonding and localized delamination.

* ****Soldering Temperature:**** While the thermal data doesn't directly indicate soldering issues, the hotspots in Area 4, showing the highest anomalies, **could** also be partly related to soldering temperature exceeding 270°C in localized areas, causing thermal stress fractures within cells.

- Visual Inspection:** Conduct a thorough visual inspection of the SolarBoard MAX30000, focusing on areas 1, 2, 3, 4, 5, and 6 identified in the thermal map. Look for cracks, delamination, or other physical defects. High-resolution photography or infrared imaging would be beneficial.
- Electroluminescence (EL) Testing:** Perform EL testing to identify any cell defects or micro-cracks that might not be visible to the naked eye. This will confirm the existence and extent of the suspected damage.
- Microscopic Analysis:** A microscopic inspection of the suspected damaged areas (especially area 4) is crucial to confirm the nature of the damage.

5. ****Process Optimization:**** If the production parameters were outside the recommended ranges, adjust them to the ideal values to prevent similar defects in future production. Special attention should be paid to ensuring even lamination pressure across the entire panel.
