Calibration Report on Brewers #033, #157, #183, #185 at Izaña – Aug. 28-Sept. 6, 2009

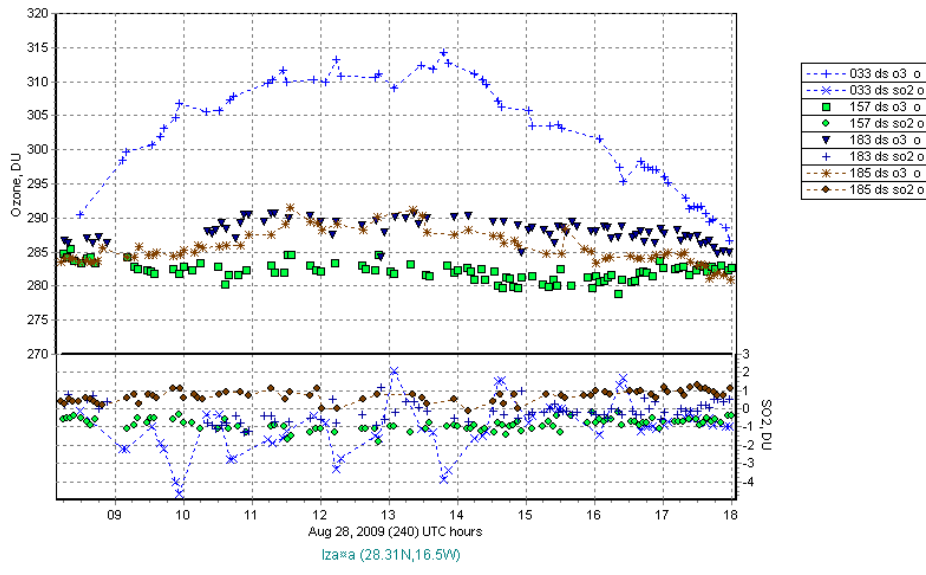
Below is graph of the ozone/SO₂ results without any corrections from the 4 local instruments on the day before this visit. #033 showed the greatest differences and #185 had higher ozone results than normal when compared to the very stable #157 instrument.

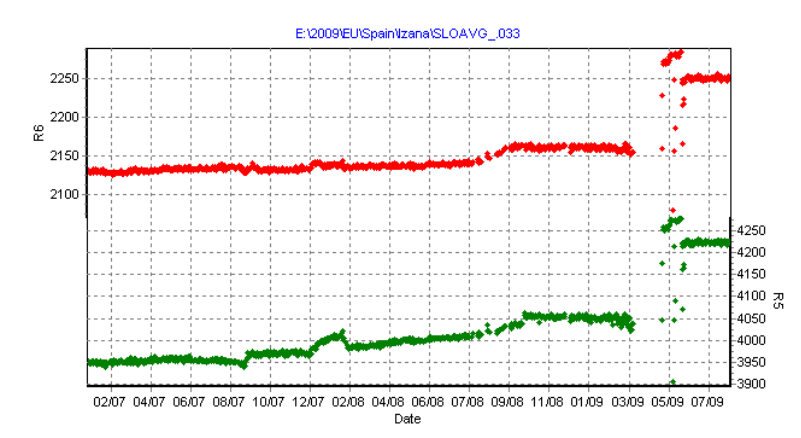
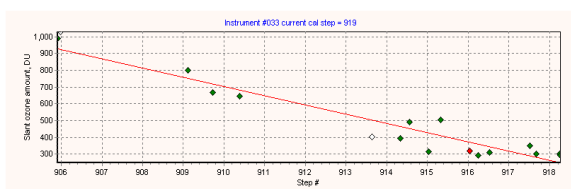
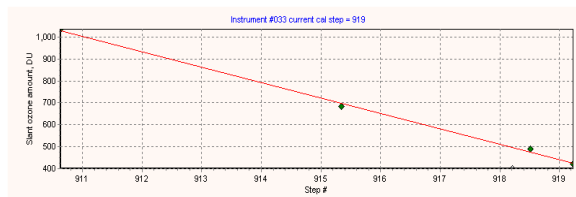
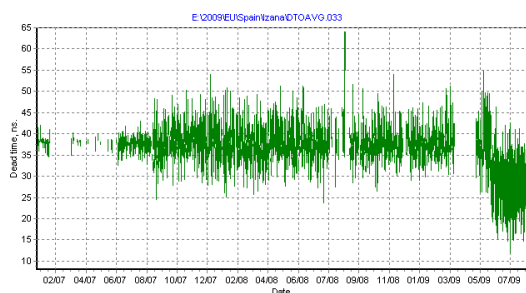
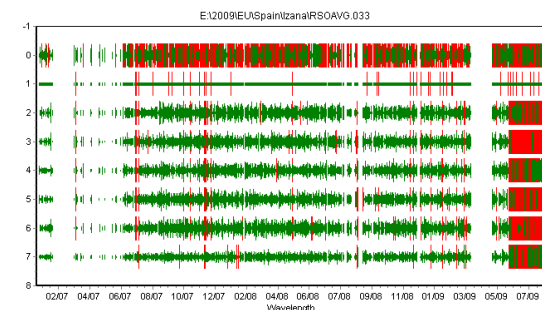
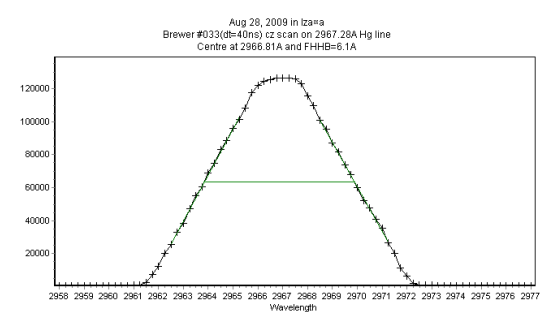
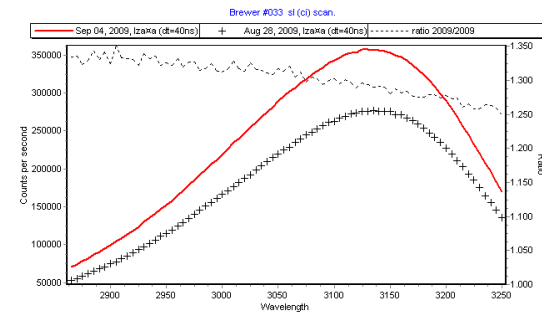
V. Note and graphs of SL, SC, DT, RS, CZ and CI results for the MKII Brewer #033:

The instrument required servicing a few months ago and the heat sink assembly was replaced to fix high voltage problem. The larger mirror was adjusted since Hg test would not work which was wrong method to use. The spectrometer alignment was completed during this visit, which did not require any large adjustments. The standard lamp was replaced and the zenith drive aligned. The initial sun scan results in first graph below showed that the cal step setting of 919 should be adjusted to 912. After the re-alignments the final cal step setting was 916 as shown in second graph. The last graph shows final and previous SL CI scans, note the higher intensity level now.

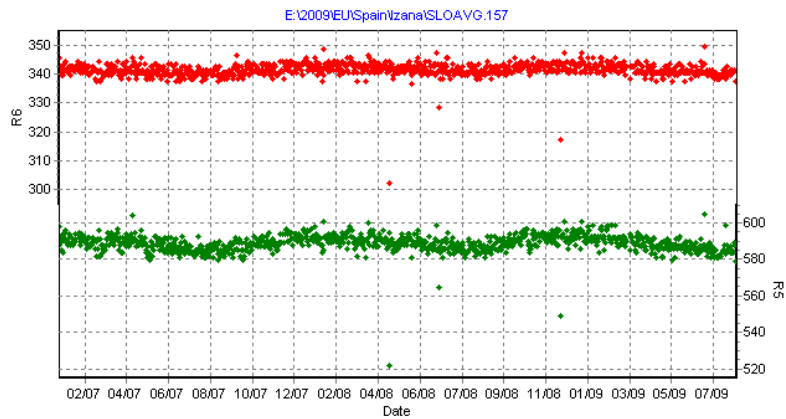
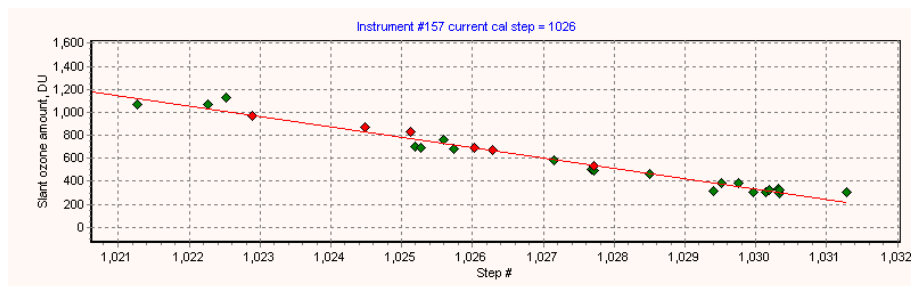
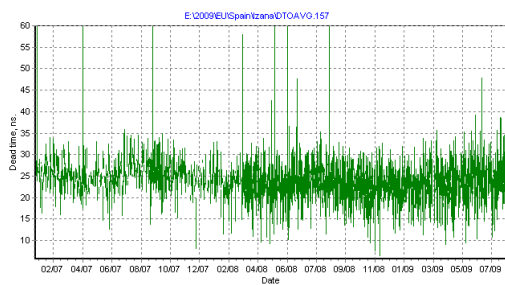
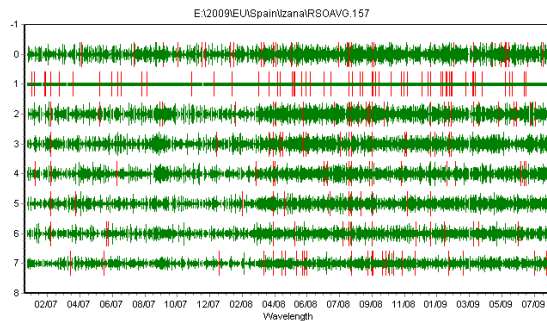
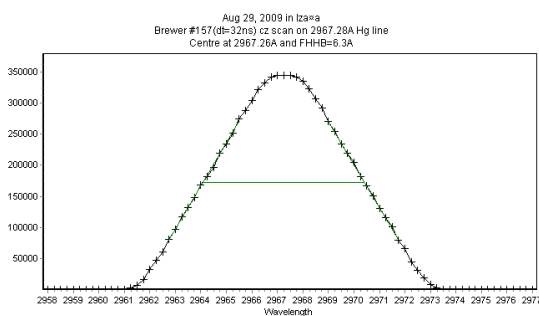
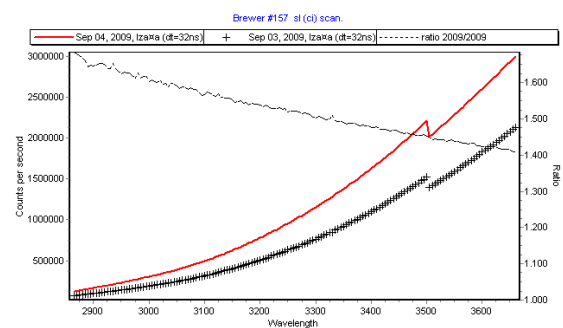
VI. Below are graphs of MKIII Brewer #157 of SL, SC, DT, RS, CZ and CI results:

In the past 2 years the lamp test results from #157 have continued to be very stable. During this visit the standard lamp was replaced and power adjusted to increase intensity, reference the last graph. The sun scan results show cal step 1026 is still the proper position.

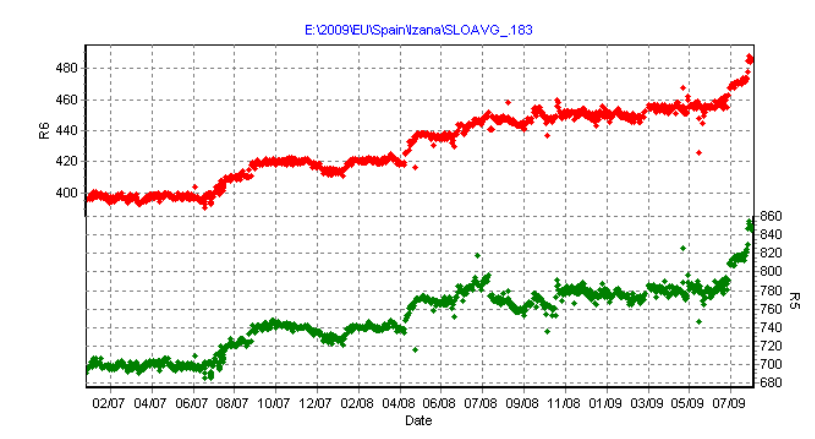
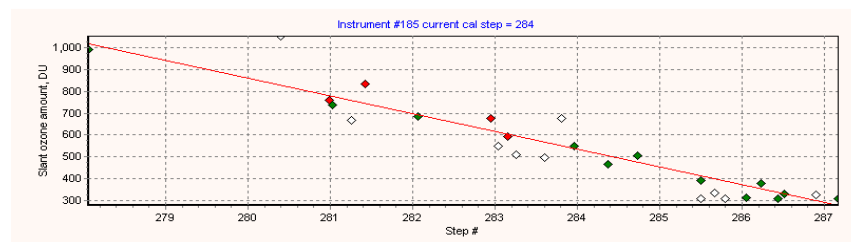
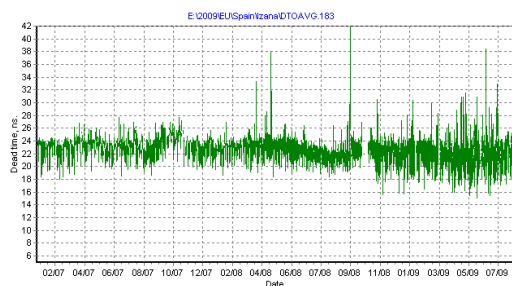
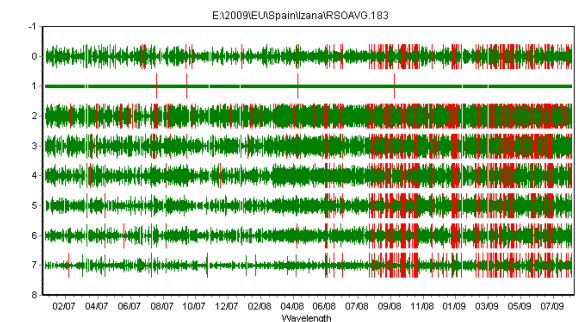
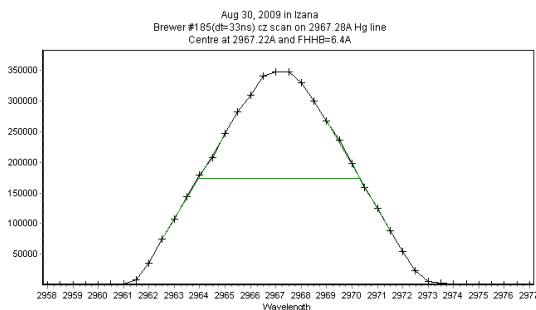
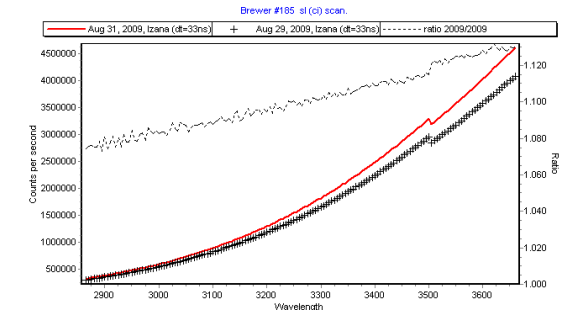
VII. Below are graphs of SL, SC, DT, RS, CZ and CI test results from the MKIII Brewer #183:

Note the increasing SL ratios, the noisier DT and RS results in past year. The shutter alignment on the slits was improved and the SL ratios decreased to 335/560 and the other test results improved. The sun scan results show cal step 1021 is still the proper setting for Hg calibration tests. The last graph shows the difference of CI scans before and after replacement of SL and shutter adjustment.

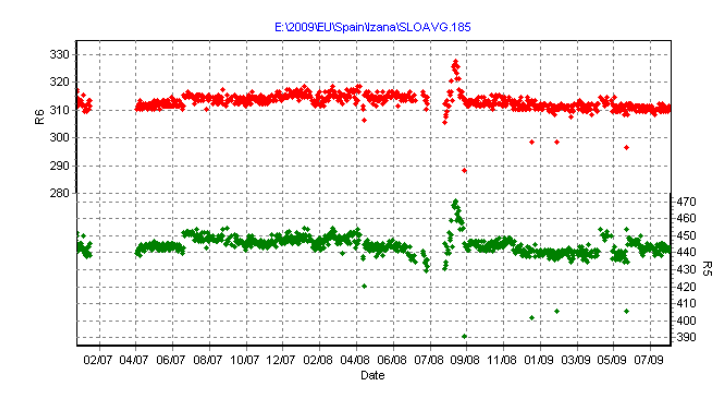
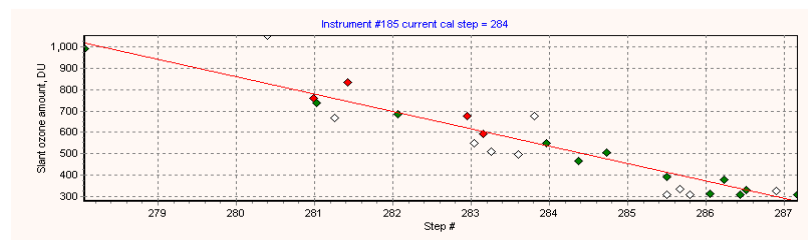
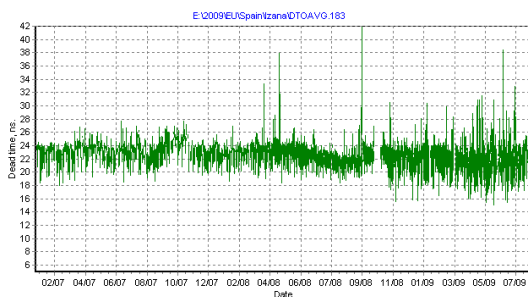
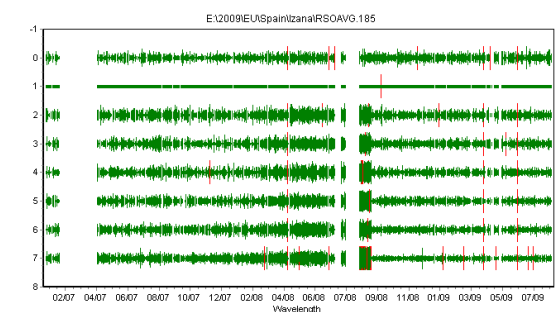
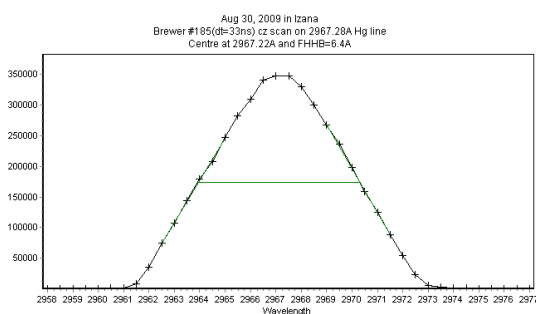
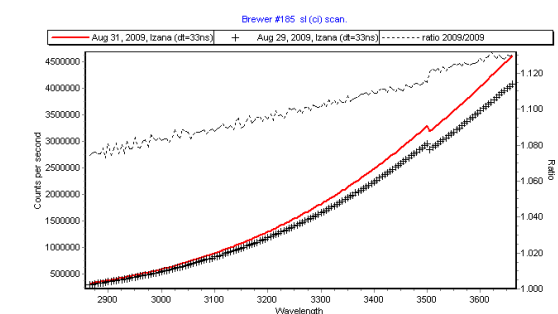
VIII. Below are graphs of SL, SC, DT, RS, CZ and CI test results from the MKIII Brewer #185:

All test results show quite good stability. The instrument had traveled to Finland and Switzerland in the past two years. The zenith prism alignment to SL had to be adjusted back to normal setting. The zenith motor has too much torque and periodically runs into end stop and shifts the prism's clamped position. This shift can be first detected by shifts of ~20 steps in zenith solar tracking (horizon correction changes). Some resistors (82 ohm) should be added in the motor wiring to reduce the motor torque. The UV calibration can be affected by this zenith prism alignment shift also. The sun scan results show cal step 284 is still the proper setting for Hg calibration tests. The last graph of SL CI scans, before and after zenith prism assembly alignment to SL.
