Audit report

Subject of measurement	Electricity quality audit	
Measurement requester	ELI Beamlines	
	Za Radnicí 835	
	25241 Dolní Břežany	
Measurement location	Substation	
Measured points	Transformer output	
Purpose of measurement	Determination of actual power quality	
Date	May 4, 2020	Measurement provider
Measurement performed by	Petr Nedorost	Blue Panther, s.r.o. Mezi Vodami 29, 143 00 Prague 4 Tel: 241 762 724
Protocol prepared by	Petr Nedorost	
Equipment used	Installed network analyzer	
List of attachments

Measurement report

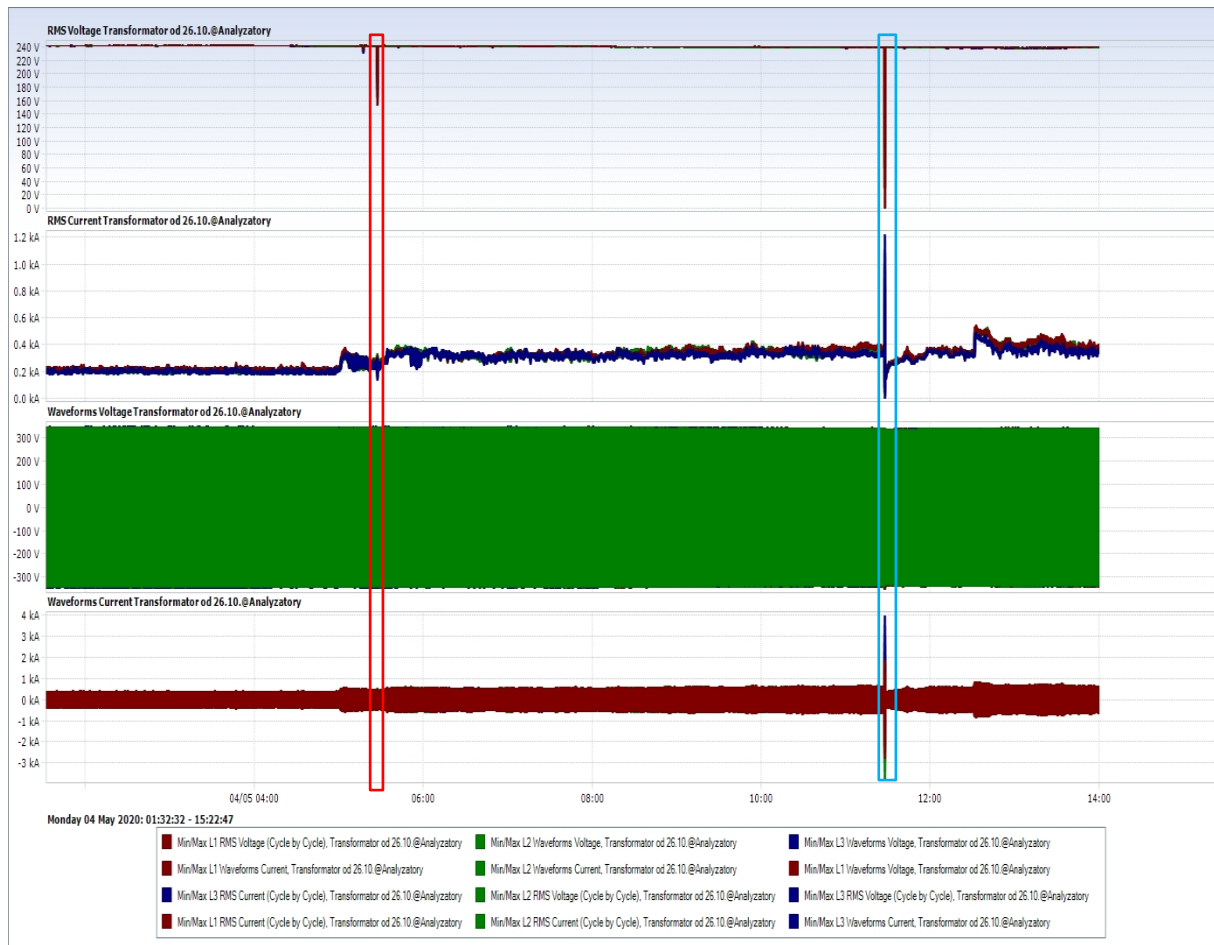
Fig. 1 shows the time course of the recording of phase U, I, and their envelopes during the day. Two significant drops are recorded in the network voltage. The marked details are shown in the following figures.

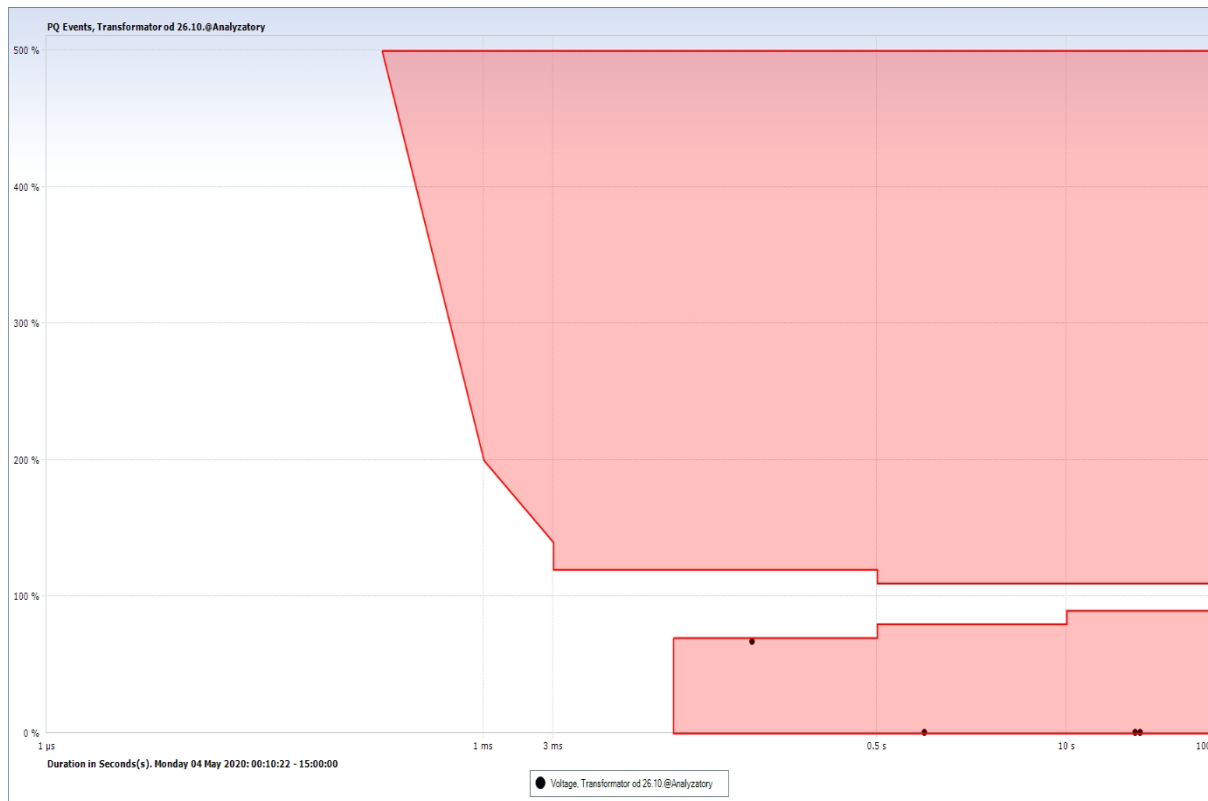
Fig. 2 The CBEMA curve shows voltage drops in the superordinate network. All voltage drops are outside the tolerance limits of EN 50160 (white field).

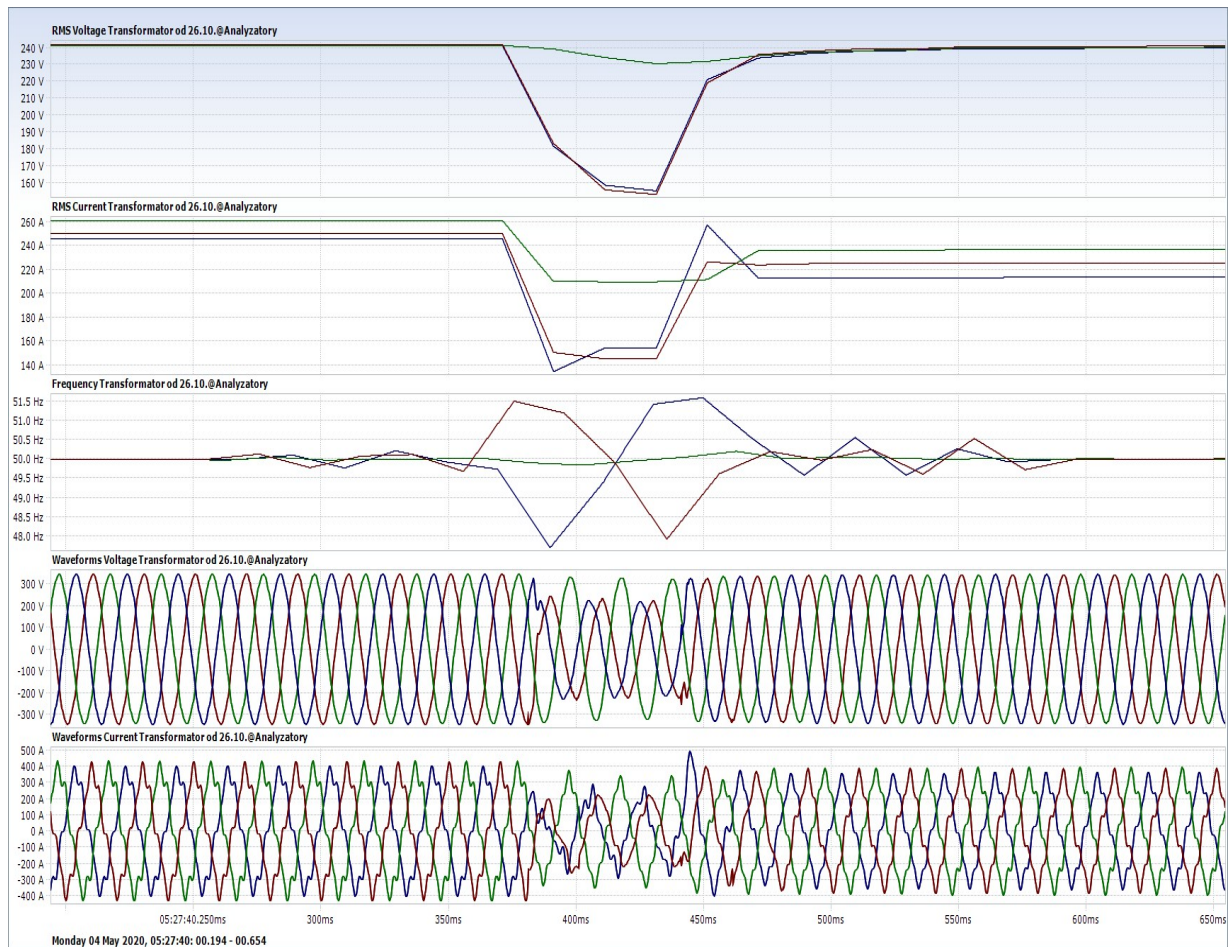
Fig. 3 shows a red detail of **Fig. 1**. The middle trace frequency shows deviations from normal (51.5 Hz) in phases 1 and 3. The voltage dropped below 160 V in these two phases.

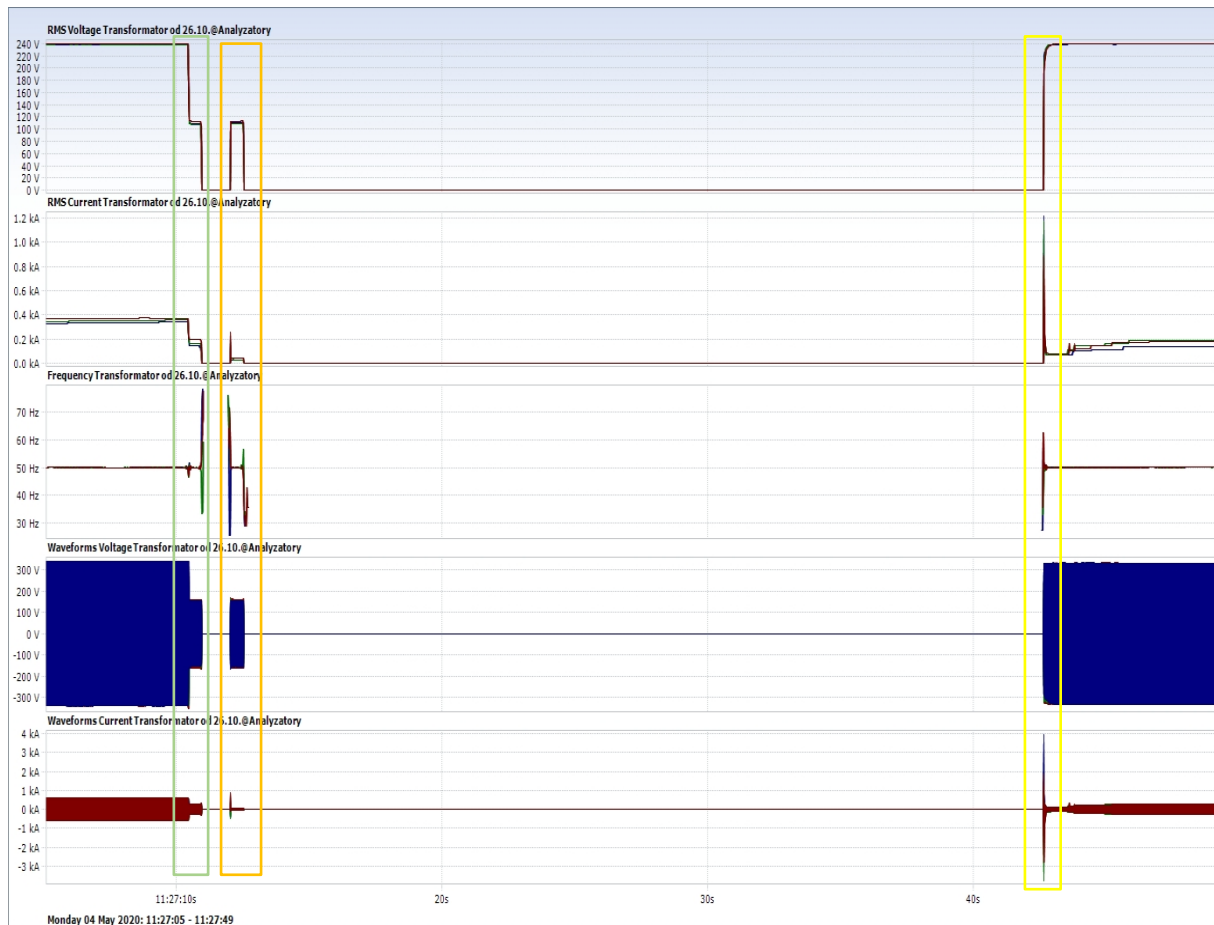
Fig. 4 shows the blue detail of **Fig. 1**. The middle trace frequency shows significant changes. The duration of the outage was approximately 30 s. The curves can be seen in the following figures.

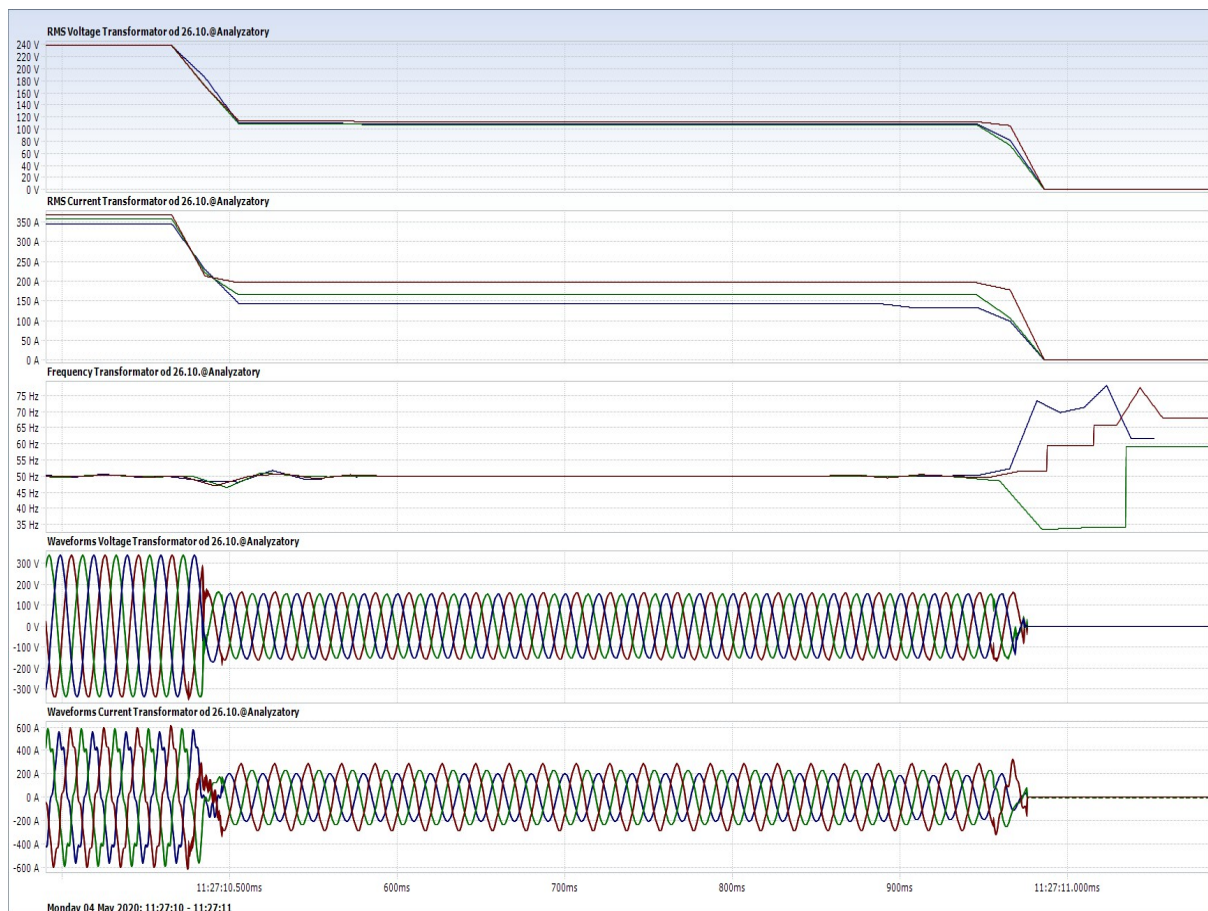
Fig. 5 shows the green detail of **Fig. 4**. The middle trace frequency shows slight fluctuations. At this time, the voltage dropped to approximately 110 V.

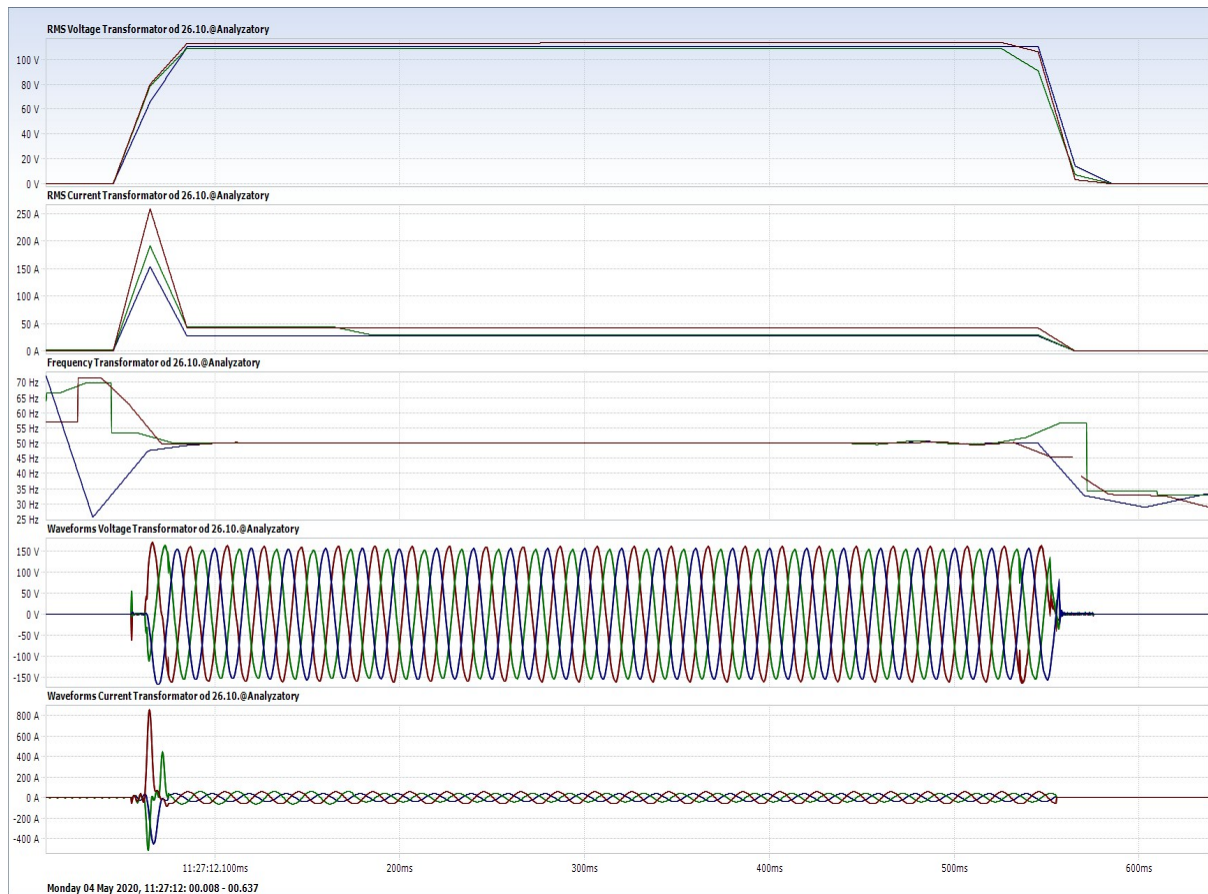
Fig. 6 shows the orange detail of **Fig. 4**. The voltage was switched on and off again for a total duration of 500 ms, and the voltage was again 110 V.

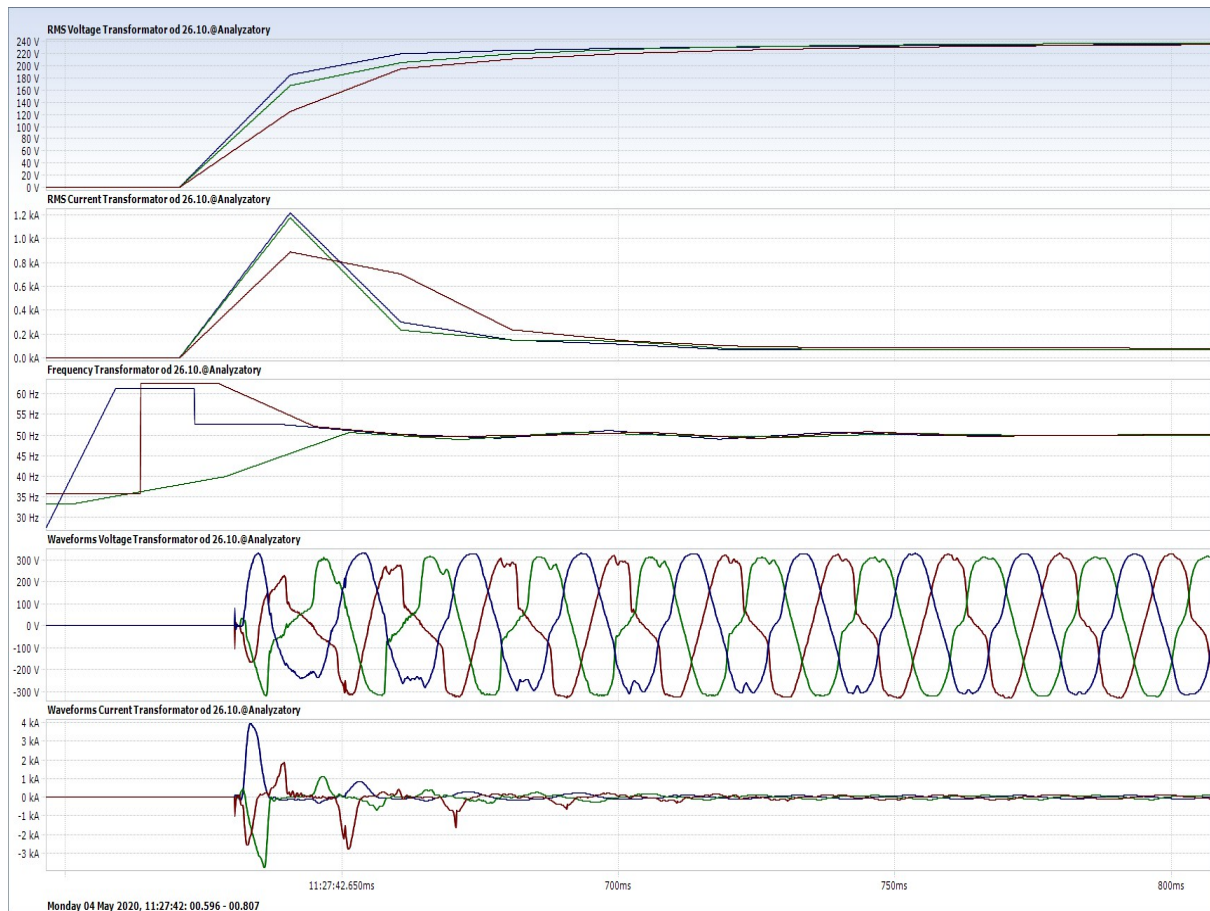
Fig. 7 shows the yellow detail in **Fig. 4**. Restarting with normal voltage.
