Technical Service Information

CHRYSLER A518 (46RH) AND 46RE BROKEN FRONT PLANETARY

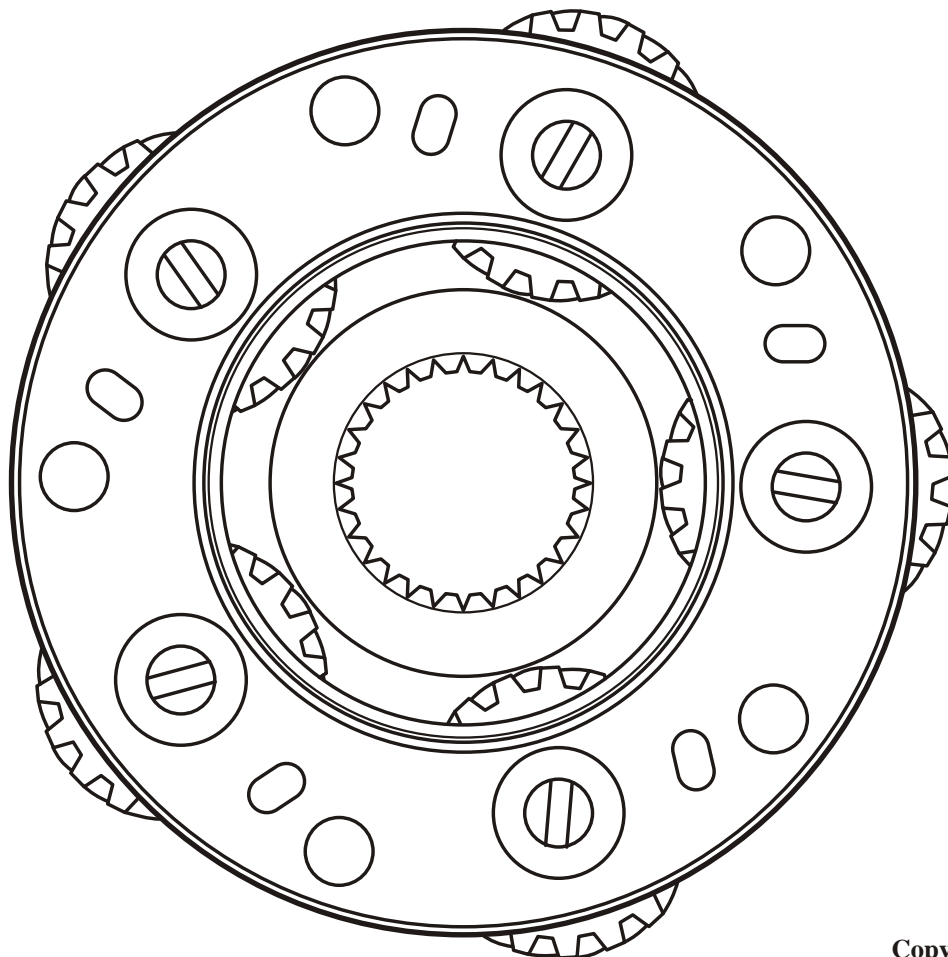
Figure 1

5 PINION STEEL FRONT CARRIER OEM PART NUMBER 4617998

CORRECTION: There is now available under OEM part number 4617998, a new design 5 pinion, steel front planetary carrier, as shown in Figure 1. The 5 pinion, steel front carrier also requires a 5 tang thrust washer for the back side of the carrier and is available under OEM part number 4539129, as shown in Figure 2. These parts should be installed in all Diesel engine equipped vehicles, and any vehicle carrying heavy loads.

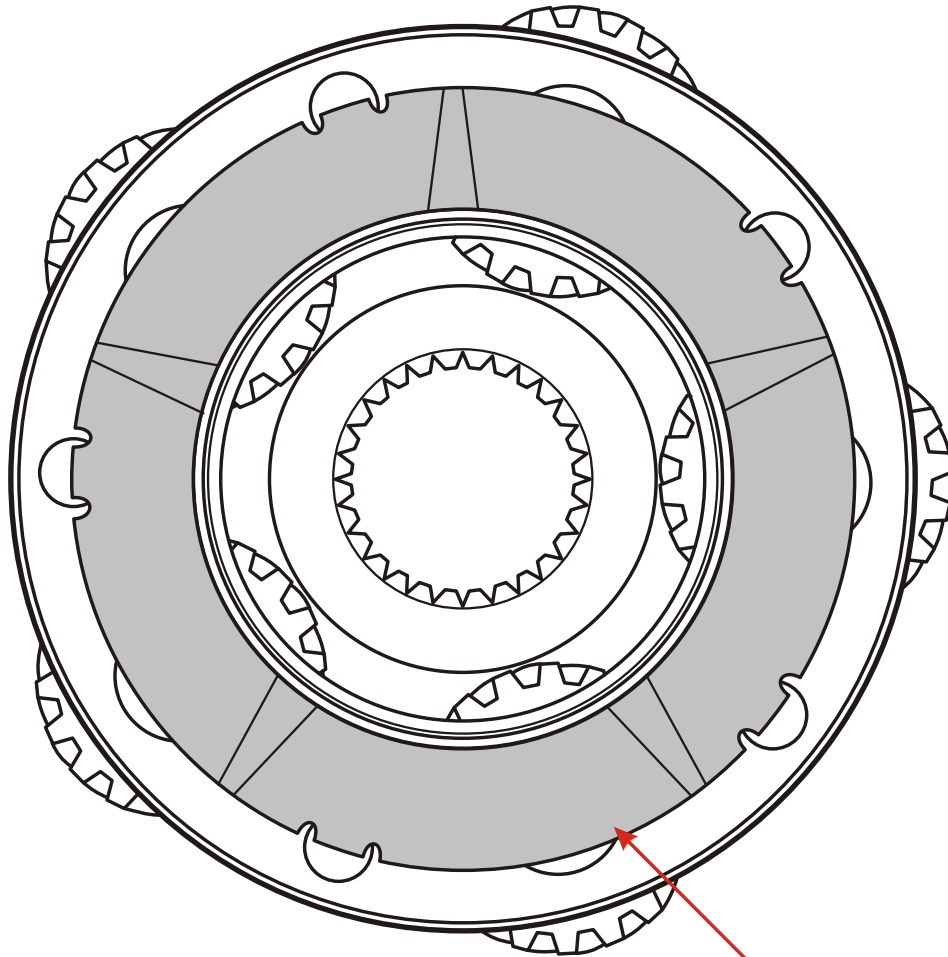
*View looking at back side of carrier
with 5 tang thrust washer in place.*

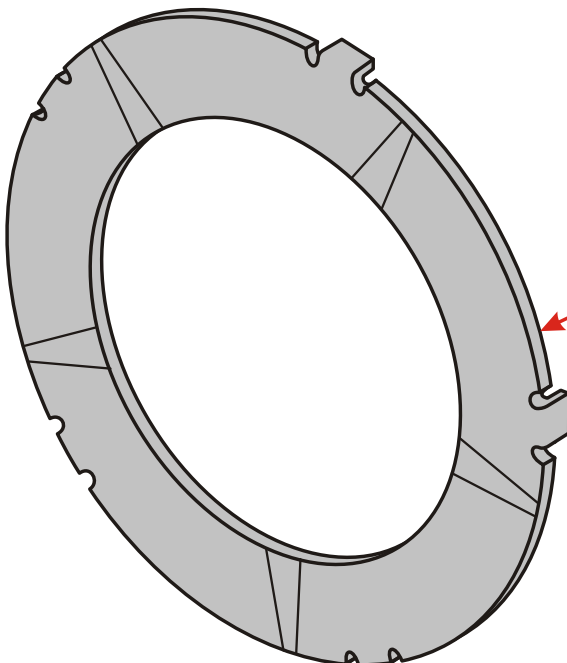
*5 Tang Thrust Washer 4539129
Required with 5 pinion Carrier.*
