Technical Service Information

TOYOTA A340 MULTIPLE SHIFT PROBLEMS

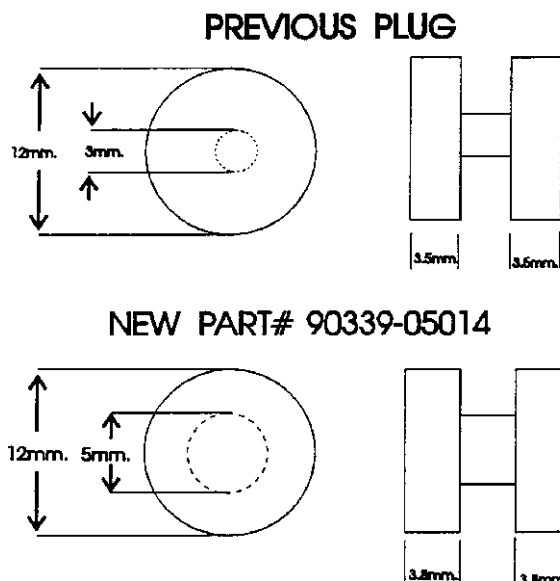
Figure 1

COMPLAINT: Multiple shift problems including misses 2nd gear, misses 3rd gear, no downshift, no overdrive, or cannot cancel overdrive.

CAUSE: Broken or cracked end plugs. Problem may not be visible unless valves are removed

CORRECTION: Install updated (stronger) end plugs, also replace retainers designed to accommodate the new end plugs (see figures 1 & 2).
